VIKING LANDER MOSAICS

VIKING LANDER 2 RECTIFIED PHOTOMOSAIC
MORNING SCENE-CAMERA 2-SECTOR 1

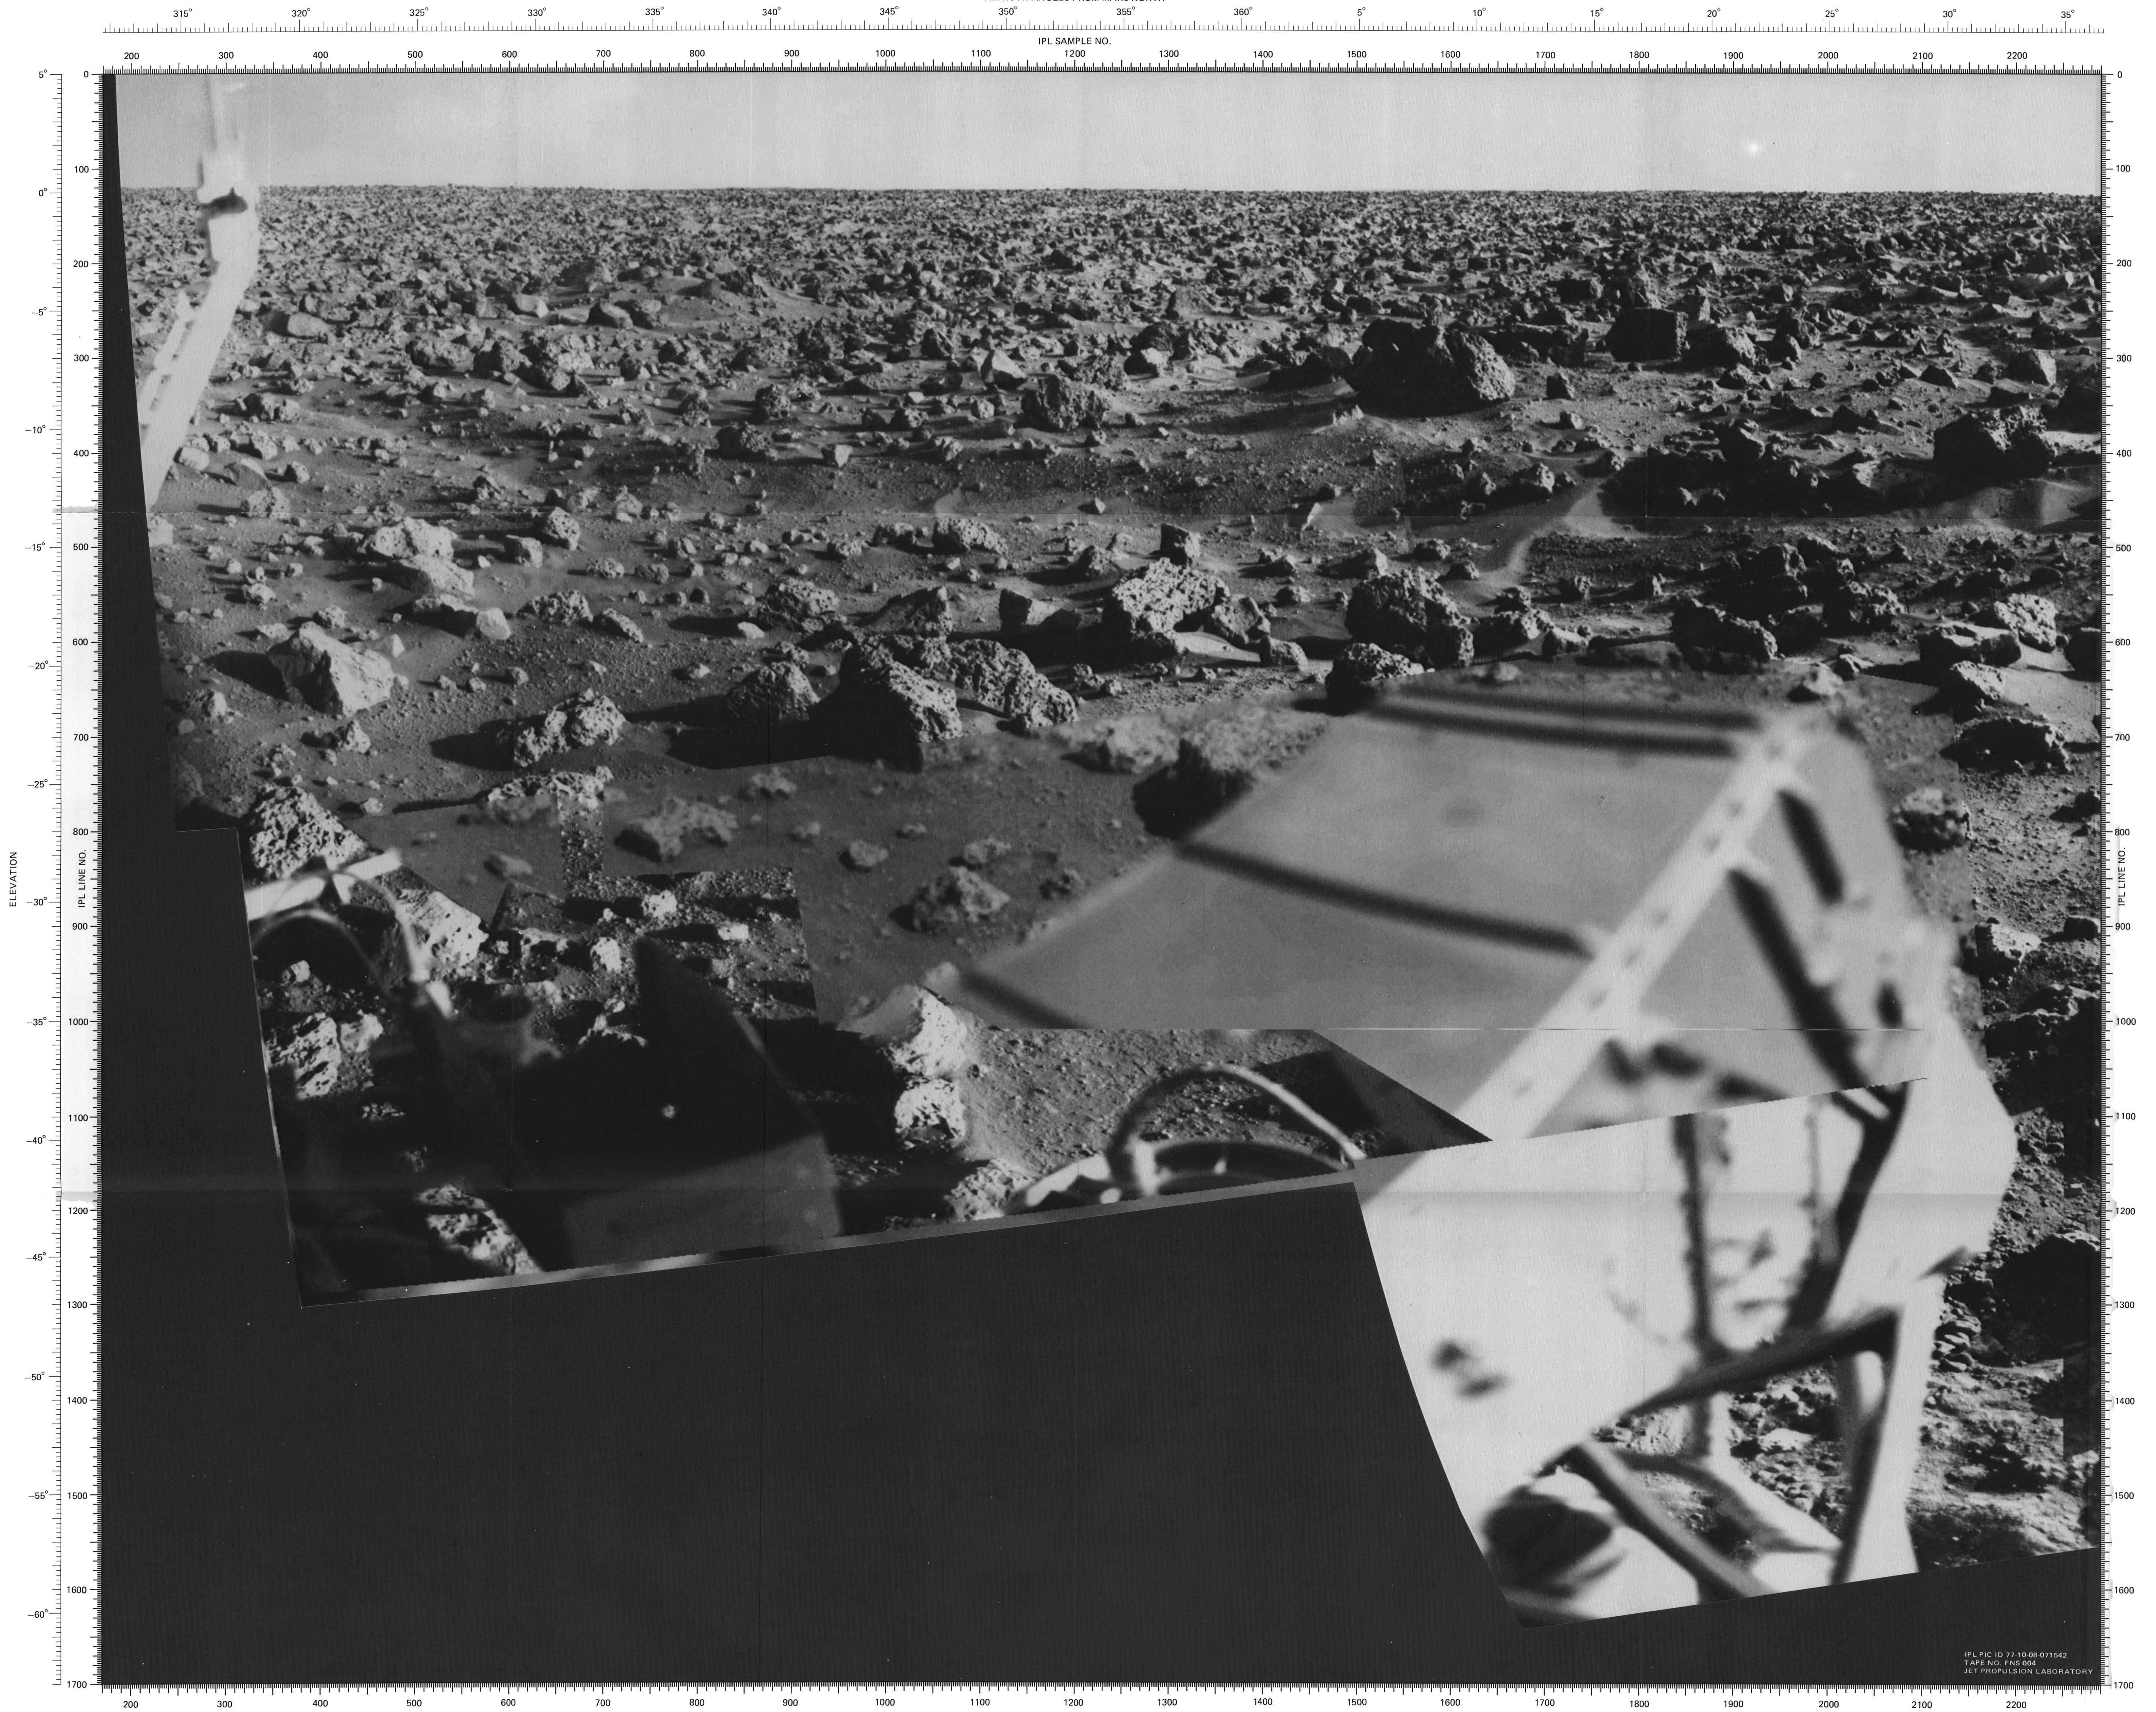
This view north of the lander shows the level rock-strewn plains of Utopia Planitia. Some of the large blocks appear to lie on the fine-grained material that partly covers the interblock areas. This appearance probably is due to scour or erosion by the martian winds that have carried away the fine-grained material from between the larger rocks. Some of the boulders seem to stand on pedestals of the protected material (line 320, sample 1130). Most of the rocks are highly pitted or vesicular. The vesicles probably formed from gas bubbles in a cooling lava. A few of the rocks are fine-grained and appear to be loessic, probably by wind erosion (line 430, sample 2320). A shallow trough crosses the main field, trending approximately east-west (line 330, sample 300; line 470, sample 2250). The trough is 8 m from the lander, about 1 m wide, and 10 cm deep. Small drifts occupy the floor of the trough (line 460, sample 1050). The trough is part of a polygonal network which suggests that it may have formed from cracks owing to contraction during cooling of a basaltic lava flow or to thermal expansion and contraction of frozen ground.

The meteorological instruments used to measure the temperature, pressure, speed, and direction of the martian winds are mounted on the end of the white tubular arm (line 20, sample 290) at the right of the scene. The prominent object at the lower right is the surface sampler (line 800, sample 1750). The true form of the instrument is not apparent in the mosaic; three pictures were taken when the instrument was in different positions so that a minimum of the surface would be occulted.

The cameras on the Viking Lander acquire data by sampling in equal increments of elevation and azimuth angle. In the accompanying mosaic, 8 mm subtends a 1° horizontal or vertical angle, regardless of the place of measurement within the panorama. If the martian surface were flat, one pixel (0.04°) on the surface would be 1 mm wide at 40° camera elevation and 2 m wide at the horizon 3 km away. Characteristically for this type of imaging system, most straight lines in the scene appear curved in the reconstruction. This representation of the picture data differs from that of a conventional camera having "point perspective" picture geometry, in which rays are projected from object space, through the perspective point of the camera lens, to an image plane in the camera.

The geometry of the lander pictures is complicated by additional factors. Because both landers are tilted with respect to the horizon, on the uncorrected pictures the horizon resembles a sine curve. Computer rectification of the pictures results in a straight horizon along which vertical angles can be measured with respect to the local gravity vector, and horizontal angles can be measured from martian north. These angles are not related in any simple way to the azimuth and elevation angles given in "camera coordinates" for the uncorrected pictures.

There are other geometric distortions due to the camera: optic path distortion that affects a light ray after it passes the camera windows; and camera-system distortions, or "bold-down" errors, that are caused by the way the cameras are mounted on the lander. The geometric transformation used in creating the mosaics took into account the optic path distortion but not the "bold-down" errors. However, along the horizon, the error in azimuth angle is equal to the positional "bold-down" error for each camera to an accuracy of less than 1 pixel. The scale "azimuth angle from Mars north" has been adjusted to take into account this correction.

The residual azimuth angle errors are less than 1 pixel along the horizon and become larger with steeper elevation angles and larger lander tilts. For the worst case, Lander 2, camera 1, this error is a maximum of 5.7, 1 pixel at 40° elevation. The somewhat sinusoidal azimuth-dependent residual elevation error is a maximum of 3.1 pixels for Lander 2, camera 1, and approximately 1 pixel for the other cameras.
