THE VIKING MISSION

VIKING LANDER MOSAICS

VIKING LANDER 2 RECTIFIED PHOTOMOSAIC MORNING SCENE-CAMERA 2 - SECTOR 3

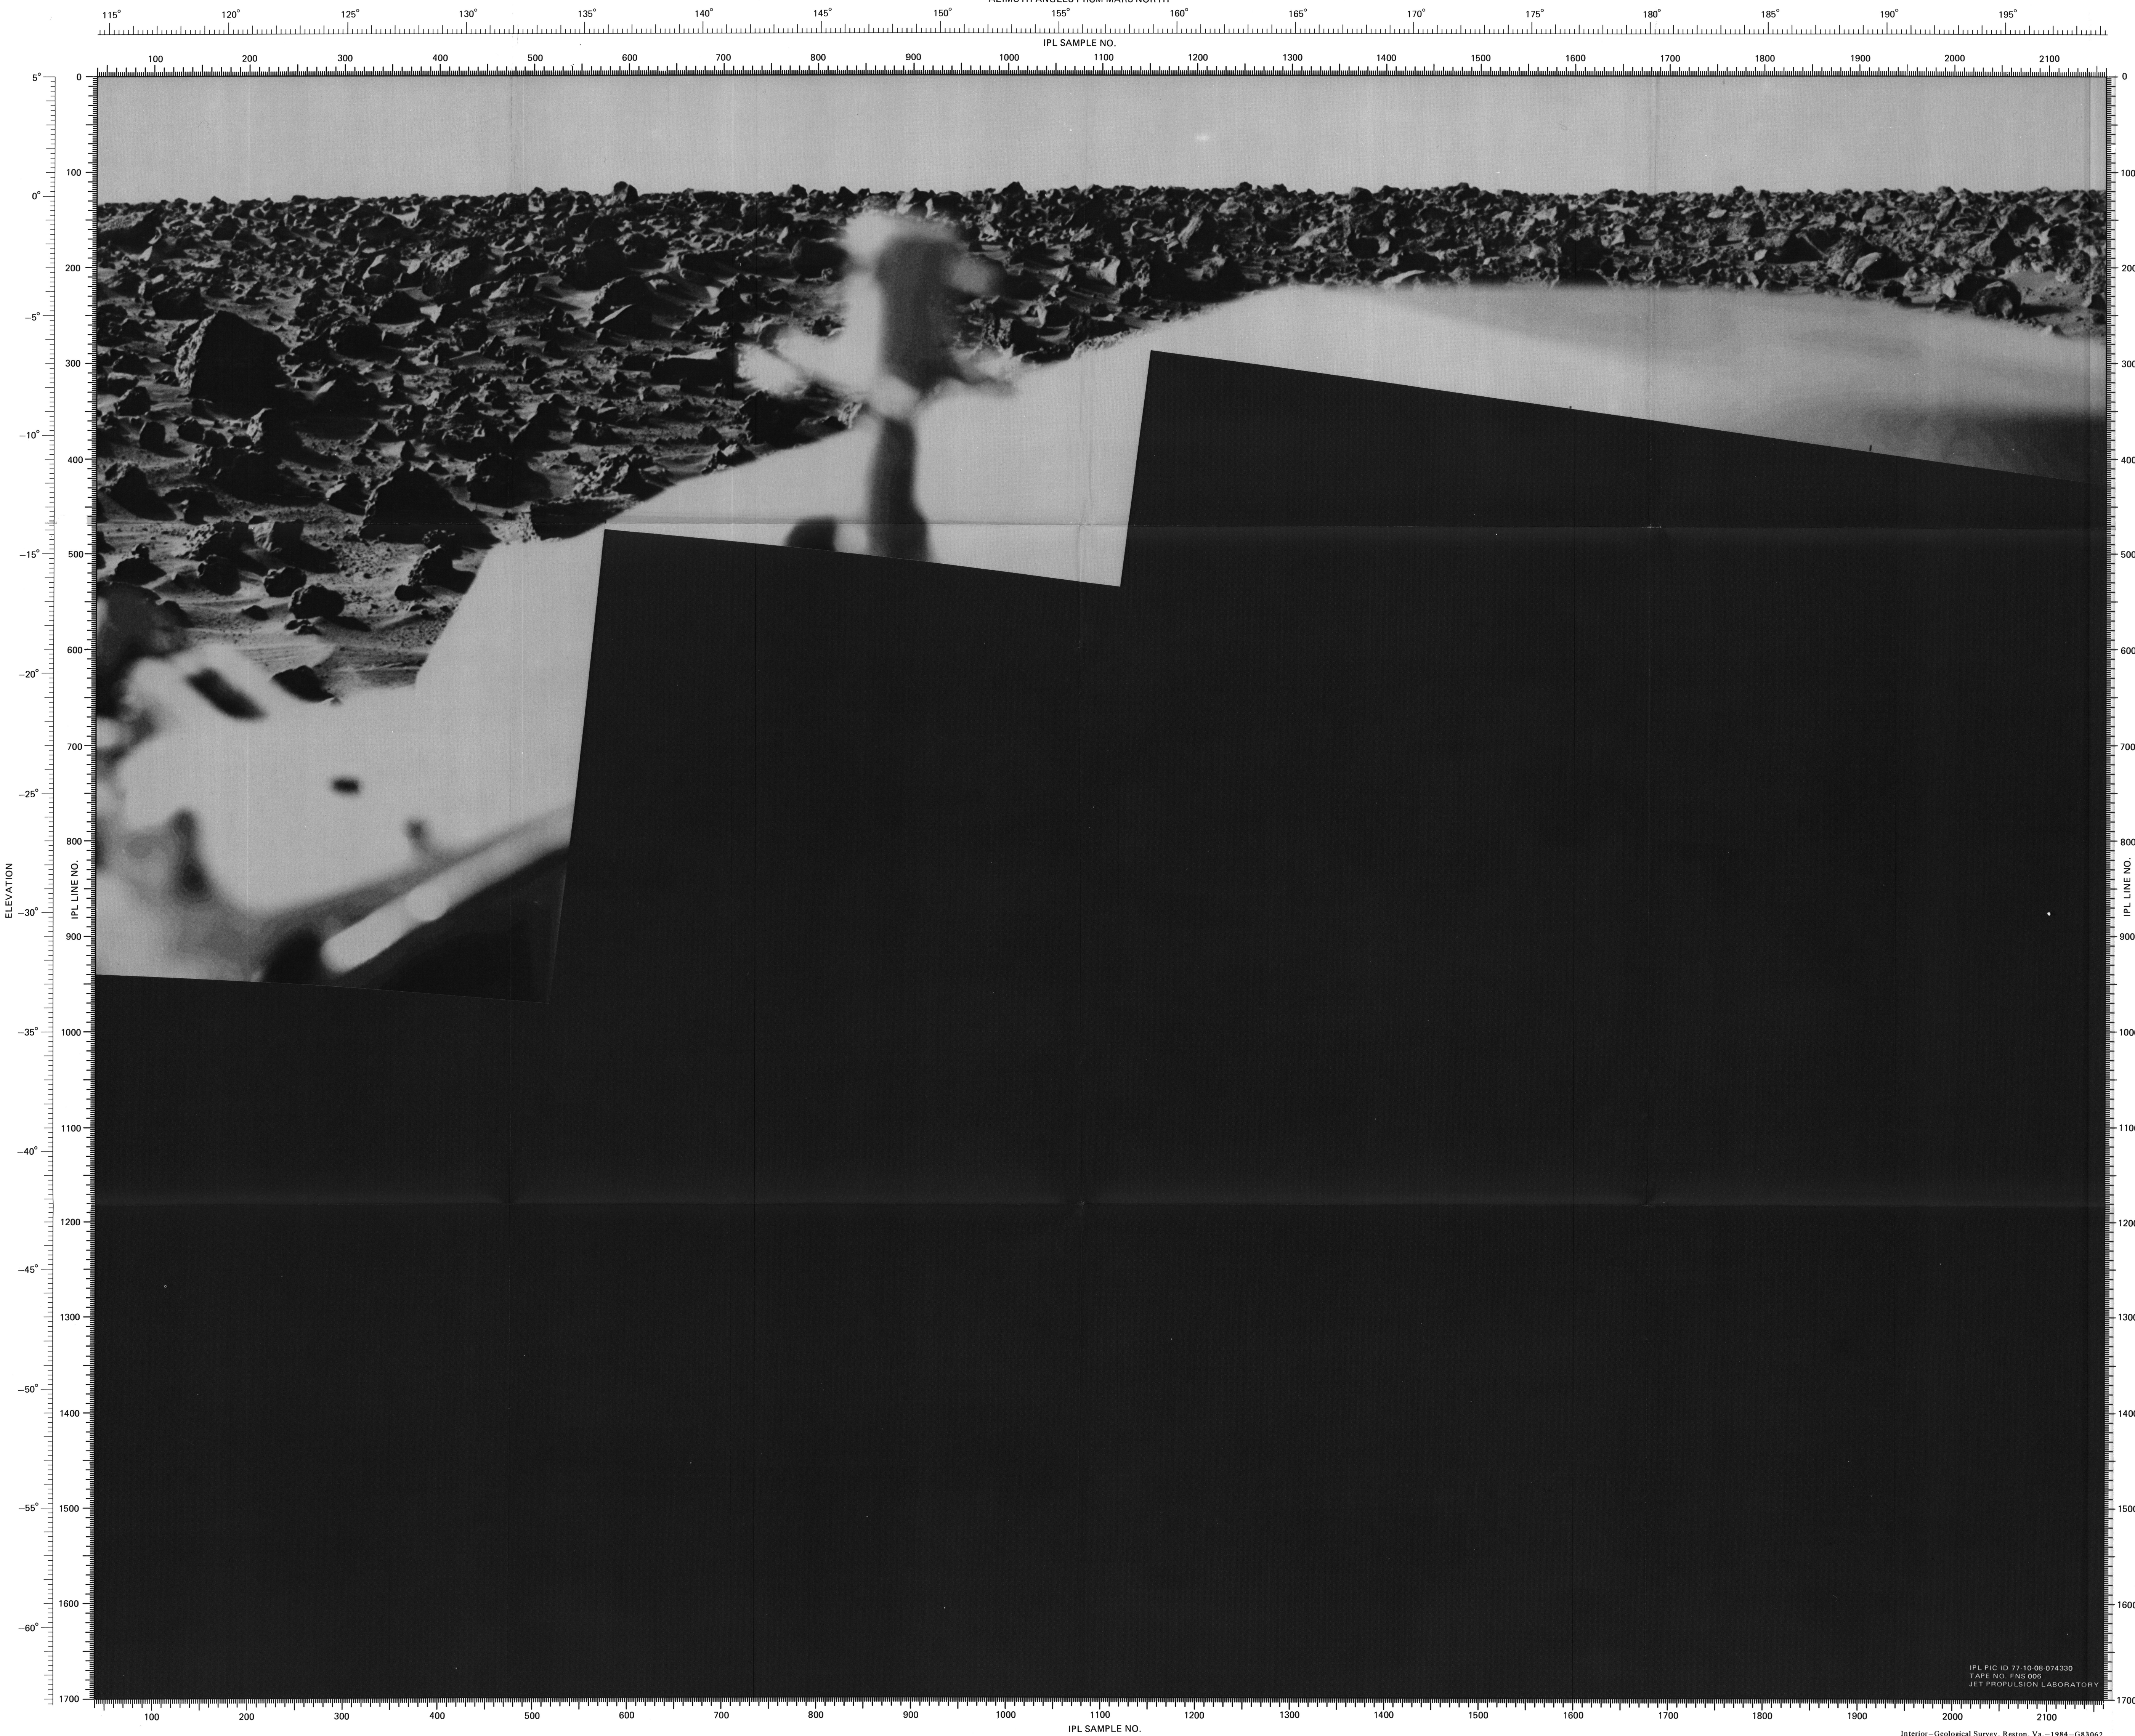
Much of the surface south of the lander is occulted by the spacecraft because the view is over the top of the lander. The flat-level plain is littered with large subangular, equidimensional pitted blocks. A few small drifts of fine-grained material are scattered among the blocks.

Parts of the spacecraft that occult the scene are the Radioscope Thermoelectric Generator (RTG) (line 300, sample 1600) and the low-gain S-band antenna (line 250, sample 900).

The cameras on the Viking Lander acquire data by sampling in equal increments of elevation and azimuth angle. In the accompanying mosaic, 8 mm subpixels are 1° horizontal or vertical angle, regardless of the place of measurement within the panorama. If the martian surface were flat, one pixel (0.04°) on the surface would be 1 mm wide at 40° camera elevation and 2 m wide at the horizon 3 km away. Characteristically for this type of imaging system, most straight lines in the scene appear curved in the reconstruction. This representation of the picture data differs from that of a com-

The geometry of the lander pictures is complicated by additional factors. Because both landers are tilted with respect to the horizon, on the uncorrected pictures the horizon resembles a sine curve. Computer rectification of the pictures results in a straight horizon along which vertical angles can be measured with respect to the local gravity vector, and horizontal angles can be measured from martian north. These angles are not related in any simple way to the azimuth and elevation angles given in "camera coordinates" for the unrectified pictures.

There are other geometric distortions due to the camera: optic path distortion that affects a light ray after it passes the camera windows; and camera-system distortions, or "bolt-down" errors, that are caused by the way the cameras are mounted on the lander. The geometric transformation used in creating the mosaics took into account the optic path distortion but not the "bolt-down" errors. However, along the horizon, the error in azimuth angle is equal to the rotational "bolt-down" error for each camera to an accuracy of less than 1 pixel. The scale "azimuth angles from Mars north" has been adjusted to take into account this correction.

The residual azimuth angle errors are less than 1 pixel along the horizon and become larger with steeper elevation angles and large lander tilts. For the worst case, Lander 2, camera 1, this error is a maximum of 5.7 pixels at 40° elevation. The somewhat sinusoidal azimuth-dependent residual elevation error is a maximum of 3 pixels for Lander 2, camera 1, and approximately 1 pixel for the other cameras.
