THE VIKING MISSION

VIKING LANDER MOSAICS

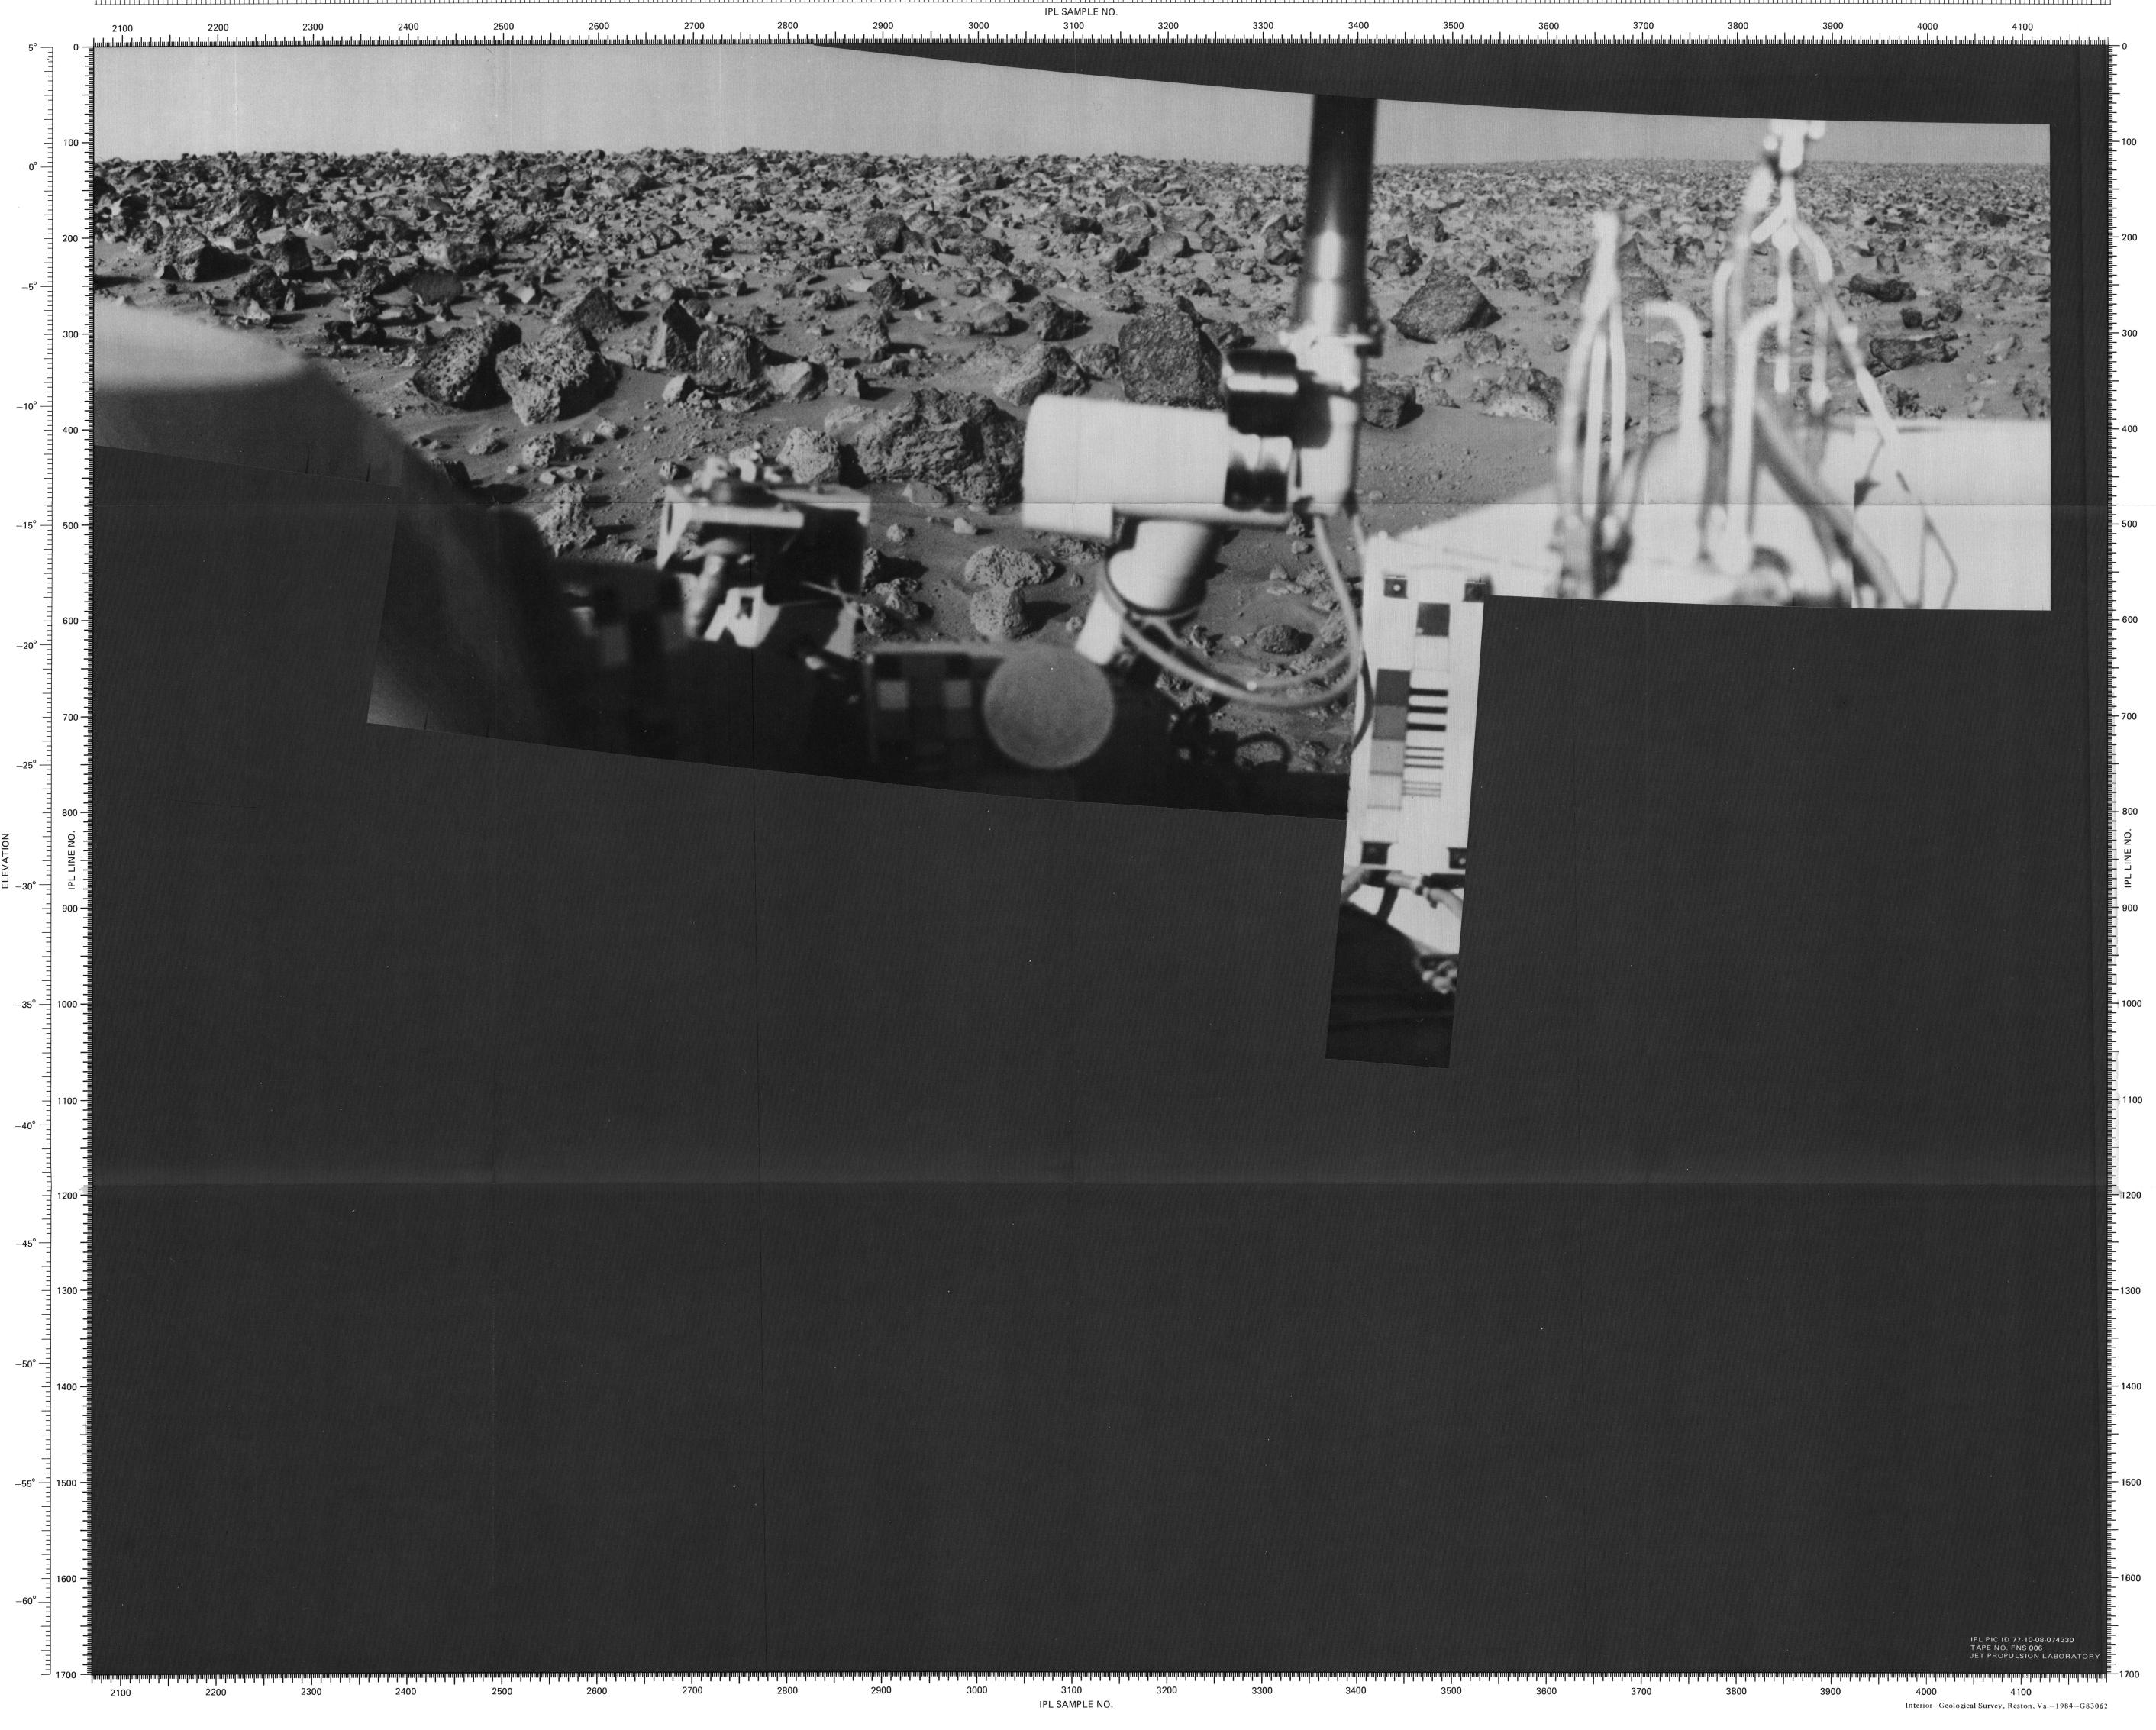
DESCRIPTION OF SCENE This view southwest over the top of the lander shows the same flat-level surface of Utopia Planitia as is viewed in all directions from the lander. The distribution of the large, subangular pitted or vesicular blocks is nearly uniform in all directions out to the horizon. The large blocks appear to lie mostly on the surface of fine-grained material. Distributed among the blocks are a few small drifts of the fine-grained material. The martian winds have probably scoured and winnowed away the fine-grained material from between the blocks and sculpted the drifts. Parts of the lander that are seen in the view are from the left: a cover over a Radioisotope Thermoelectric Generator (RTG) (line 350, sample 2300); mounting structure for Leg 1 (line 500, sample 2800); three calibration test charts for the cameras (line 600, sample 2600; line 700, sample 2950; line 650, sample 3470); a parabolic mirror for viewing the magnets on the surface-sampler backhoe (line 690, sample 3080); the mast that supports the high gain S-band antenna, (line 250, sample 3380); the cover over the other RTG (line 450, sample 4050); tubes and cables that connected the lander to the orbiter during transit to Mars (line 200, sample 3850). Upon command from Earth, the lander separated from the orbiter and performed all of its preprogrammed landing maneuvers under its own

GEOMETRY OF THE MOSAICS The cameras on the Viking Lander acquire data by sampling in equal increments of elevation and azimuth angle. In the accompanying mosaic, 8 mm subtends a 1° horizontal or vertical angle, regardless of the place of measurement within the panorama. If the martian surface were flat, one pixel (0.04°) on the surface would be 1 mm wide at -60° camera elevation and 2 m wide at the horizon 3 km away. Characteristically for this type of imaging system, most straight lines in the scene appear curved in the reconstruction. This representation of the picture data differs from that of a con-

ventional camera having "point perspective" picture geometry, in which rays are projected from object space, through the perspective point in the camera lens, to an image The geometry of the lander pictures is complicated by additional factors. Because both landers are tilted with respect to the horizon, on the uncorrected pictures the horizon resembles a sine curve. Computer rectification of the pictures results in a straight horizon along which vertical angles can be measured with respect to the local gravity vector, and horizontal angles can be measured from martian north. These angles are not related in any simple way to the azimuth and elevation angles given in "camera coordinates" for the unrectified pictures. There are other geometric distortions due to the camera: optic path distortion that affects a light ray after it passes the camera windows; and camera-system distortions, or "bolt-down" errors, that are caused by the way the cameras are mounted on the lander. The geometric transformation used in creating the mosaics took into account the optic path distortion but not the "bolt-down" errors. However, along the horizon, the error in azimuth angle is equal to the rotational "bolt-down" error for each camera to an accuracy

of less than 1 pixel. The scale "azimuth angles from Mars north" has been adjusted to take into account this correc-The residual azimuth angle errors are less than 1 pixel along the horizon and become larger with steeper elevation angles and large lander tilts. For the worst case, Lander 2, camera 1, this error is a maximum of 5.7 ± 1 pixels at -60° elevation. The somewhat sinusoidal azimuth-dependent residual elevation error is a maximum of 3 ± 1 pixels for Lander 2, camera 1, and approximately 1 pixel for the other cameras. REFERENCES

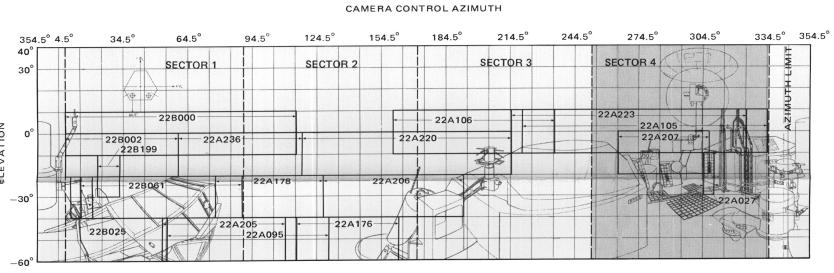
OUTLINE OF CAMERA 2 VIEW SHOWING CAMERA EVENTS USED IN MOSAIC

CAMERA CONTROL AZIMUTH 154.5°
