DESCRIPTION OF SCENE

VIKING LANDER MOSAICS

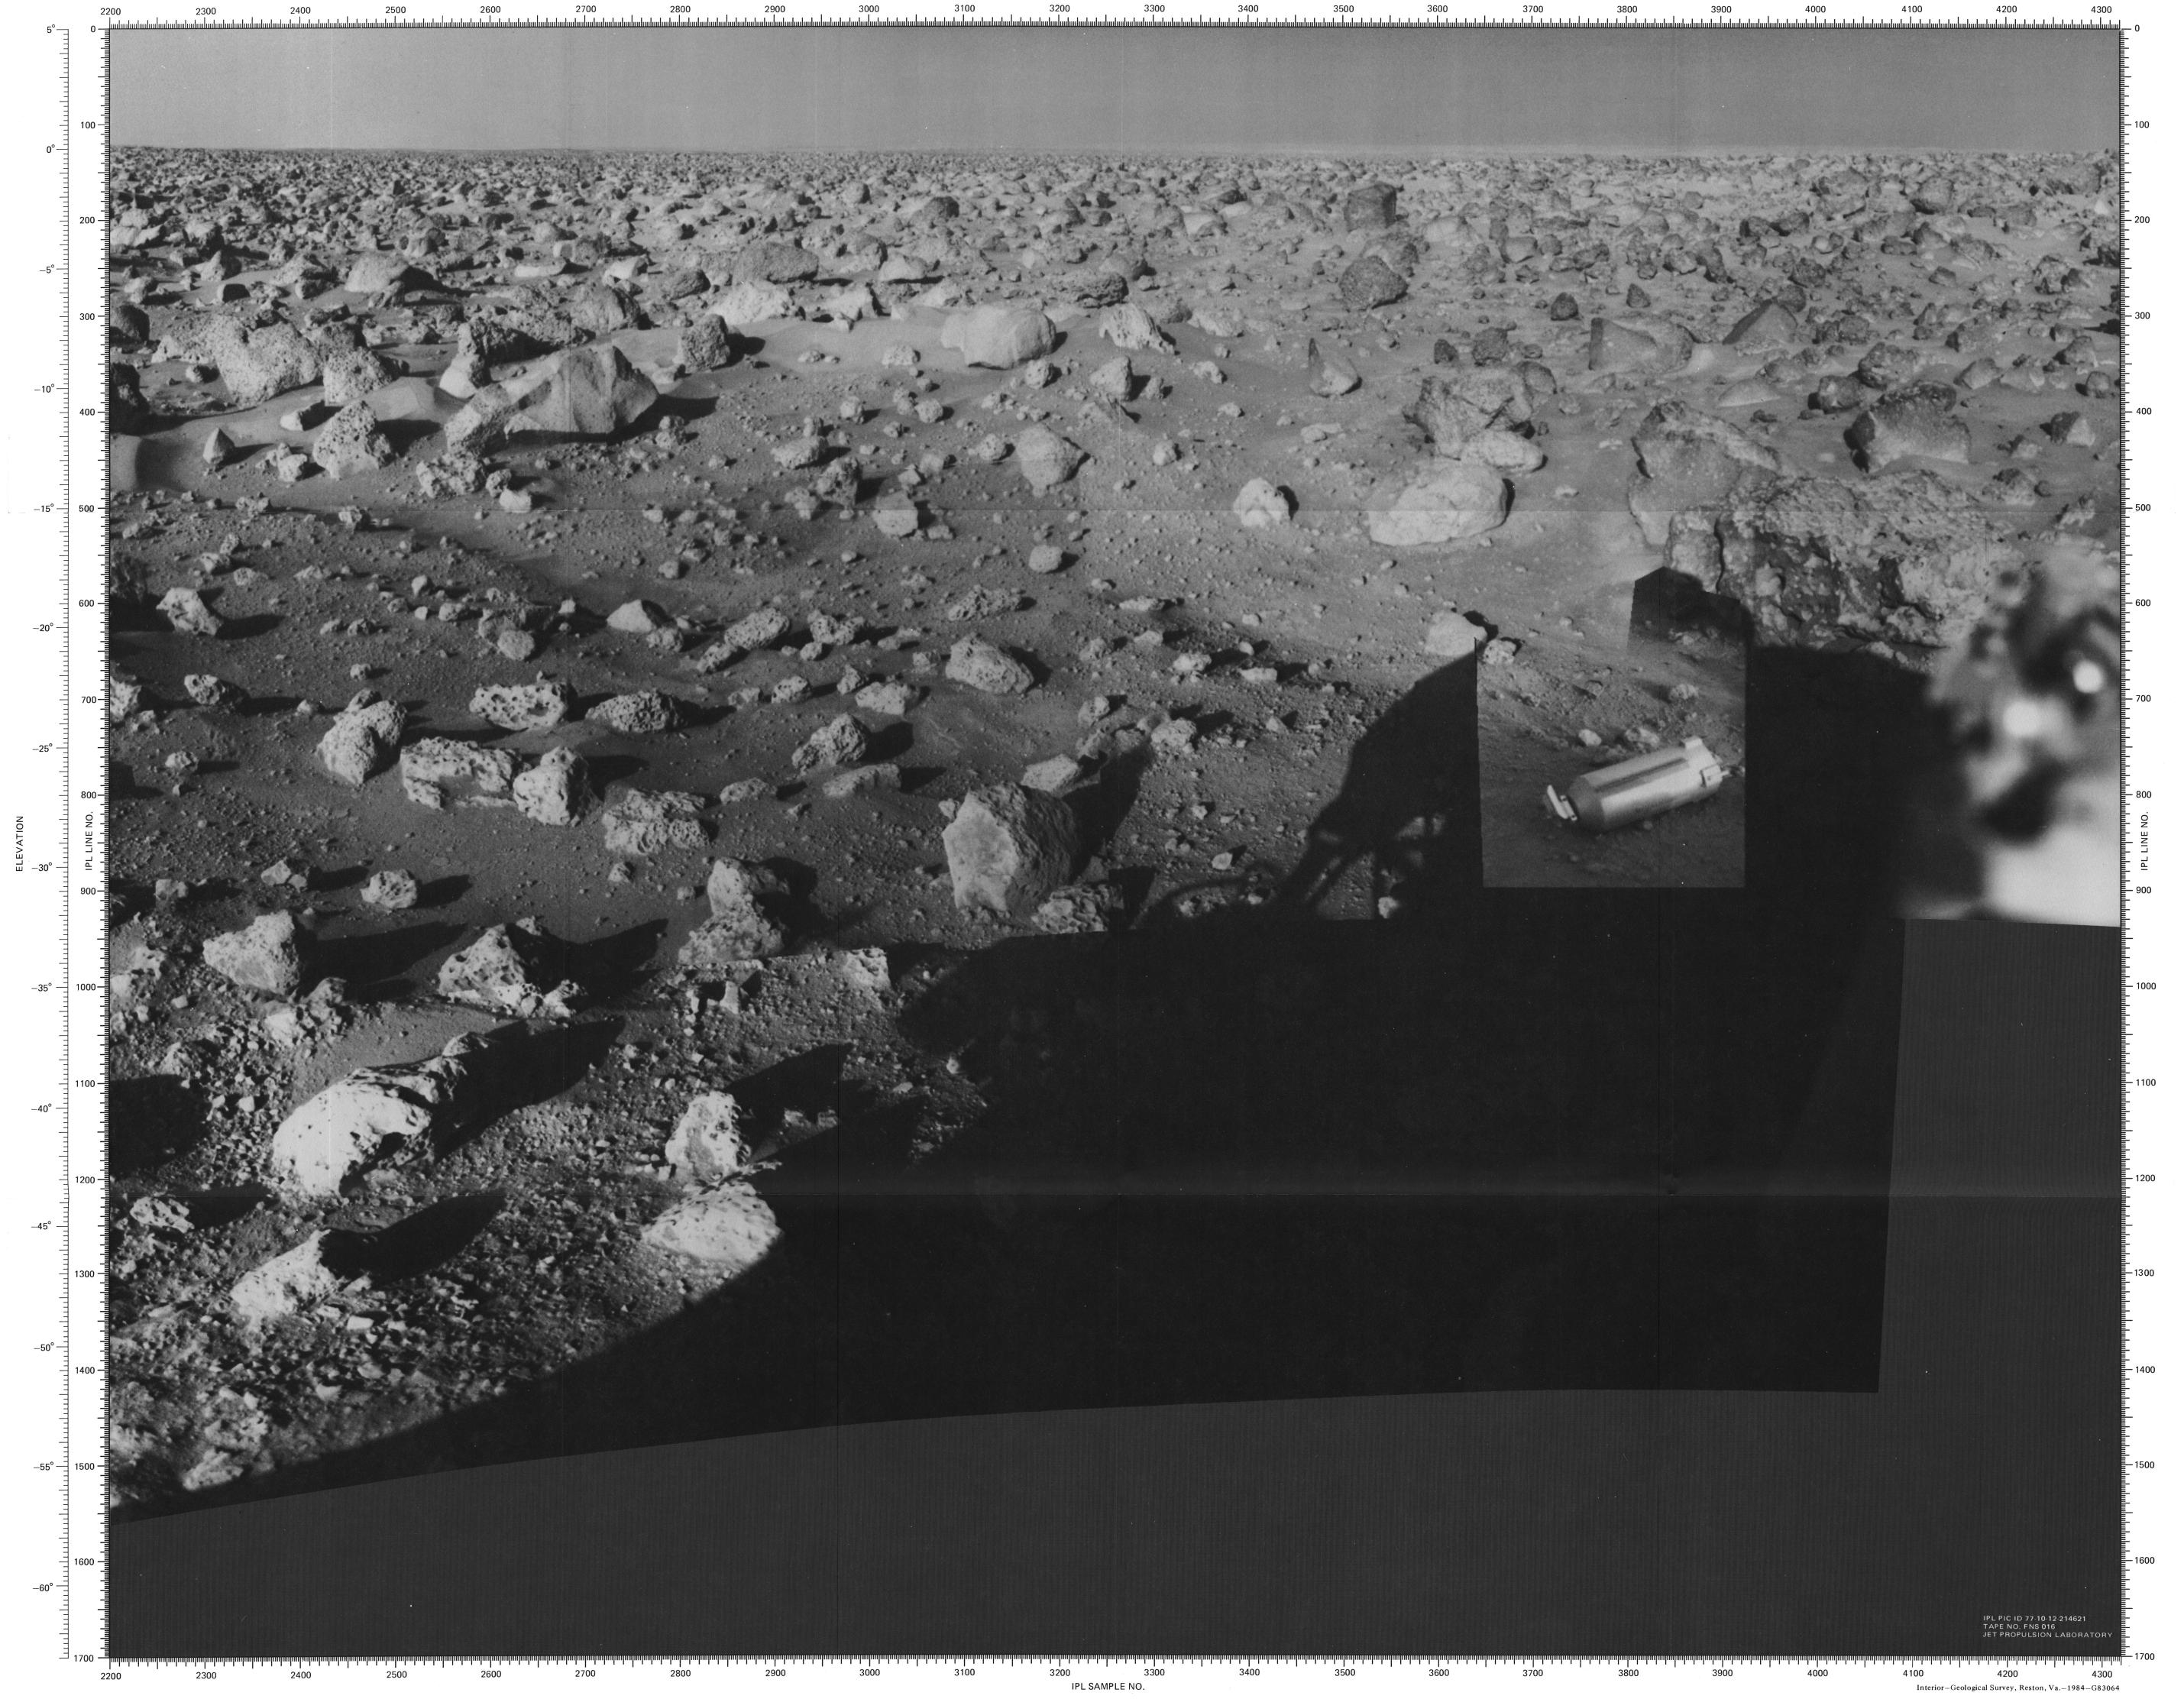
Grid is in spacecraft coordinates

A trough 1 m wide and about 10 cm deep extends from left to right across the foreground 8 m in front of the lander (line 470, sample 2250; line 600, sample 2800). Resting on the far rim of the trough is a large block (line 400, sample 2700) that has many more pits or vesicles on its left end than on its right. The layered appearance of the pits indicates that this rock may have been part of a lava flow in which the left end was near the top where most vesiculation occurred during cooling and solidification. Barely visible in the far distance just above the horizon (line 125, sample 3300) are several bright plateaus which may be ejecta lobes from the crater Mie, a 100-km-diameter crater that lies 170 km east of the lander. The windswept or scoured appearance of the surface at the bottom of the scene immediately below the surface sampler (line 1400, sample 2200) was caused by erosion from the exhaust of the descent rocket engines during landing. A thin veneer of fine-grained sediment has been swept away and the material beneath has been broken into rectangular and polygonal platy fragments. The material that has been broken into the platy fragments has been termed "duricrust" and forms much of the surface in the foreground between the blocks. The crust is a centimeter or two thick. The cylindrical object at the right foreground (line 800, sample 3800) is a hollow metal canister or shroud that covered the surface sampler during transit to Mars. The canister was ejected by command from Earth the second day after landing.

It struck a rock near footpad 3, bounced, and came

to rest at its present position.

The view east shows a flat, rock-strewn land-

scape with a few small drifts of very fine-grained

material scattered among the rocks (line 320,

sample 2950). The rocks range from a centimeter

subangular, equidimensional, and profusely pitted

to meters in size and are very similar to each other:

or vesicular. A few rocks, however, appear to be

fine-grained without pits or vesicles (line 350,

sample 3500); some fine-grained rocks may be

ventifacts (line 440, sample 2320), i.e., rocks with

multiple facets eroded by the wind.

GEOMETRY OF THE MOSAICS The cameras on the Viking Lander acquire data by sampling in equal increments of elevation and azimuth angle. In the accompanying mosaic, 8 mm subtends a 1° horizontal or vertical angle, regardless of the place of measurement within the panorama. If the martian surface were flat, one pixel (0.04°) on the surface would be 1 mm wide at -60° camera elevation and 2 m wide at the horizon 3 km away. Characteristically for this type of imaging system, most straight lines in the scene appear curved in the reconstruction. This representation of the picture data differs from that of a con-

ventional camera having "point perspective" picture geometry, in which rays are projected from object space, through the perspective point in the camera lens, to an image plane in the camera. The geometry of the lander pictures is complicated by additional factors. Because both landers are tilted with respect to the horizon, on the uncorrected pictures the horizon resembles a sine curve. Computer rectification of the pictures results in a straight horizon along which vertical angles can be measured with respect to the local gravity vector, and horizontal angles can be measured from martian north. These angles are not related in any simple way to the azimuth and elevation angles given in "camera coordinates" for the unrectified pictures. There are other geometric distortions due to the camera: optic path distortion that affects a light ray after it passes

the camera windows; and camera-system distortions, or "bolt-down" errors, that are caused by the way the cameras are mounted on the lander. The geometric transformation used in creating the mosaics took into account the optic path distortion but not the "bolt-down" errors. However, along the horizon, the error in azimuth angle is equal to the rotational "bolt-down" error for each camera to an accuracy of less than 1 pixel. The scale "azimuth angles from Mars north" has been adjusted to take into account this correc-1, this error is a maximum of 5.7 ± 1 pixels at -60° elevation.

The residual azimuth angle errors are less than 1 pixel along the horizon and become larger with steeper elevation angles and large lander tilts. For the worst case, Lander 2, camera The somewhat sinusoidal azimuth-dependent residual elevation error is a maximum of 3 ± 1 pixels for Lander 2, camera 1, and approximately 1 pixel for the other cameras.
