VIKING LANDER MOSAICS

VIKING LANDER 2 RECTIFIED PHOTOMOSAIC EVENING SCENE - CAMERA 2 - SECTOR 4

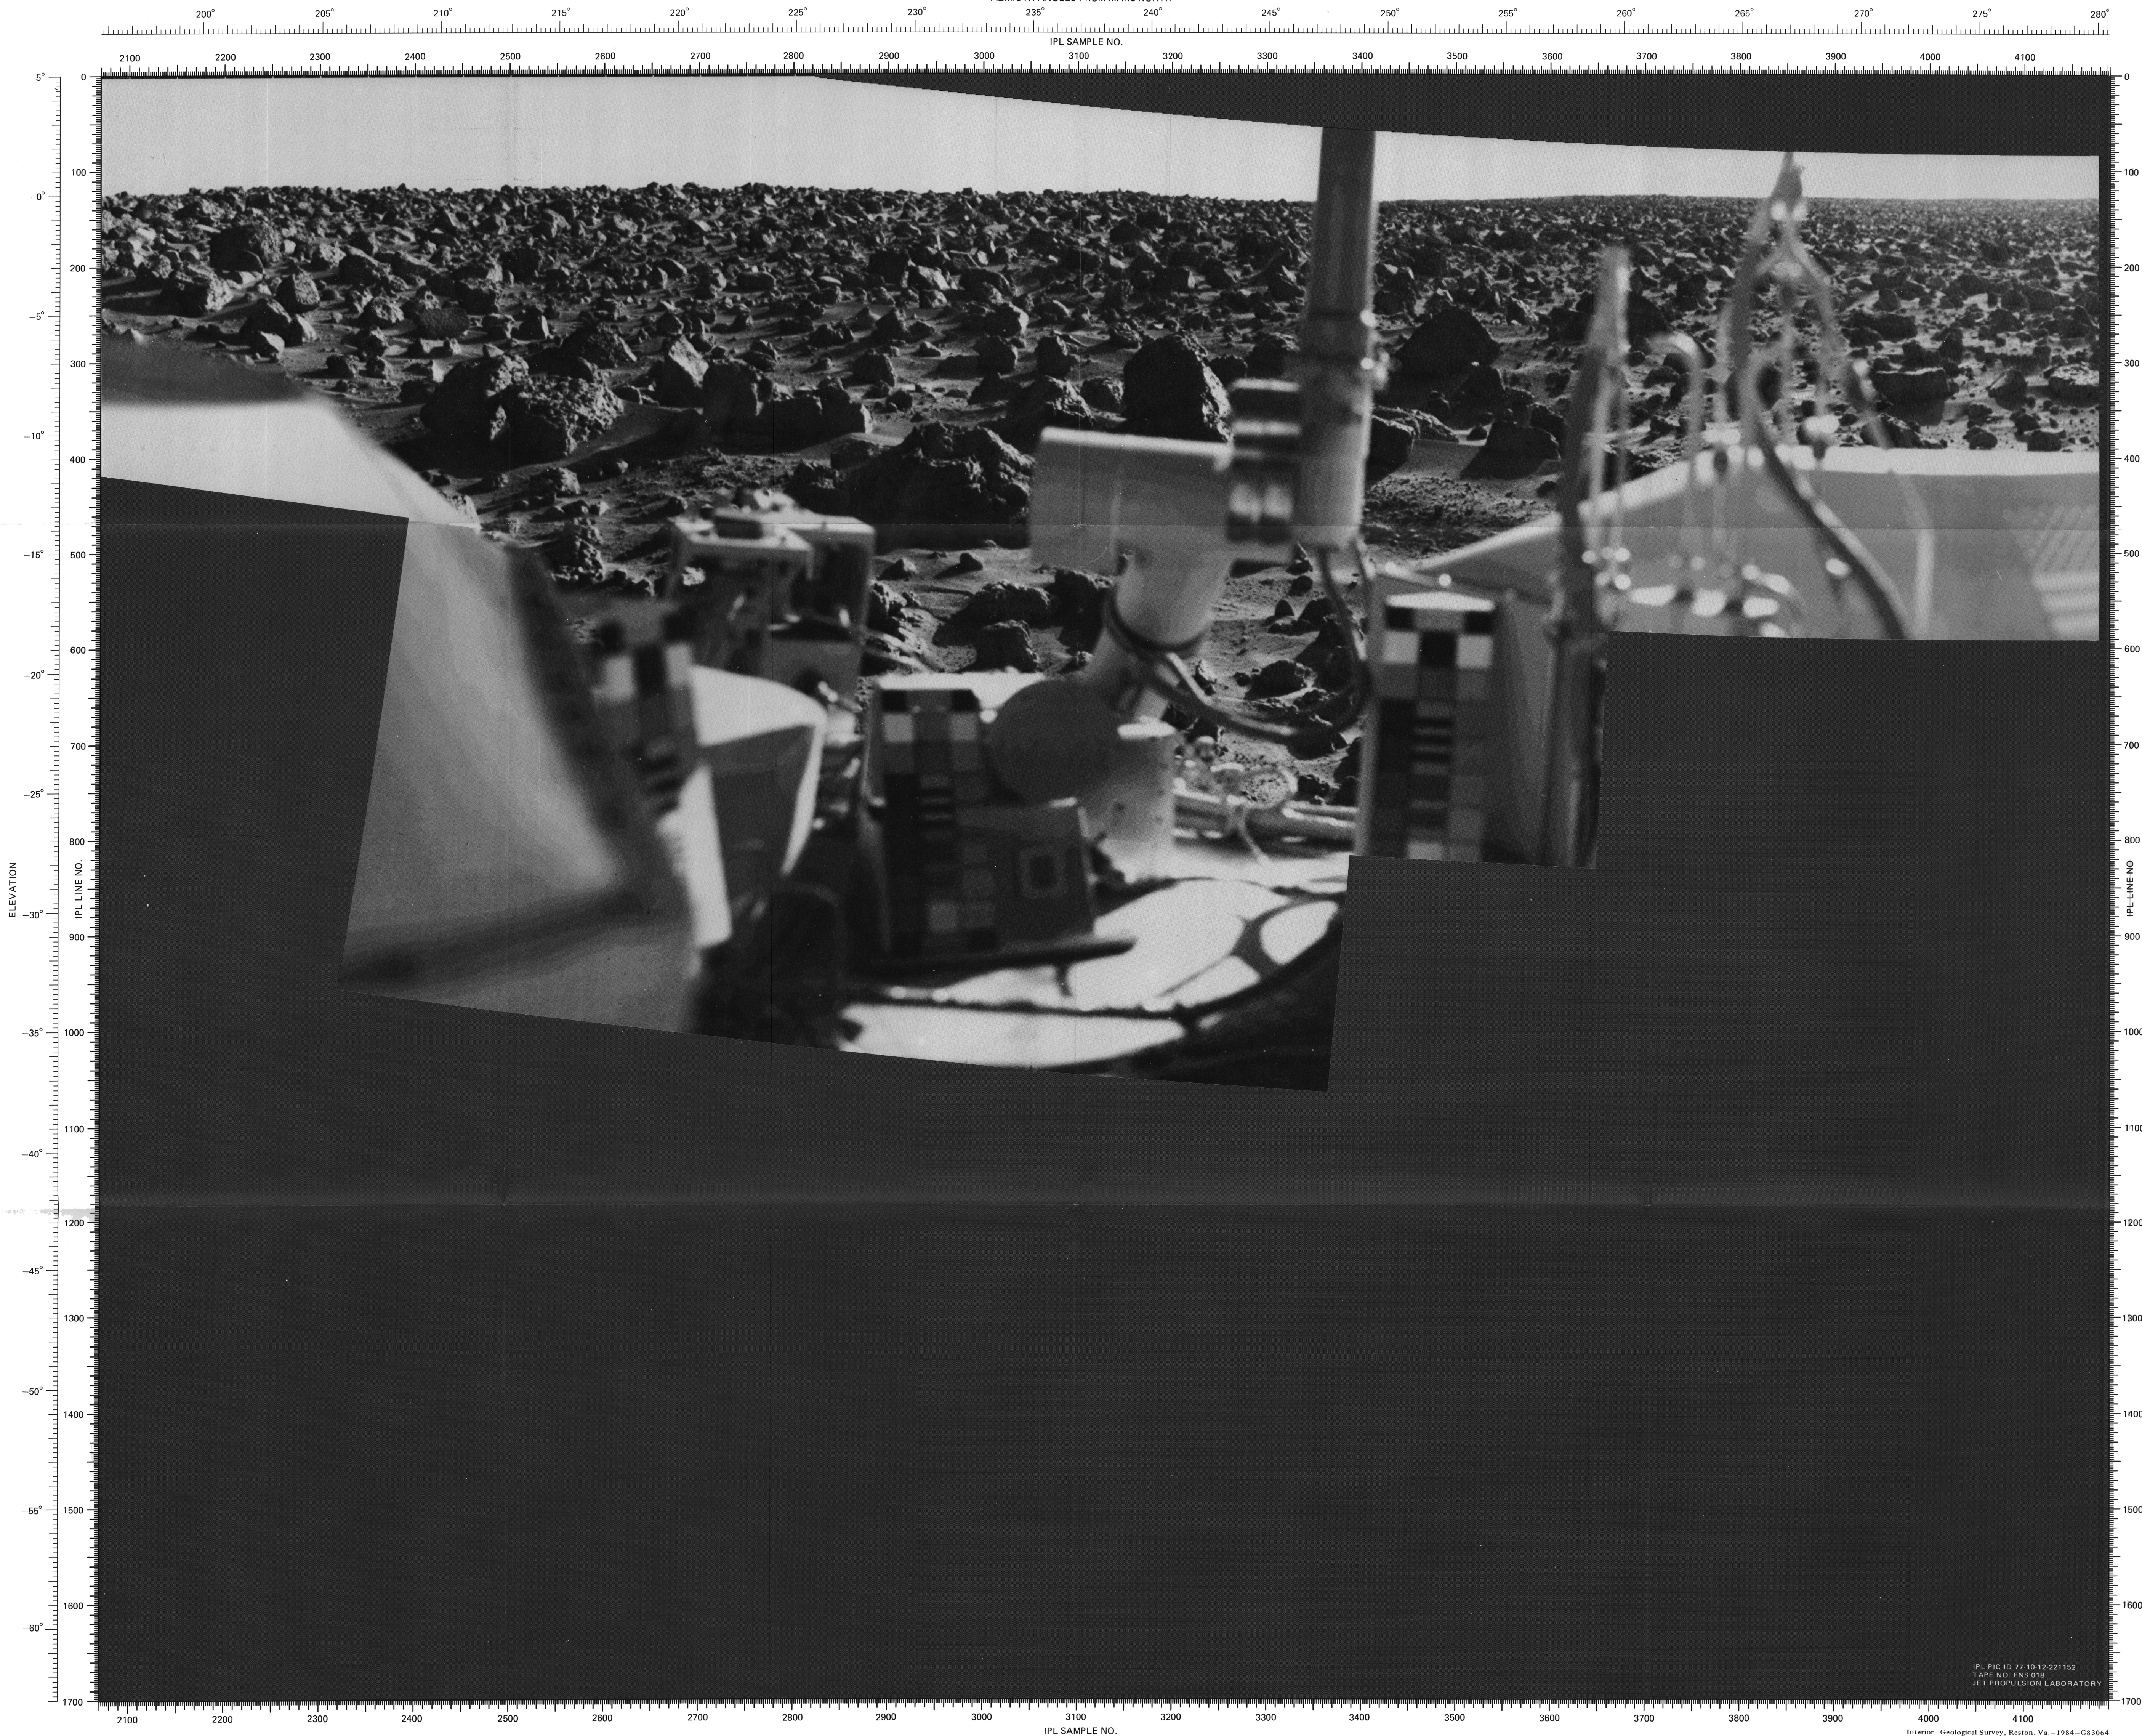
This view southwest over the top of the lander shows the same flat-level surface of Utopia Planitia as is viewed in all directions from the lander. The distribution of the large, subangular pitted or vesicular blocks is nearly uniform in all directions out to the horizon. The large blocks appear to lie mostly on the surface of fine-grained material. Distributed among the blocks are a few small drifts of the fine-grained material. The martian winds have probably scooped and winnowed away the fine-grained material from between the blocks and sculpted the drifts. Parts of the lander that are seen in the view are the left: a cover over a Radioisotope Thermoelectric Generator (RTG) (line 350, sample 2300); mounting structure for Leg 1 (line 500, sample 2800); three calibration text charts for the camera (line 600, sample 2600; line 700, sample 2950; line 650, sample 3470); a parabolic mirror for viewing the magnet on the surface-sampler backhoe (line 690, sample 3080); the mast that supports the high gain S-band antenna (line 250, sample 3380); the cover over the other RTG (line 450, sample 4050); tubes and cables that connected the lander to the other during transit to Mars (line 200, sample 3850). Upon command from Earth, the lander separated from the orbiter and performed all of its pre-programmed landing maneuvers under its own power.

The cameras on the Viking Lander acquire data by sampling in equal increments of elevation and azimuth angle. In the accompanying mosaic, 8 mm subfields at 1° horizontal or vertical angle, regardless of the place of measurement within the panorama. If the martian surface were flat, one pixel (0.04°) on the surface would be 1 mm wide at 60° camera elevation and 2 m wide at the horizon 3 km away. Characteristically for this type of imaging system, most straight lines in the scene appear curved in the reconstruction. This representation of the picture data differs from that of a conventional camera having "point perspective" picture geometry, in which rays are projected from object space, through the perspective point in the camera lens, to an image plane in the camera.

The geometry of the lander pictures is complicated by additional factors. Because both landers are tilted with respect to the horizon, on the uncorrected pictures the horizon resembles a sine curve. Computer rectifications of the pictures result in a straight horizon along which vertical angles can be measured with respect to the local gravity vector, and horizontal angles can be measured from martian north. These angles are not related in any simple way to the azimuth and elevation angles given in "camera coordinates" for the unrectified pictures. There are other geometric distortions due to the camera: optic path distortion that affects a light ray after it passes the camera windows, and camera-system distortions, or "bolt-down" errors, that are caused by the way the cameras are mounted on the lander. The geometric transformation used in creating the mosaics took into account the optic path distortion but not the "bolt-down" errors. However, along the horizon, the error in azimuth angle is equal to the rotational "bolt-down" error for each camera to an accuracy of less than 1 pixel. The scale "azimuth angles from Mars north" has been adjusted to take into account this correction. The residual azimuth angle errors are less than 1 pixel along the horizon and become larger with steeper elevation angles and large lander tilts. For the worst case, Lander 2, camera 1, this error is a maximum of 5.7 ± 1 pixels at 46° elevation. The somewhat sinusoidal residual-dependent residual elevation error is a maximum of 3.1 pixels for Lander 2, camera 1, and approximately 1 pixel for the camera errors.
