COMPLETE MOSAIC, MORNING SCENE, CAMERA 1

THE VIKING MISSION

VIKING LANDER MOSAICS

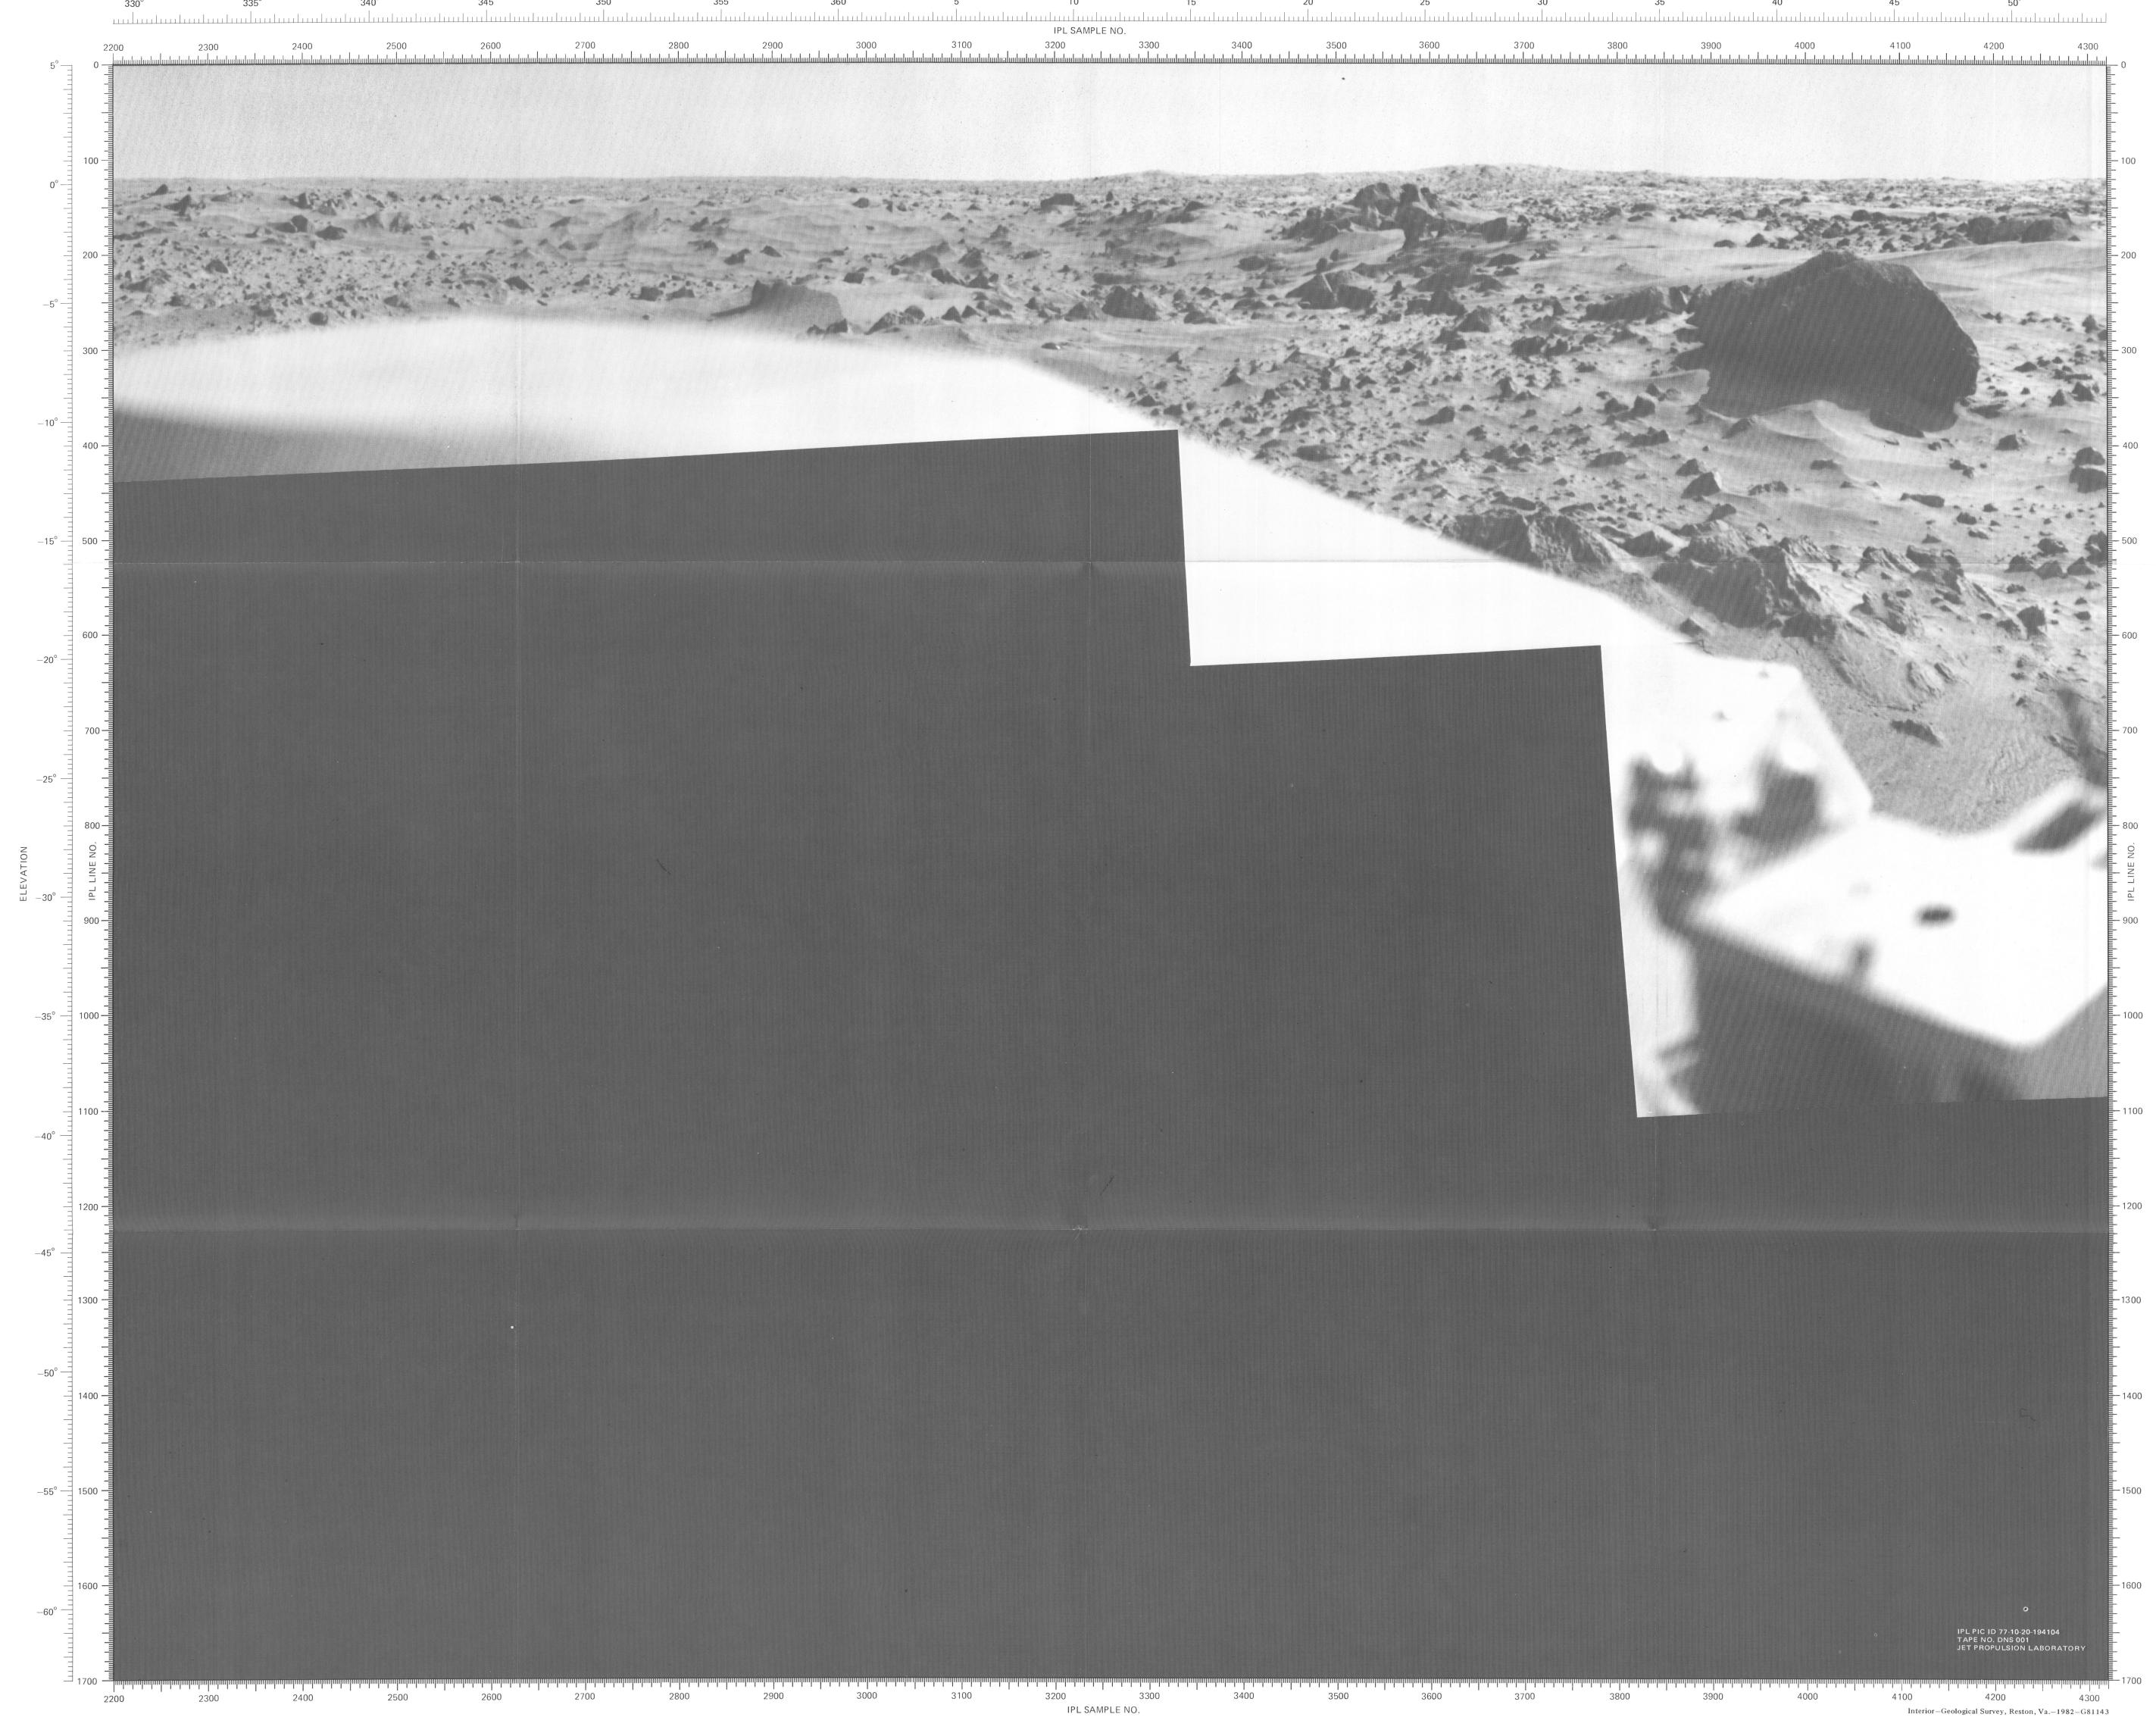
(Corrected for tilt)

DESCRIPTION OF SCENE The area north of the lander is dominated by drifts of fine-grained material (about 100 μ m) that covers much of the surface. The drifts are probably remnants of a thicker layer of material that has been swept away by the wind. The large rock on the right that has been split in two (line 250, sample 4050) is about 2 m across, 1 m high, and about 9 m from the lander. Its cap of fine grained material suggests that it was once buried by this material. The large rock is part of a boulder field that can be seen beyond it (line 150, sample 3550). This field is probably part of a ray of material from a nearby impact crater. Part of the rim of the 150-m diameter crater J can be seen (line 100, sample 3700) on the horizon northeast of the lander. Parts of the lander visible at the bottom of the picture are the cover of a Radioisotope Thermo-

electric Generator (RTG) (line 300, sample 2800) and the mounting structure of leg 2 of the lander (line 850, sample 4200).

The cameras on the Viking Lander acquire data by sampling in equal increments of elevation and azimuth angle. In the accompanying mosaic, 8 mm subtends a 1° horizontal or vertical angle, regardless of the place of measurement within the panorama. If the martian surface were flat, one pixel (0.04°) on the surface would be 1 mm wide at -60° camera elevation and 2 m wide at the horizon 3 km away. Characteristically for this type of imaging system, most straight lines in the scene appear curved in the reconstruction. This representation of the picture data differs from that of a con-
