COMPLETE MOSAIC, EVENING SCENE, CAMERA 1

THE VIKING MISSION

VIKING LANDER MOSAICS

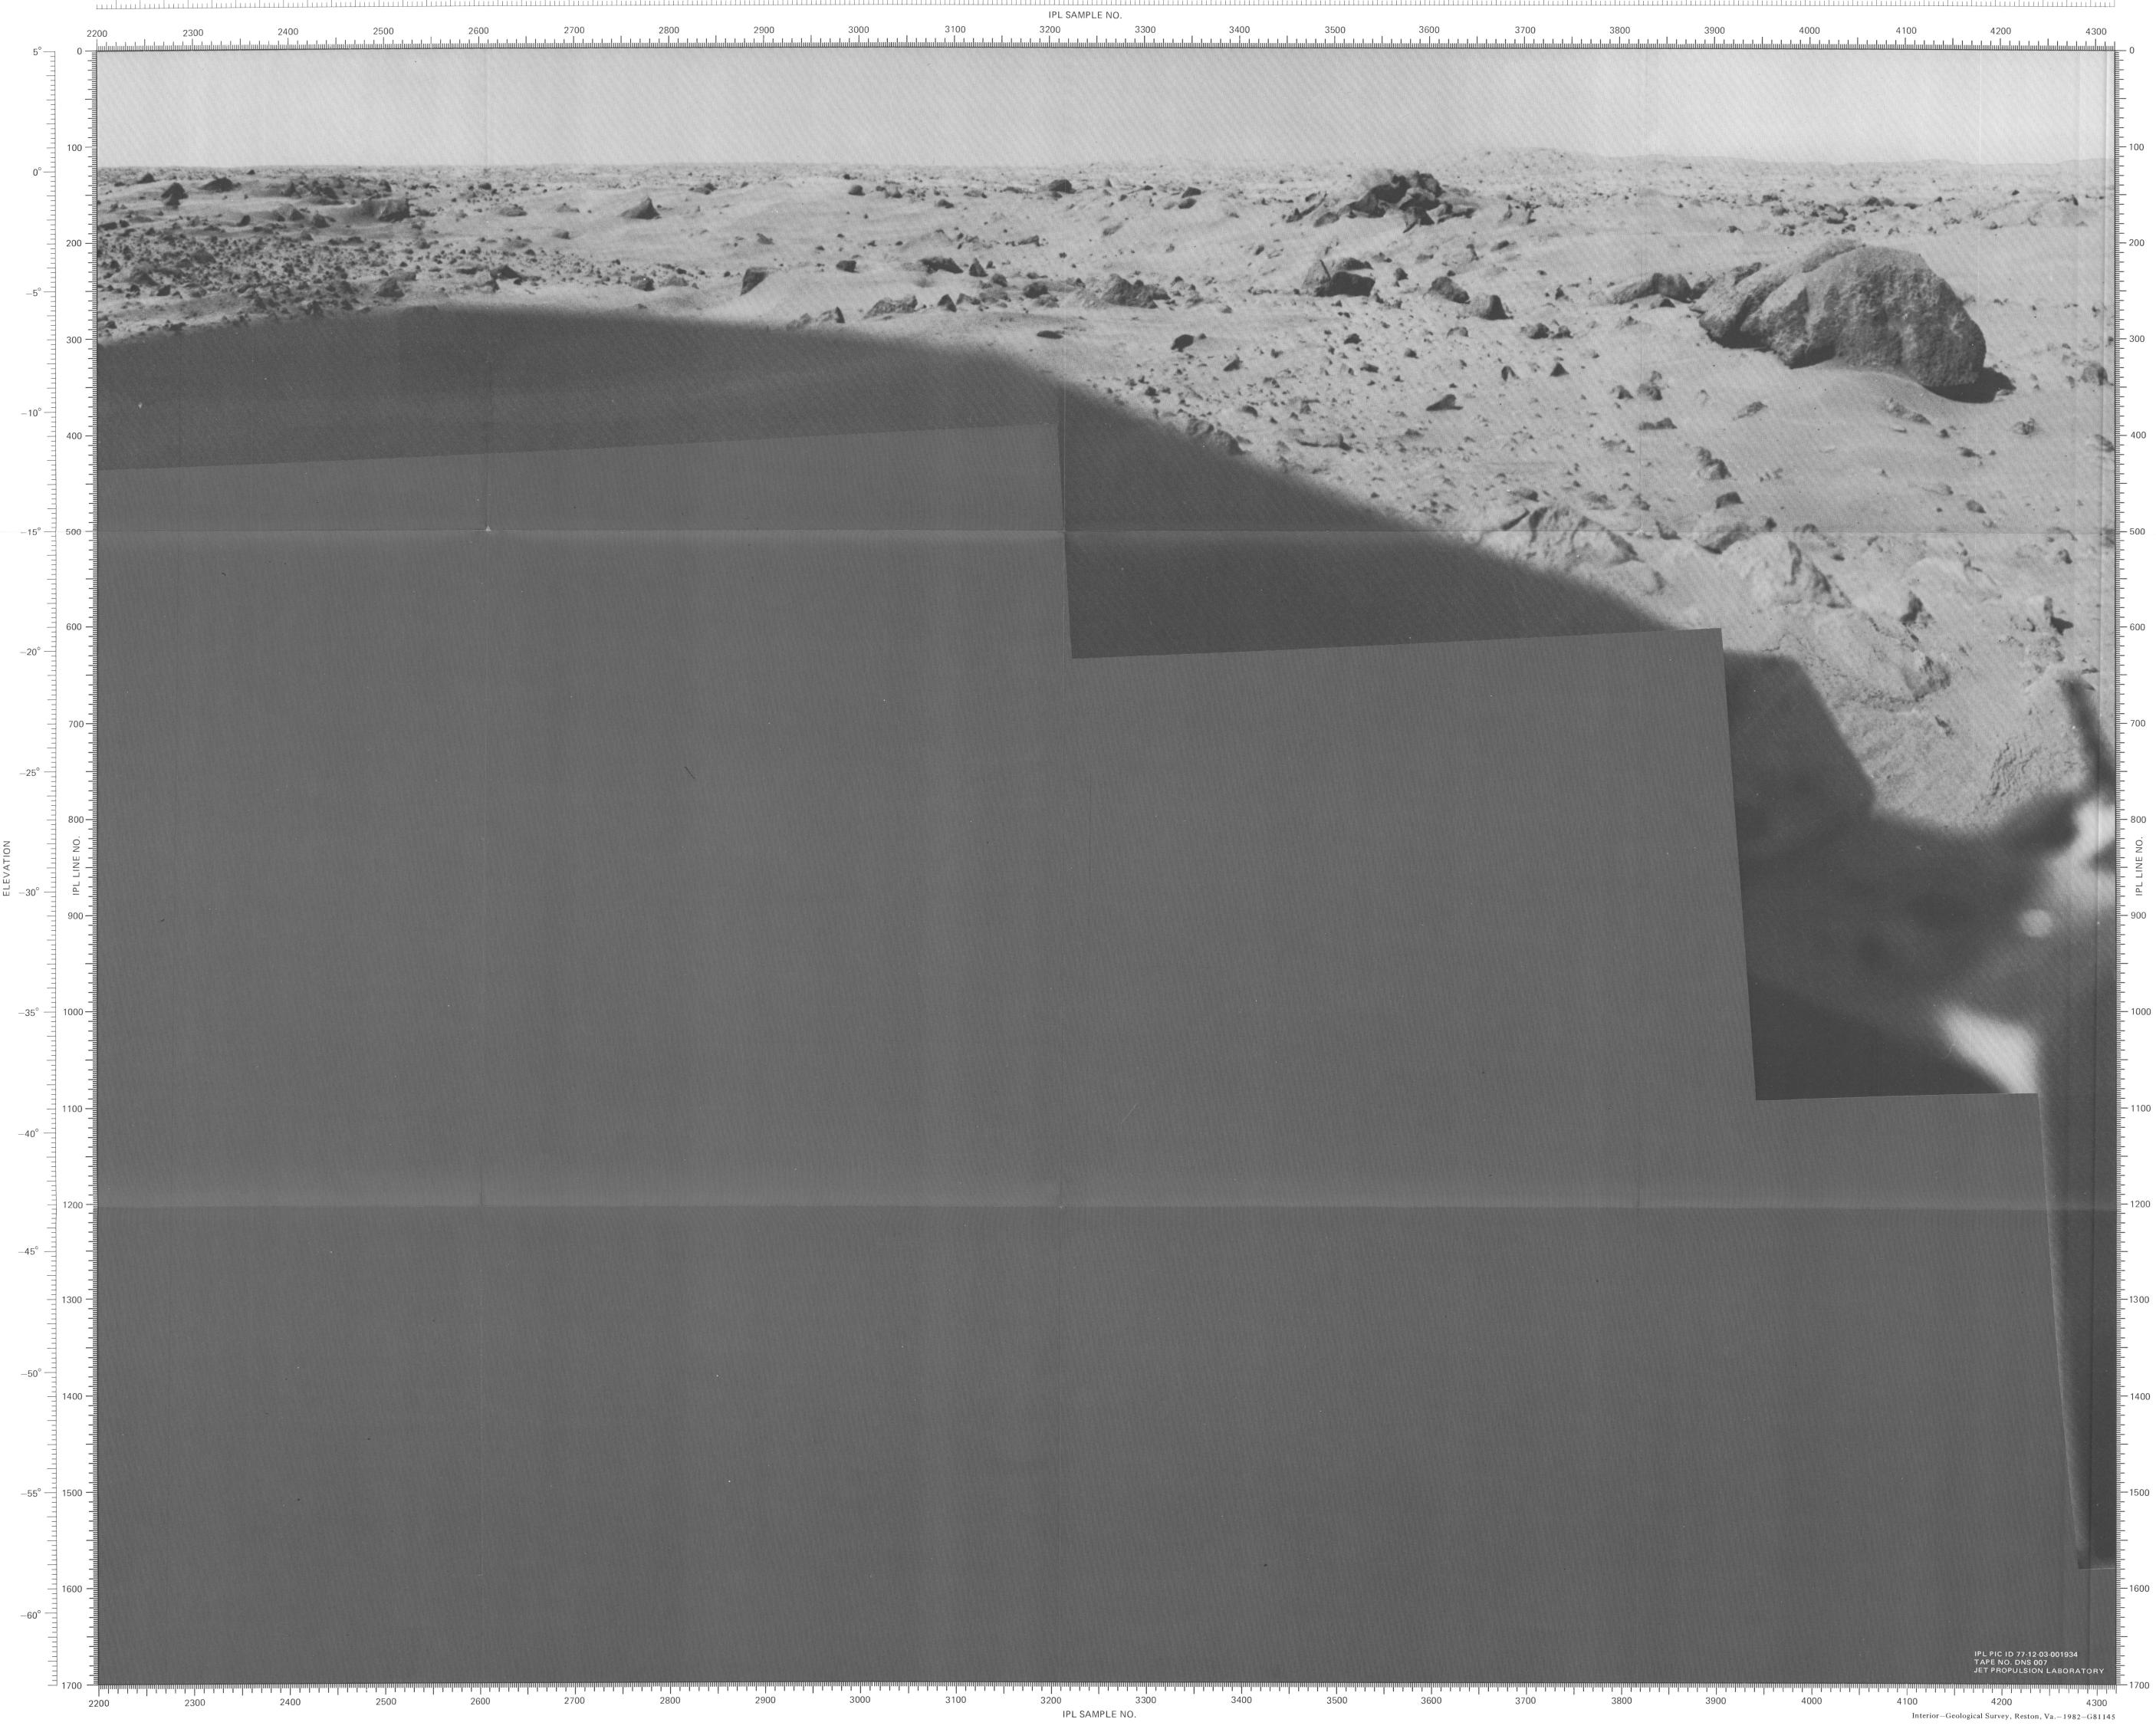
DESCRIPTION OF SCENE The area north of the lander is dominated by drifts of fine-grained material (about 100 µm) that covers much of the surface. The drifts are probably remnants of a thicker layer of material that has been swept away by the wind. The large rock on the right that has been split in two (line 250, sample 4050) is about 2 m across, 1 m high, and about 9 m from the lander. Its cap of finegrained material suggests that it was once buried by this material. The large rock is part of a boulder field that can be seen beyond it (line 150, sample 3550). This field is probably part of a ray of material from a nearby impact crater. Part of the rim of the 150-m diameter crater J can be seen (line 100, sample 3700) on the horizon northeast Parts of the lander visible at the bottom of the picture are the cover of a Radioisotope Thermoelectric Generator (RTG) (line 300, sample 2800) and the mounting structure of leg 2 of the lander

(line 850, sample 4200).

GEOMETRY OF THE MOSAICS The cameras on the Viking Lander acquire data by sampling in equal increments of elevation and azimuth angle. In the accompanying mosaic, 8 mm subtends a 1° horizontal or vertical angle, regardless of the place of measurement within the panorama. If the martian surface were flat, one pixel (0.04° on the surface would be 1 mm wide at -60° camera elevation and 2 m wide at the horizon 3 km away. Characteristically for this type of imaging system, most straight lines in the scene appear curved in the reconstruction. This representation of the picture data differs from that of a con-

ventional camera having "point perspective" picture geometry, in which rays are projected from object space, through the perspective point in the camera lens, to an image plane in the camera. The geometry of the lander pictures is complicated by additional factors. Because both landers are tilted with respect to the horizon, on the uncorrected pictures the horizon resembles a sine curve. Computer rectification of the pictures. results in a straight horizon along which vertical angles can be measured with respect to the local gravity vector, and horizontal angles can be measured from martian north. These angles are not related in any simple way to the azimuth and elevation angles given in "camera coordinates" for the unrectified pictures. There are other geometric distortions due to the camera: optic path distortion that affects a light ray after it passes the camera windows; and camera-system distortions, or "bolt-down" errors, that are caused by the way the cameras are mounted on the lander. The geometric transformation used in creating the mosaics took into account the optic path distortion but not the "bolt-down" errors. However, along the horizon, the error in azimuth angle is equal to the rotational "bolt-down" error for each camera to an accuracy of less than 1 pixel. The scale "azimuth angles from Mars north" has been adjusted to take into account this correc-

The residual azimuth angle errors are less than 1 pixel along the horizon and become larger with steeper elevation angles and large lander tilts. For the worst case, Lander 2, camera 1, this error is a maximum of 5.7 ± 1 pixels at -60° elevation. The somewhat sinusoidal azimuth-dependent residual elevation error is a maximum of 3 ± 1 pixels for Lander 2, camera 1, and approximately 1 pixel for the other cameras. Davies, M. E., Katayama, F. Y., and Roth, J. A., 1978,
