VIKING LANDER MOSAICS

## CAMERA CONTROL AZIMUTH AZIMUTH ANGLES FROM MARS NORTH COMPLETE MOSAIC, EVENING SCENE, CAMERA 1

VIKING LANDER 1 RECTIFIED PHOTOMOSAIC **EVENING SCENE - CAMERA 1 - SECTOR 4** 1982

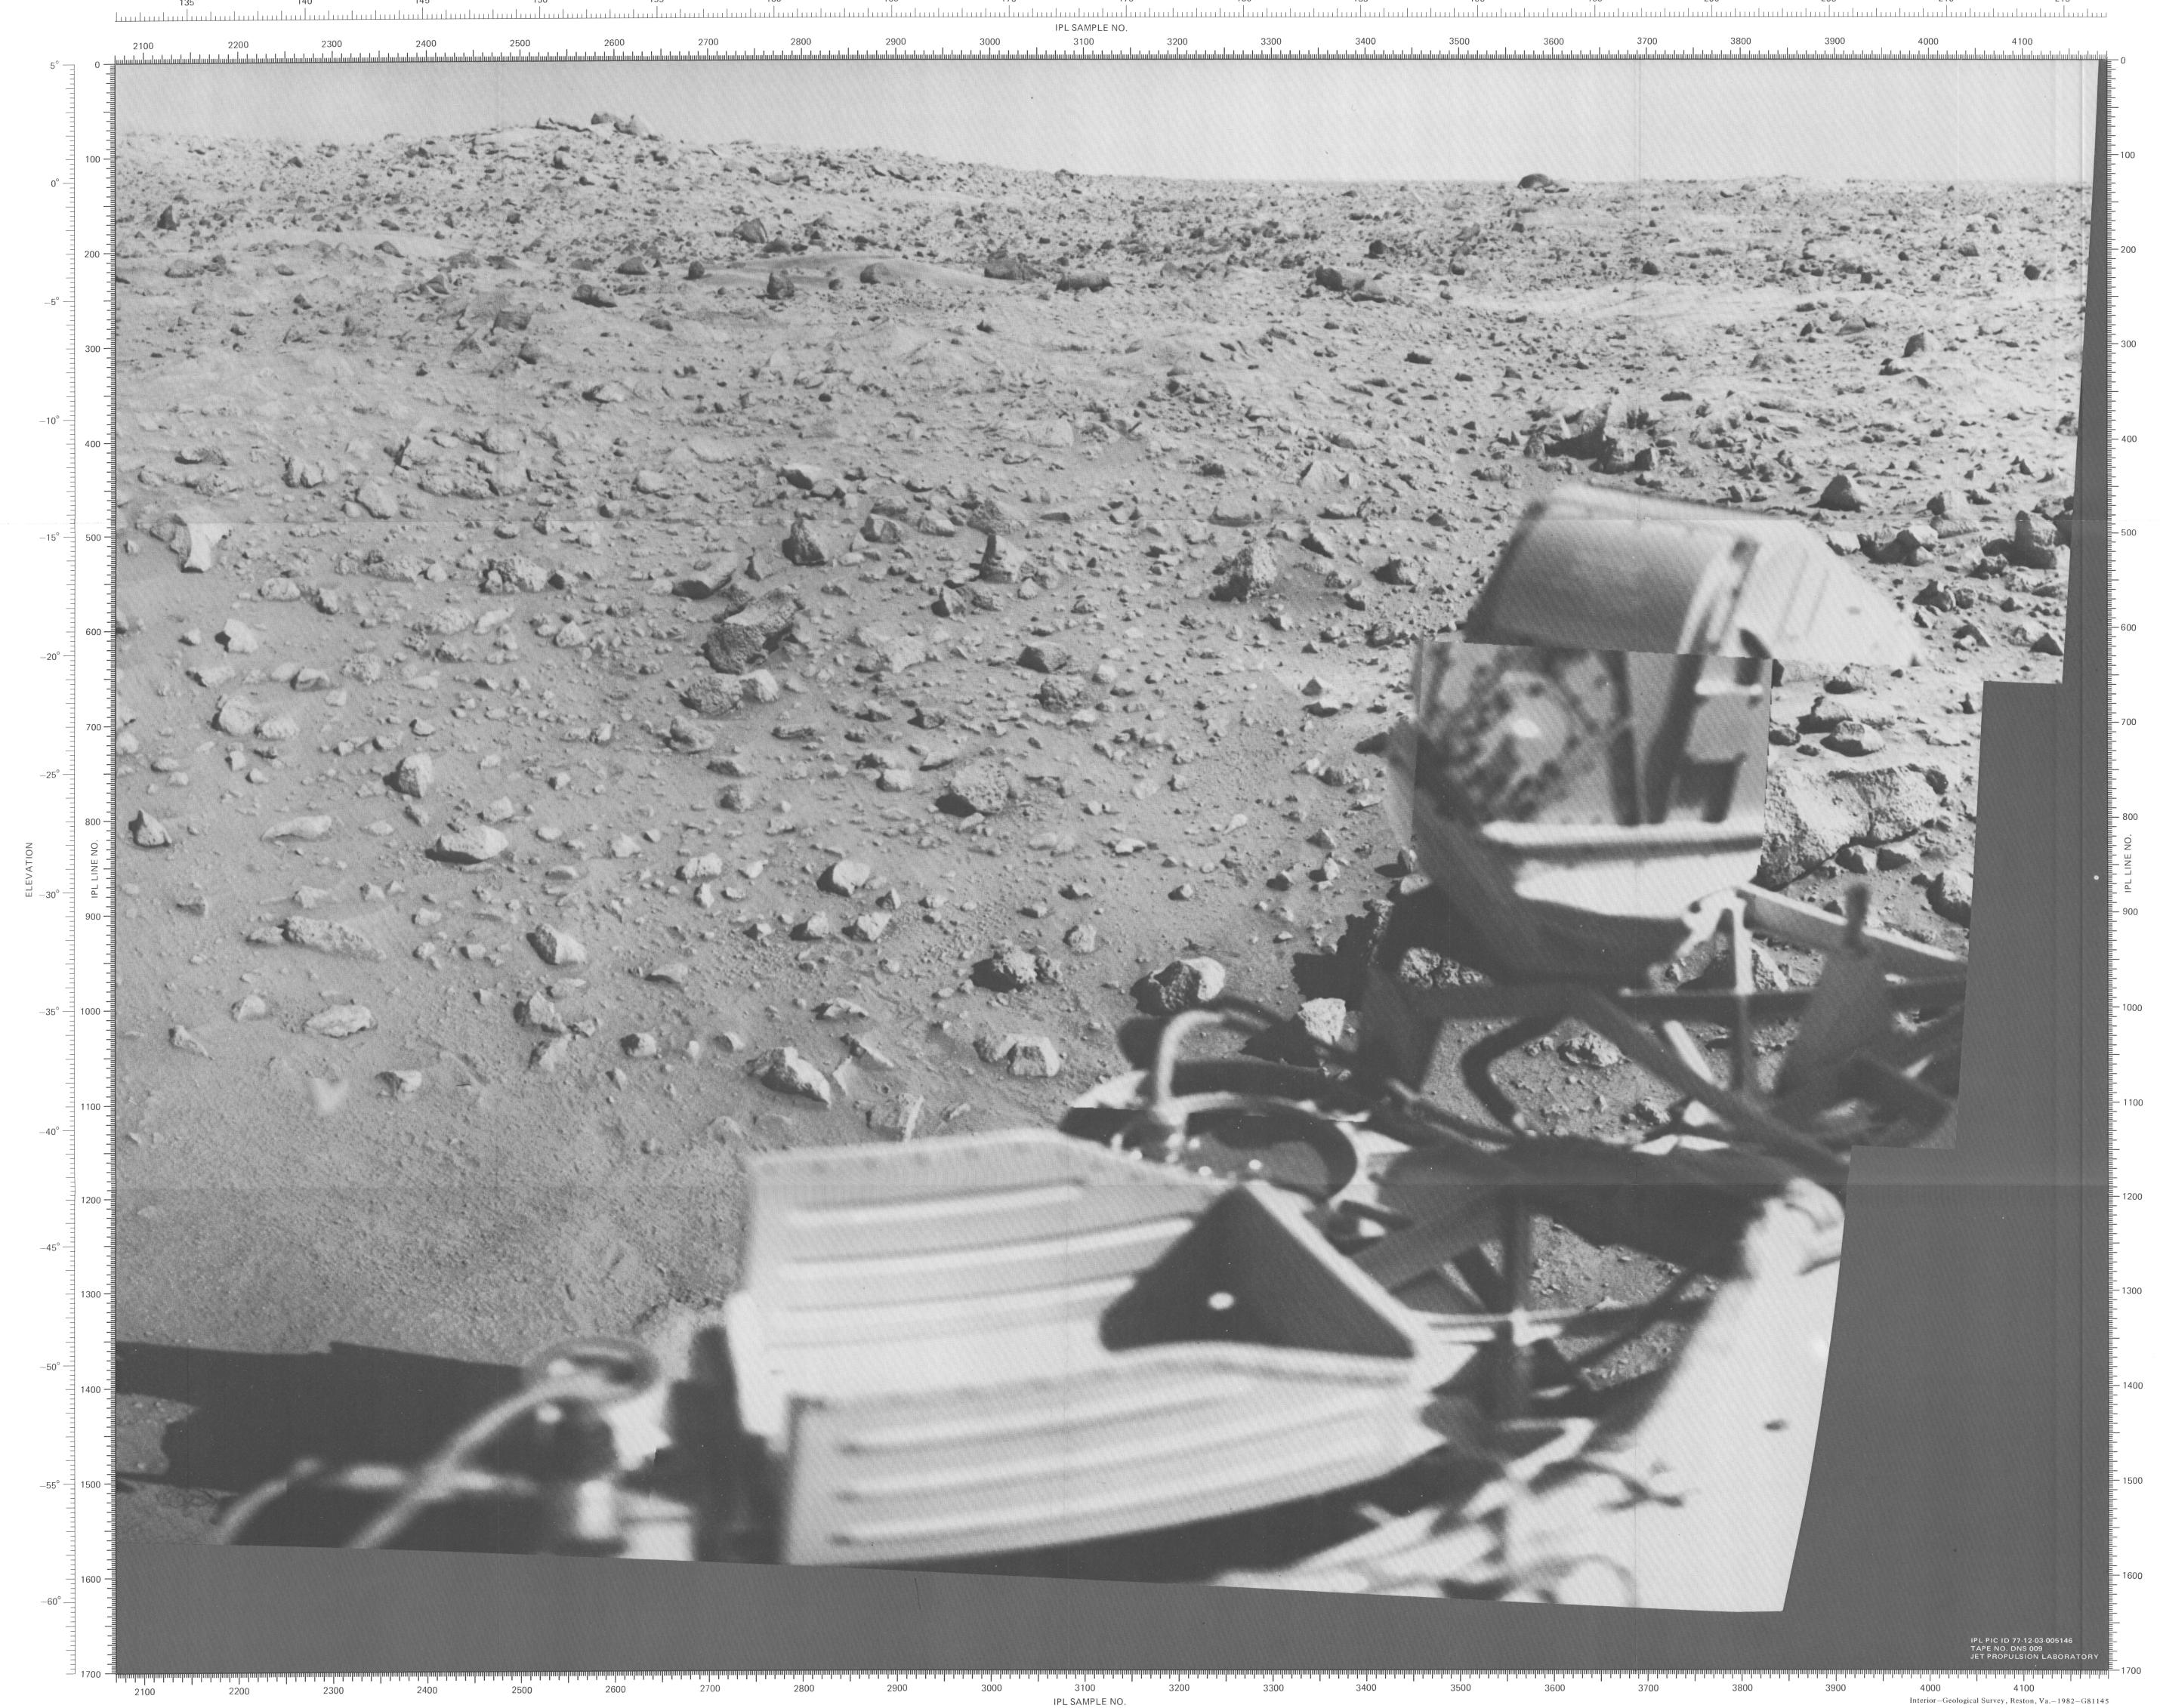
DESCRIPTION OF SCENE

of the lander shows a rock-strewn landscape with

several small drifts of very fine grained material

scattered among the rocks (line 230, sample

2850). The rocks range from a centimeter to

several meters in size. Bedrock is exposed in some

places through the thin covering of fragmental

material (line 300, sample 3200). The blocky ridge

forming the horizon southeast of the Lander (line

90, sample 2800) is the rim of 150 meter diameter

crater C. The large blocks (line 70, sample 2600)

resting on the crest of the rim are about 3 m across

A shallow depression forms the surface immedi-

ately in front of the lander. The surface rises

gradually towards the south, until the rim of the

depression forms the near horizon about 130 m

from the lander. Two large blocks (line 120,

sample 3590) each about 3 m across, lie on the

rim. In the far distance, a broad flat ridge (line

120, sample 3400) is just barely visible above the

near horizon. The near end of the ridge (R-4)

The object at right center of the scene (line 700,

sample 3700) is the surface sampler instrument.

The true form of the instrument is not apparent

because the image is a mosaic of three pictures

taken when the instrument was in different posi-

tions so that it would block a minimum of the

surface. The box-like structure at the lower left

(line 1300, sample 2900) is the housing in which

the meteorology instruments were stowed during

launch and transit to Mars.

Viking Lander I faces southeast. This view south

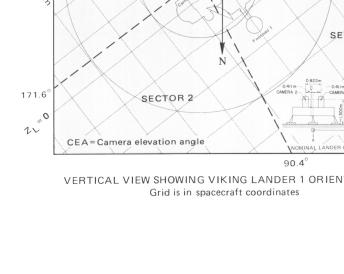
## SECTOR 4 No Data SECTOR 3 SECTOR 1 SECTOR 2 CEA = Camera elevation angle VERTICAL VIEW SHOWING VIKING LANDER 1 ORIENTATION

OUTLINE OF CAMERA 1 VIEW SHOWING CAMERA EVENTS USED IN MOSAIC
