Development and Analysis of Regional Curves for Streams in the Non-Urban Valley and Ridge Physiographic Province, Maryland, Virginia, and West Virginia

Scientific Investigations Report 2005-5076

By Jefferson N. Keaton, Terence Messinger, and Edward J. Doheny

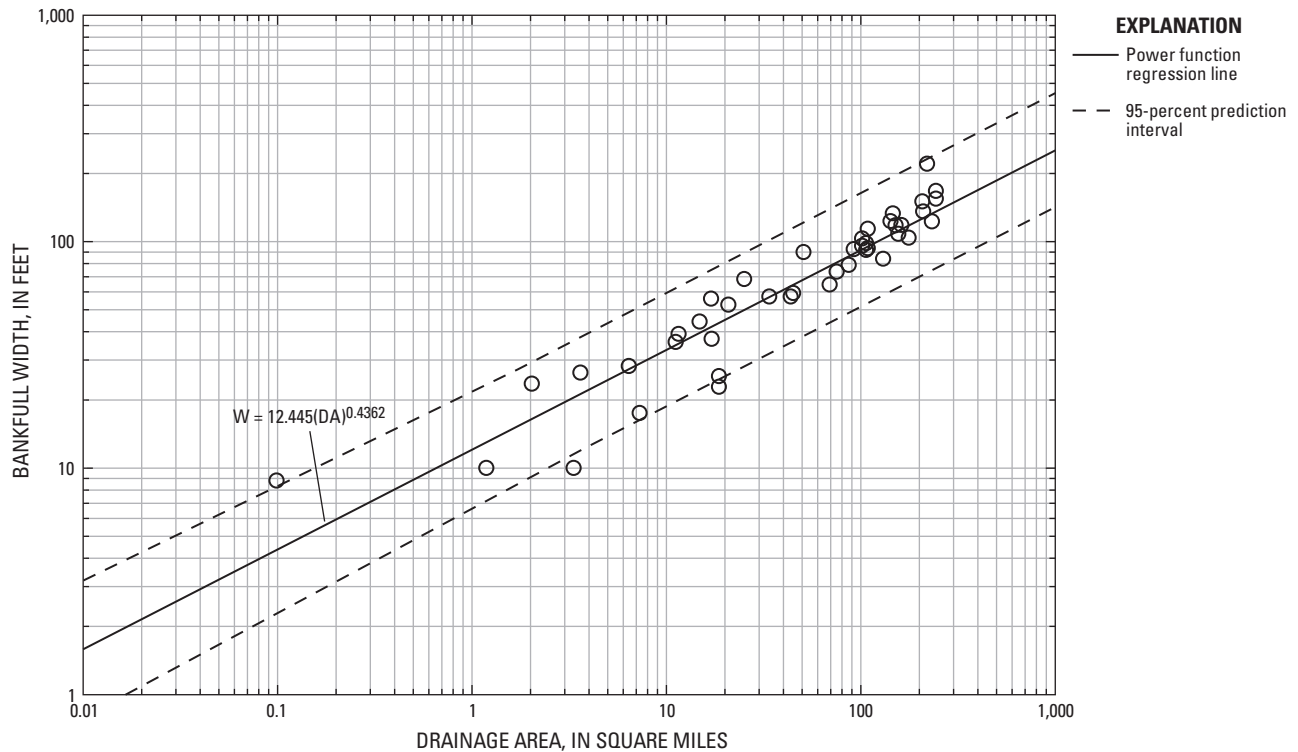
Figure 4. Regional curve relating bankfull width (W) to drainage area (DA) in the non-urban Valley and Ridge Physiographic Province in Maryland, Virginia, and West Virginia.

The regional curves (figs. 3 through 6, table 3) include 95-percent prediction intervals for individual estimates of the dependent variable. Prediction intervals are often confused with confidence intervals, but the calculations to determine the range of the two sets of intervals are different (Helsel and Hirsch, 1992). The 95-percent prediction interval on a regression relation represents a 95-percent certainty that an individual observed value of y for a given x will fall within the upper and lower limits of the interval (Helsel and Hirsch, 1992; G.E. Schwarz, written commun., 2005).

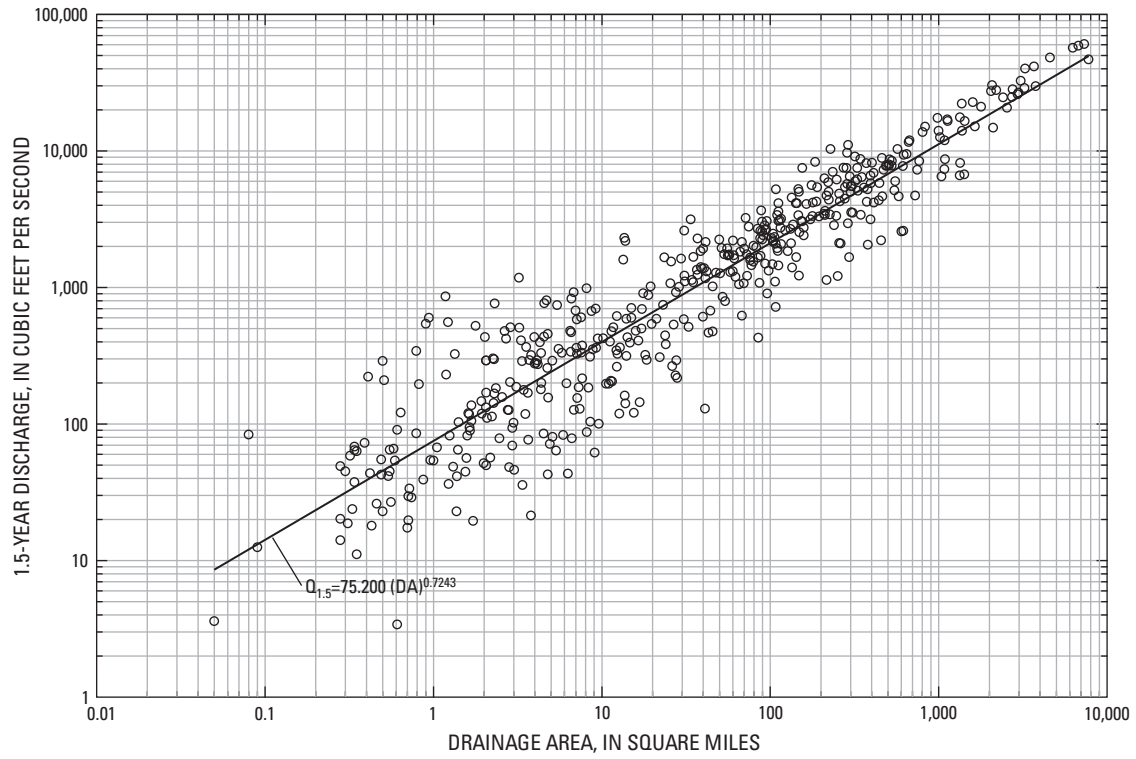
Figure 8. Regression model of 1.5-year discharge in relation to drainage area for every streamflow-gaging station with peak flow data in Virginia.

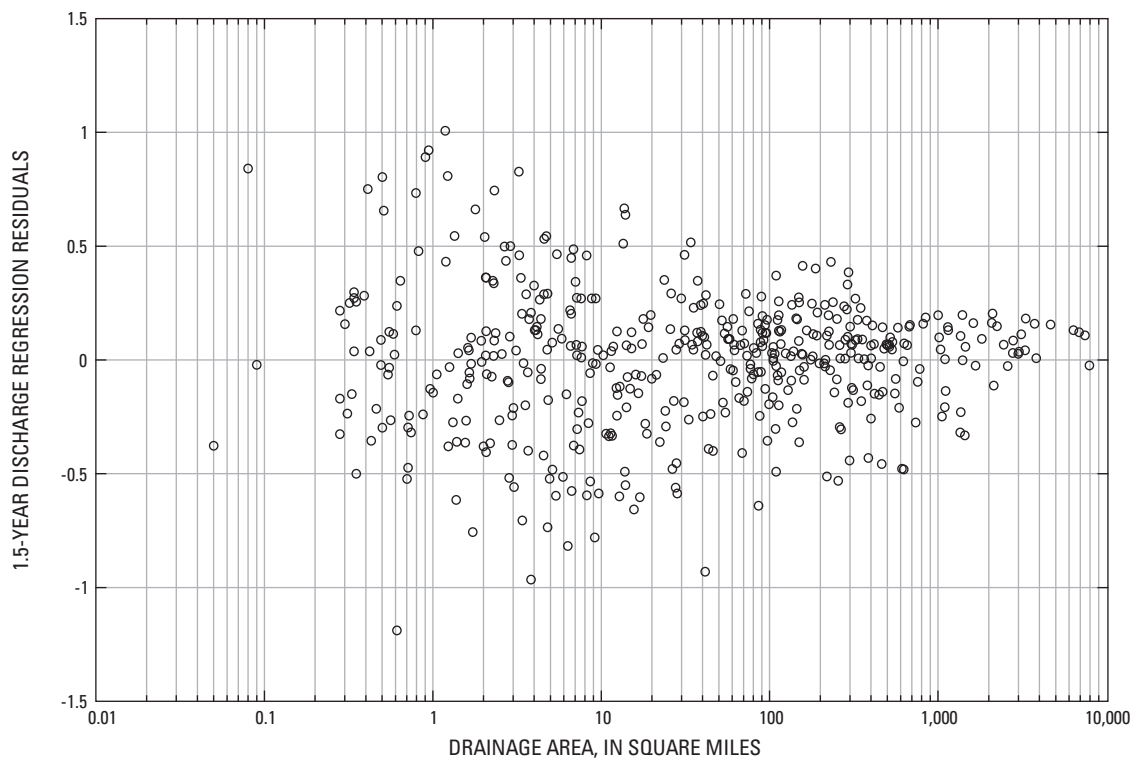
Figure 9. Regression residuals of 1.5-year discharge model in relation to drainage area.

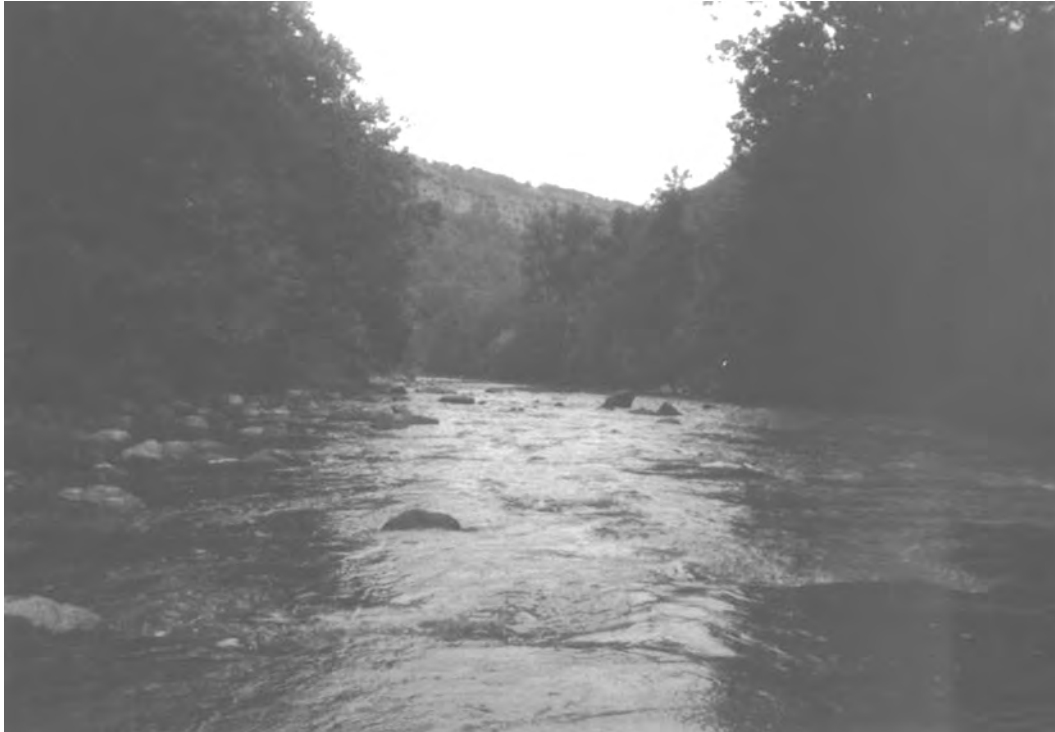
Station 01601500
Wills Creek near Cumberland, Md.

View looking downstream at reach for Willis Creek near Cumberland, Md.

The continuous-record streamflow-gaging station is located approximately 500 ft downstream of a highway bridge. Low-flow data show some slight fluctuations caused by work at an upstream quarry.

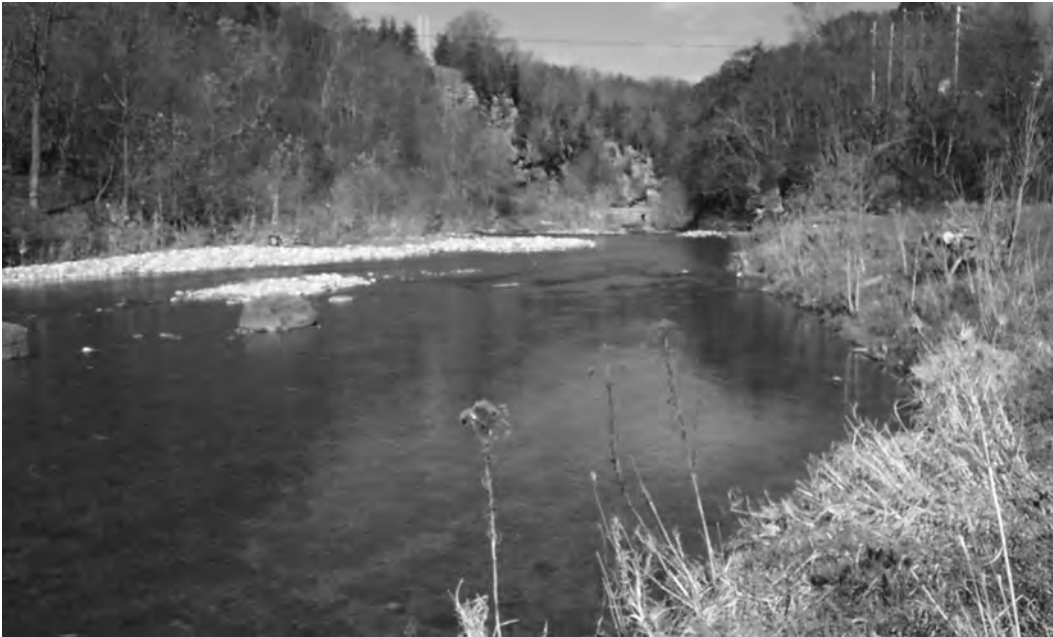
Station 01605500
South Branch Potomac River at Franklin, W. Va.

View looking downstream at reach of South Branch Potomac River at Franklin, W.Va.

The continuous record streamflow-gaging station is approximately 150 ft upstream from a bridge that may have a slight back-water effect at the bankfull discharge.

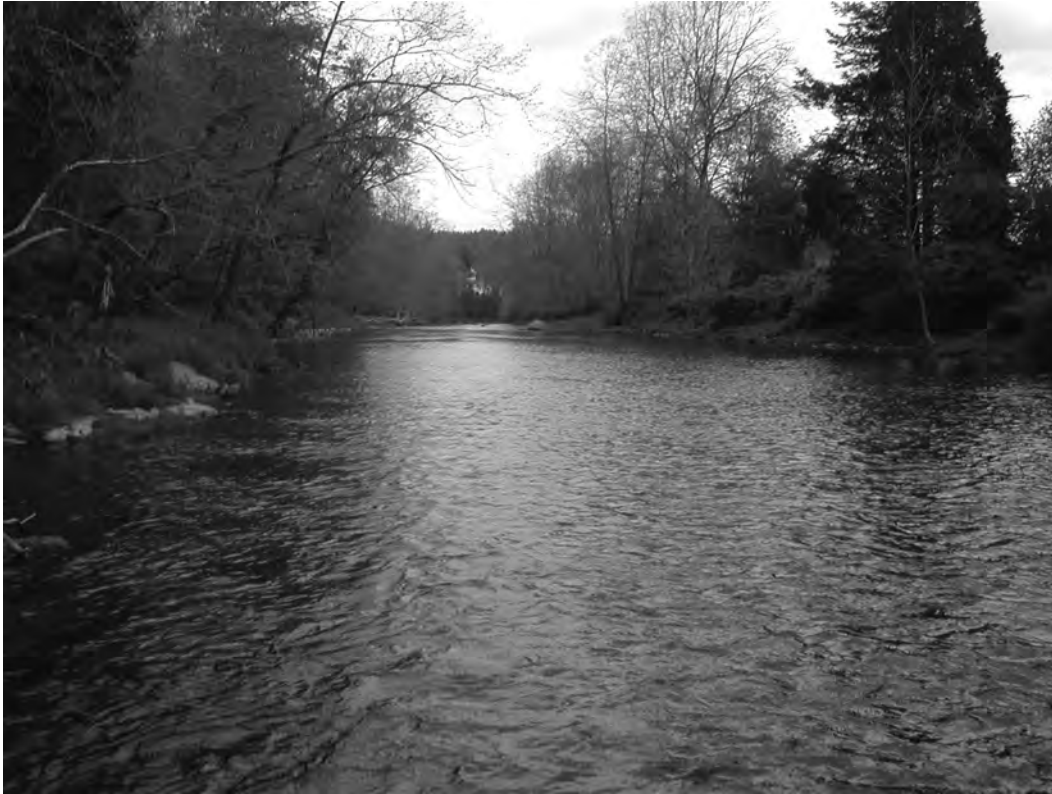
Station 01607500

View looking downstream at reach of South Fork South Branch Potomac River at Brandywine, W.Va.

The continuous-record streamflow-gaging station was approximately 100 ft upstream from a bridge that may have had a slight backwater effect on the bankfull discharge. The stage-discharge relation for this station was changed substantially in February 2003, when a flow event deposited a significant amount of coarse sediment on a mid-channel bar. Prior to this event, the discharge for the bankfull stage (gage height of 4.09 ft) was 1,529 cfs. Following this event, discharge at the same gage height was 1,195 cfs. The latter discharge is reported as bankfull in this report because it was current at the time of the survey. However, the channel may be adjusted to a larger discharge.

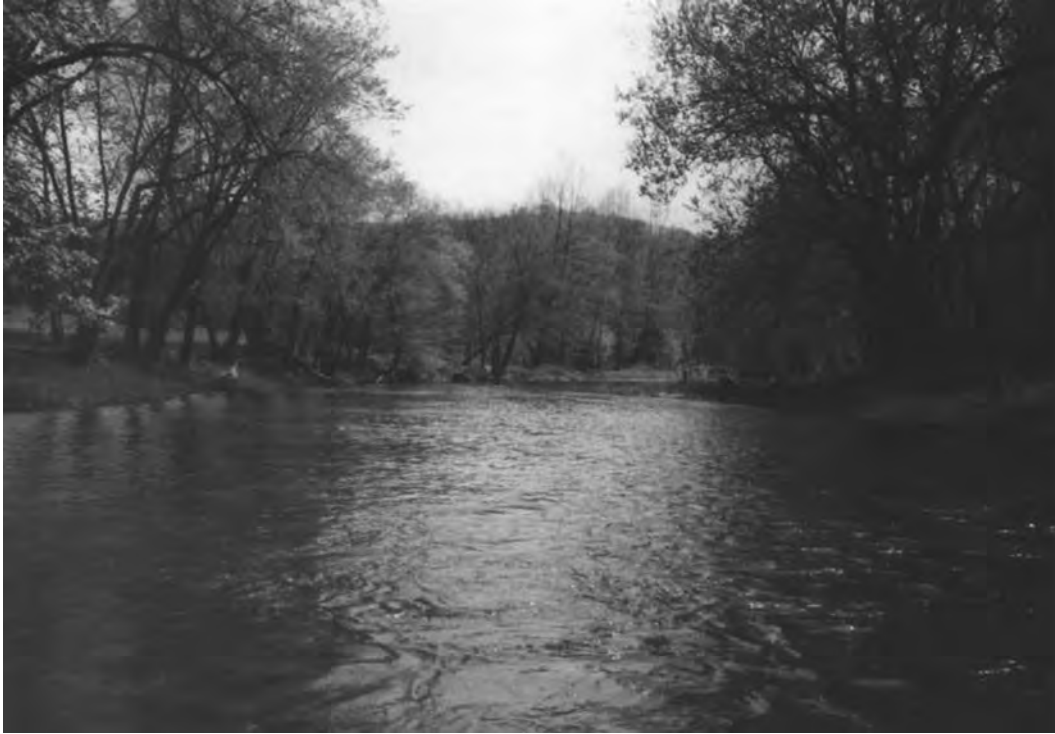
Station 01609000
Town Creek near Oldtown, Md.

View looking downstream at reach of Town Creek near Oldtown, Md.

The continuous-record streamflow-gaging station is located 2,000 ft downstream of a single-span highway bridge. The bankfull discharge is unconstricted downstream from the bridge.

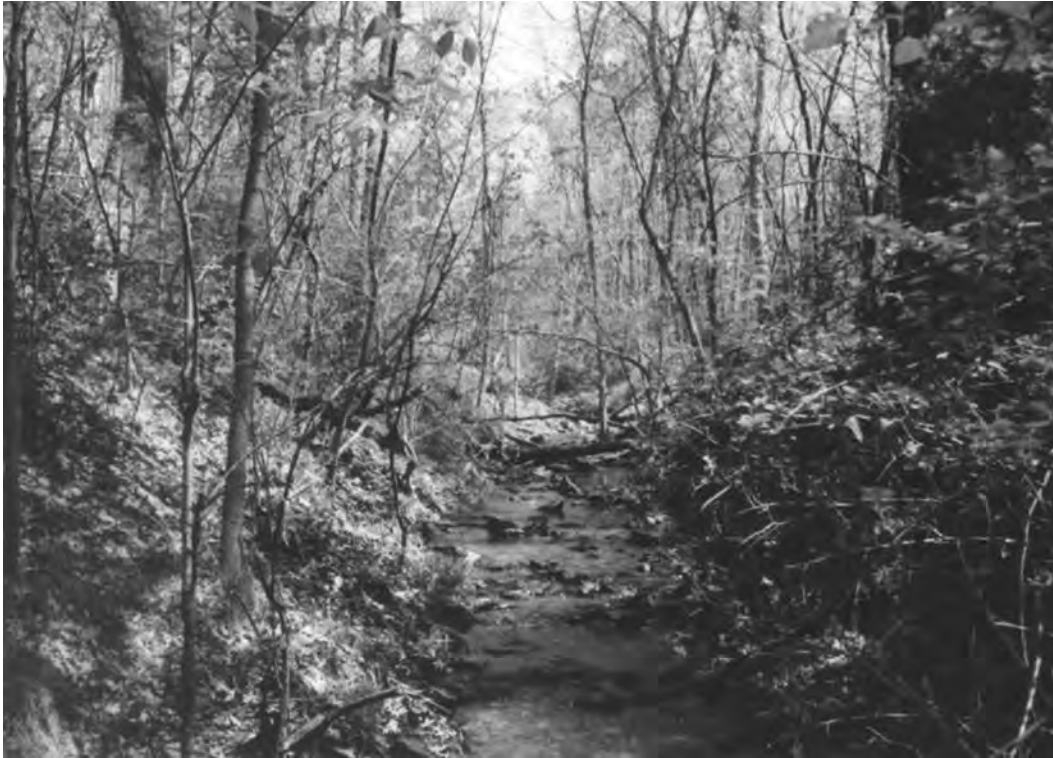
Station 01613160
Potomac River tributary near Hancock, Md.

View looking upstream at reach of Potomac River tributary near Hancock, Md.

The crest-stage partial-record streamflow-gaging station on Potomac River tributary was used to monitor peak gage heights and discharge during water years 1965 to 1976. The station is located just upstream of a circular concrete pipe culvert. The culvert may constrict the bankfull discharge slightly. However, backwater should be minimal due to a water-surface slope that typically exceeds 2 percent. Streamflow-measurement data indicate a combination of conventional discharge measurements and flow-through-culvert indirect discharge measurements that were used to calibrate a theoretical culvert rating for the site.

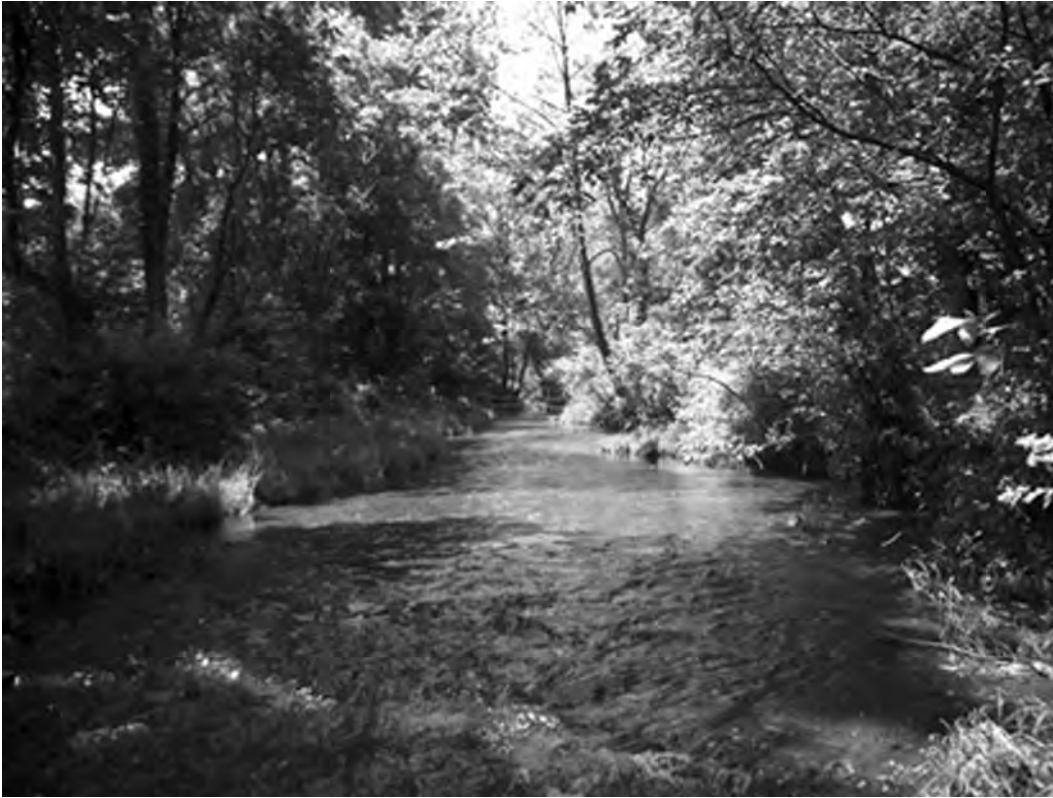
Station 01613900
Hogue Creek near Hayfield, Va.

View looking upstream at reach of Hogue Creek near Hayfield, Va.

The streamflow-gaging station at this site was originally operated as a continuous-record station but was discontinued in 1986. Operation began again as a continuous-record station in 1992. The station is on the right bank just upstream of a concrete bridge. A tributary enters the stream between the bridge and the station. There are no bridge piers in the channel and the bridge does not appear to restrict flow at bankfull stage.

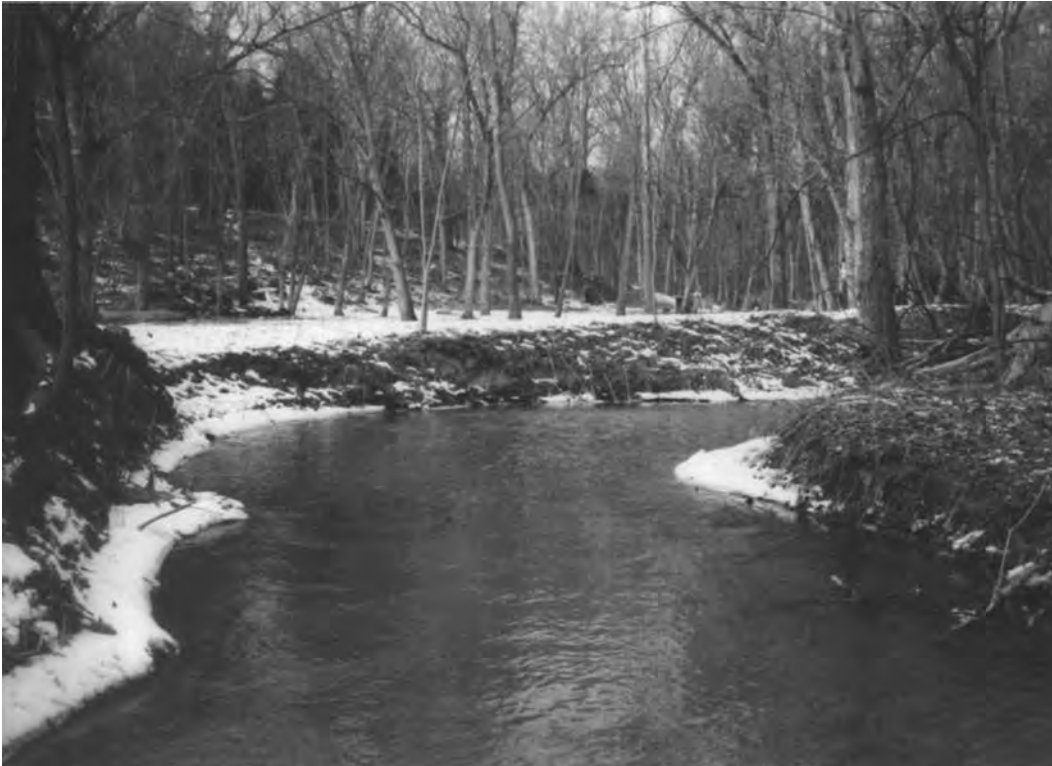
Station 01617800
Marsh Run at Grimes, Md.

View looking downstream at reach of Marsh Run at Grimes, Md.

The continuous-record streamflow-gaging station is located approximately 250 ft upstream from a highway bridge. The bridge does not appear to constrict the bankfull discharge.

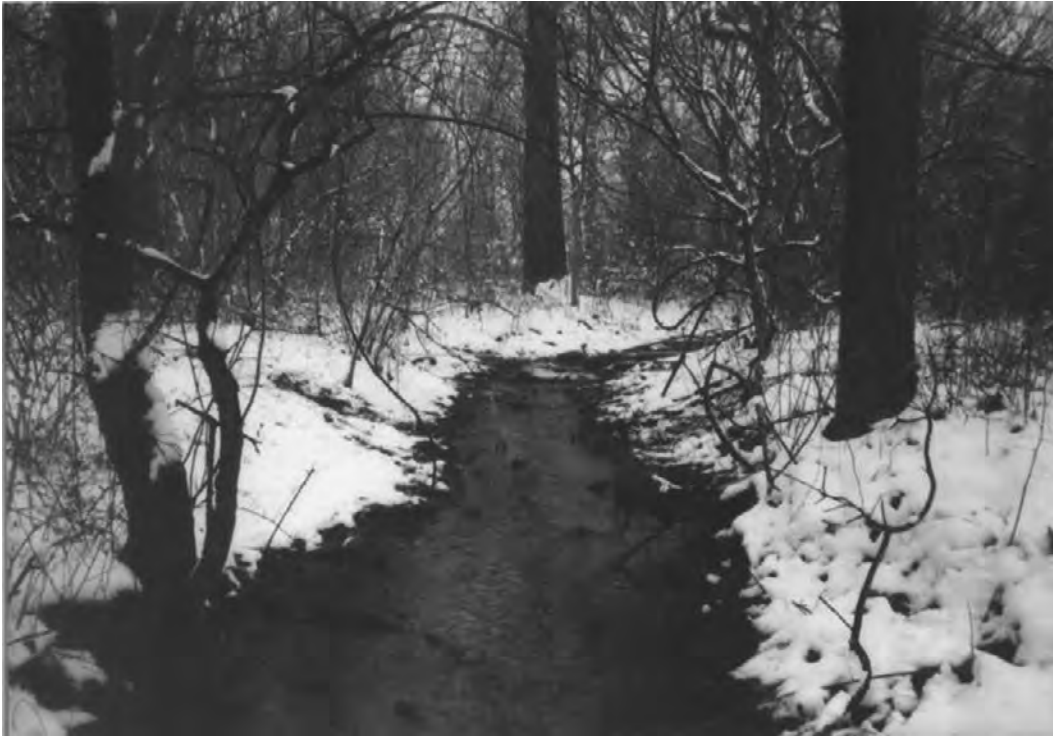
Station 01619475
Dog Creek Tributary near Locust Grove, Md.

View looking upstream at reach of Dog Creek Tributary near Locust Grove, Md.

The crest-stage streamflow-gaging station is located just upstream from a circular concrete pipe culvert. The culvert will constrict the bankfull discharge with a small amount of backwater upstream of the station. Flow-through-culvert indirect discharge measurements were used to calibrate a theoretical culvert rating.

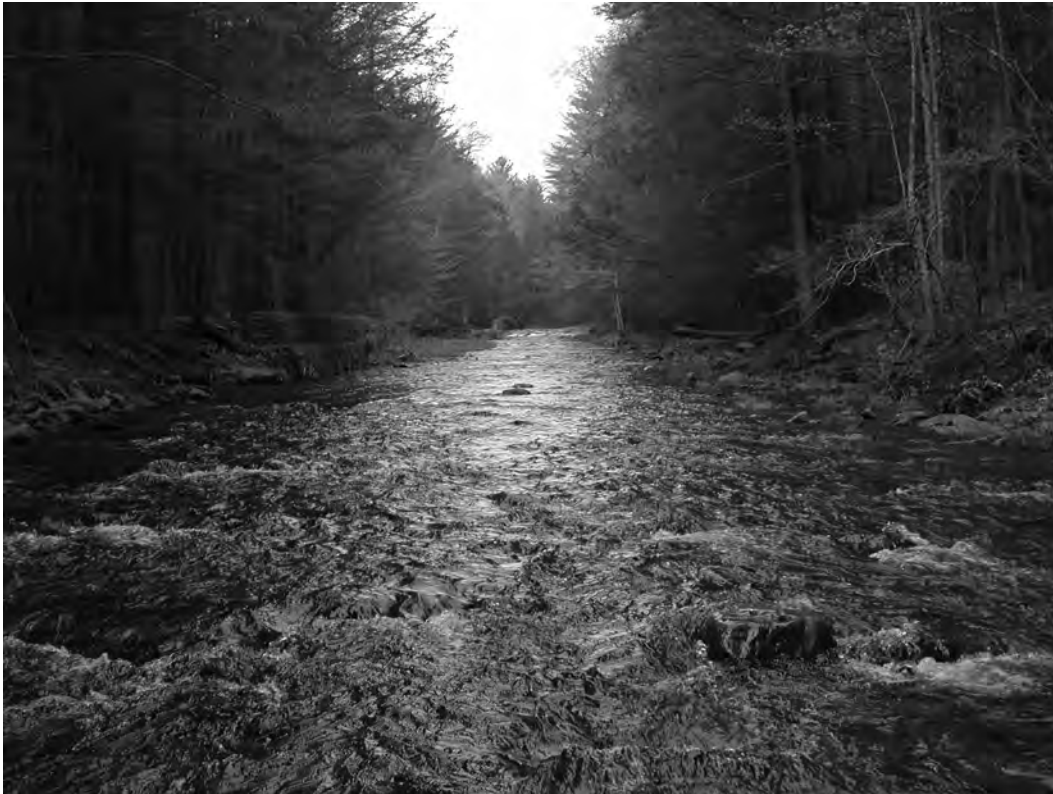
Station 01620500
North River near Stokesville, Va.

View looking downstream at reach of North River near Stokesville, Va.

This site is a continuous-record streamflow-gaging station. The station is approximately 250 ft upstream from a bridge. The bridge may cause slight backwater effect at bankfull discharge.

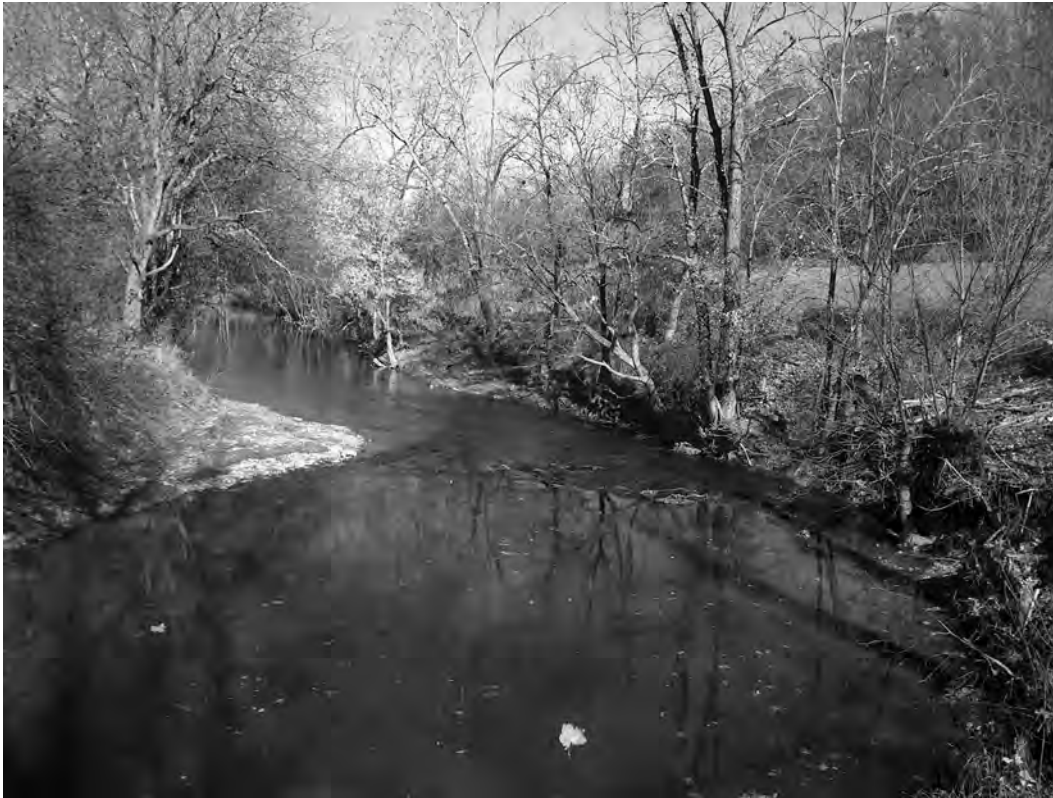
Station 01624800
Christians Creek near Fishersville, Va.

View looking downstream at reach of Christians Creek near Fishersville, Va.

The streamflow-gaging station at this site was discontinued in 1997. It is located on the right bank in a bend adjacent to an old bridge. There is not likely any effect from the bridge on the bankfull discharge.

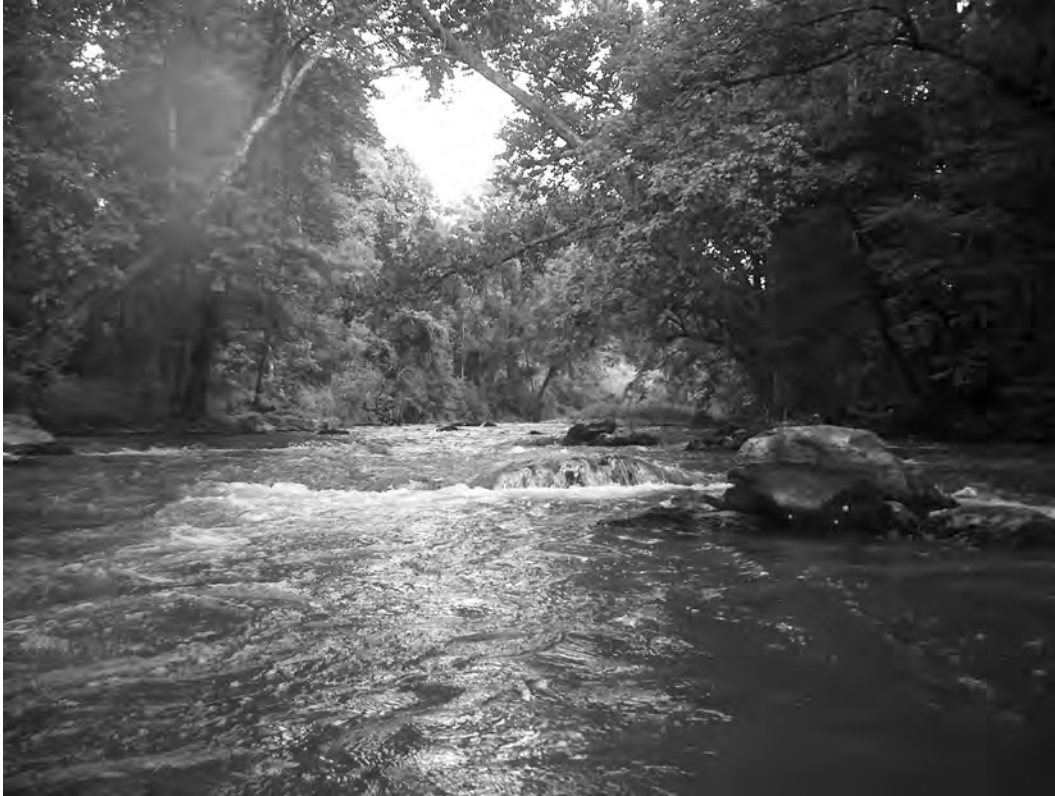
Station 01627500
South River at Harriston, Va.

View looking upstream at reach of South River at Harriston, Va.

The streamflow-gaging station at this site is located approximately 100 ft downstream of a highway bridge. The bridge may impede high flows somewhat, but should not cause a significant backwater effect at bankfull discharge. The study reach did not include the station location because of a deep, unswimmable pool at the bridge.

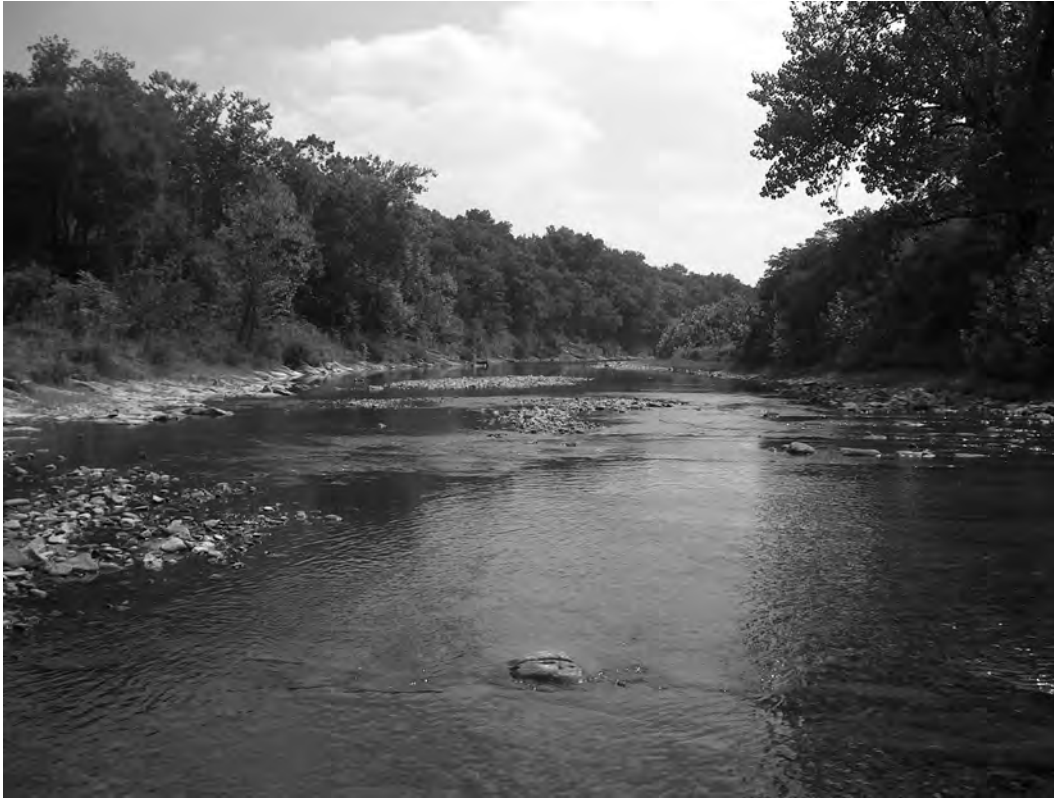
Station 01632000
North Fork Shenandoah River at Cootes Store, Va.

View looking upstream at reach of North Fork Shenandoah River at Cootes Store, Va.

The continuous record streamflow-gaging station is located on the left bank near a bridge. The bridge deck is far above the water surface but there are two piers in the channel. The bridge may cause minimal backwater effects on bankfull flows.

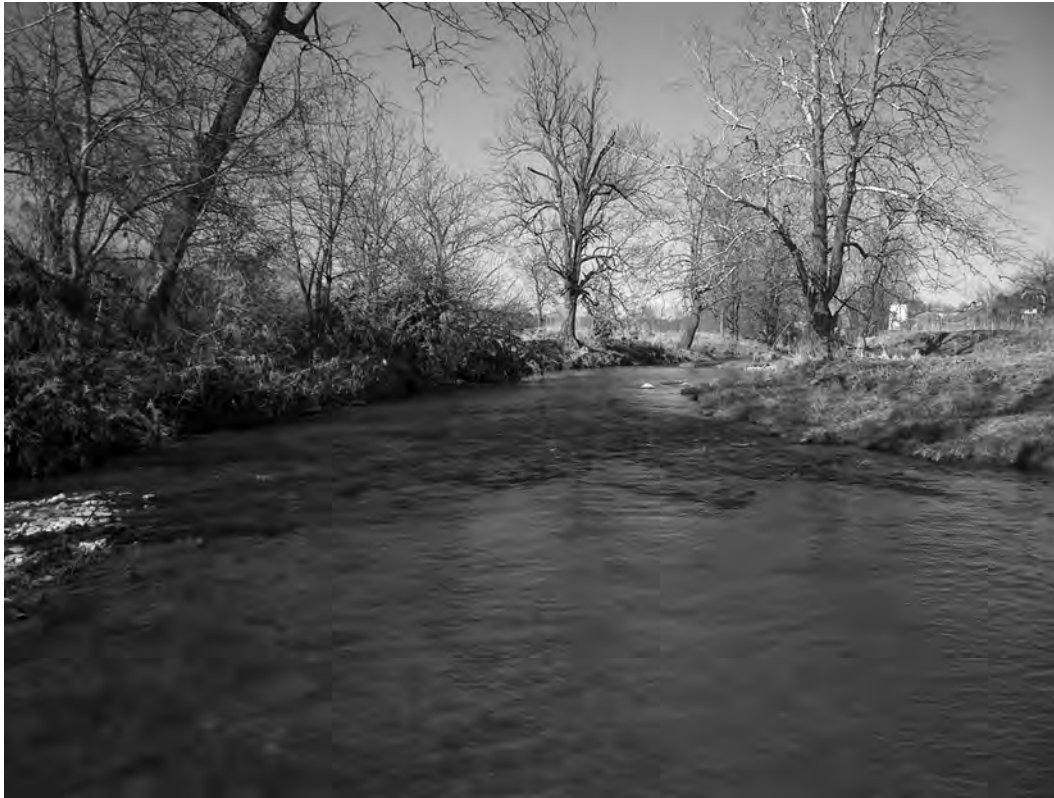
Station 01632082
Linville Creek at Broadway, Va.

View looking upstream at reach of Linville Creek at Broadway, Va.

This continuous-record streamflow-gaging station is located on the left bank approximately 200 ft downstream of a bridge. The bridge is a steel suspension bridge and is not likely to impact flows.

The channel was a fairly straight, bedrock-controlled channel with some cobbles and gravel. A large terrace ran along the left side of the channel. The main bankfull features were a bench below the top of the bank in places where the stream is entrenched, and the top of the bank in other places. The banks of the channel were poorly vegetated with sparse trees and grass. However, very little bank erosion was observed. The flood plain was flat and cleared on both sides. The upstream portion of the reach ran next to a factory that is situated approximately 300 ft upstream of the bridge. The study reach was very straight and had a mild slope.

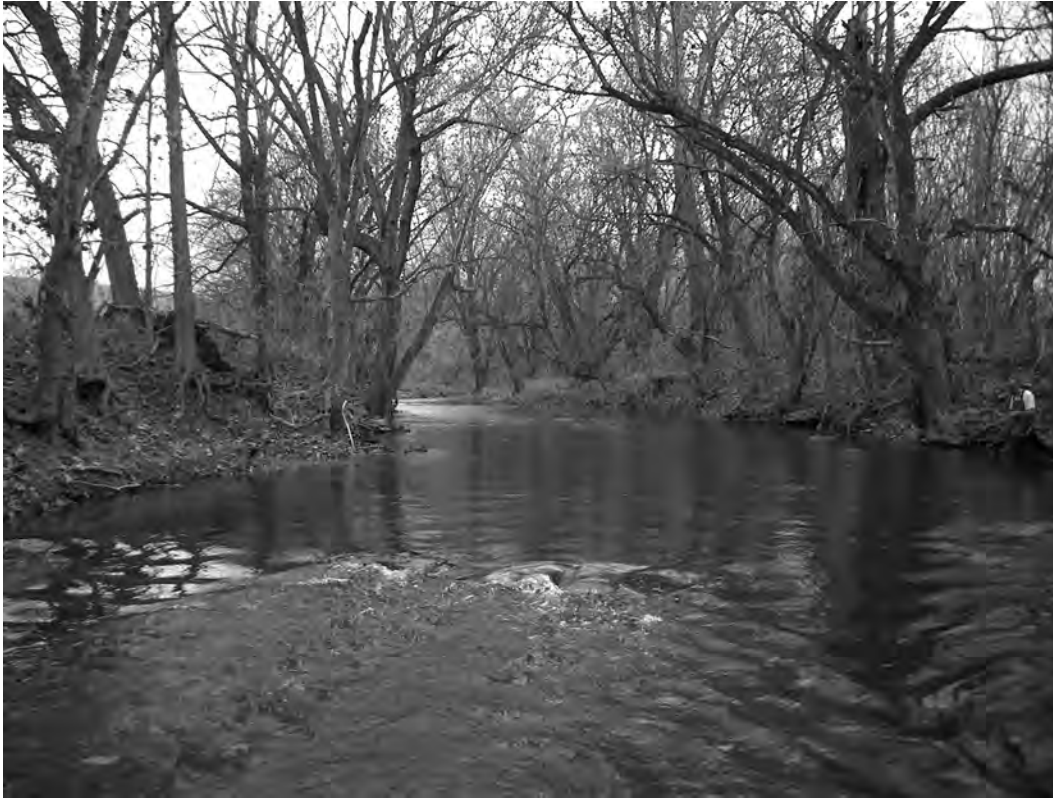
Station 01632900
Smith Creek near New Market, Va.

View looking upstream at reach of Smith Creek near New Market, Va.

This streamflow-gaging station is located just upstream of a highway bridge. The bridge has a pier at both edges of the stream that does not likely cause a significant backwater effect.

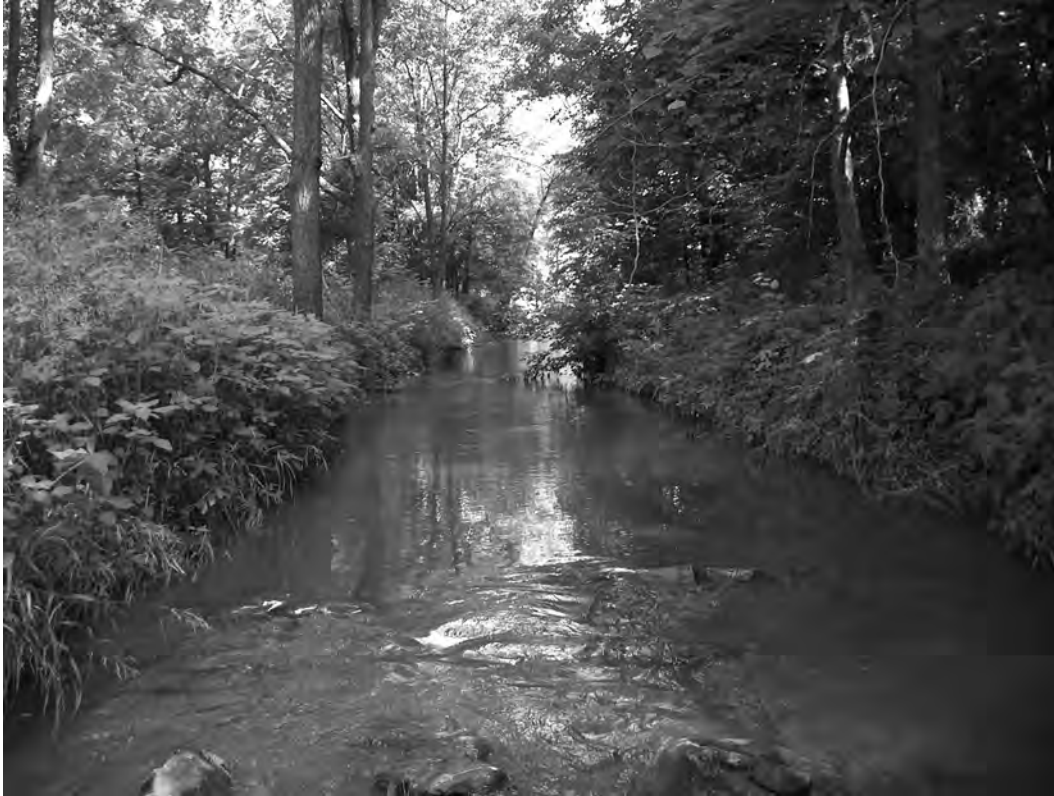
Station 01632970
Crooked Run near Mt. Jackson, Va.

View looking upstream at reach of Crooked Run near Mt. Jackson, Va.

This site has a crest-stage streamflow-gaging station on both the upstream and downstream side of a set of four box culverts. The right two box culverts are silted in and the right side of the channel downstream of the culverts has narrowed so that only two of the box culverts convey any of the flow. The culverts are likely to restrict flow at higher discharges including bankfull.

The stream channel downstream of the culverts had mostly stable banks and was more narrow and deep than the upstream section. Upstream of the culverts, the channel was less stable with significant erosion on the banks and short sections of failing banks. Most of the channel had pools, riffles, runs, and glides. Approximately 600 ft downstream of the culverts, the slope of the channel increased significantly and became dominated by riffle and run bed morphology. The stream was not surveyed beyond this point. The study reach bed material was mostly gravel with some cobble and a few instances of exposed bedrock. Most of the length of the study reach had a 10- to 20-ft wide buffer of herbaceous and woody vegetation. Land beyond the buffer on both sides of the channel was mostly flat and has been cleared for use as pastures. The primary bankfull indicators along the reach were the top of bank and a stable bankfull bench. The study reach was relatively narrow and deep, very straight, and had a mild slope.

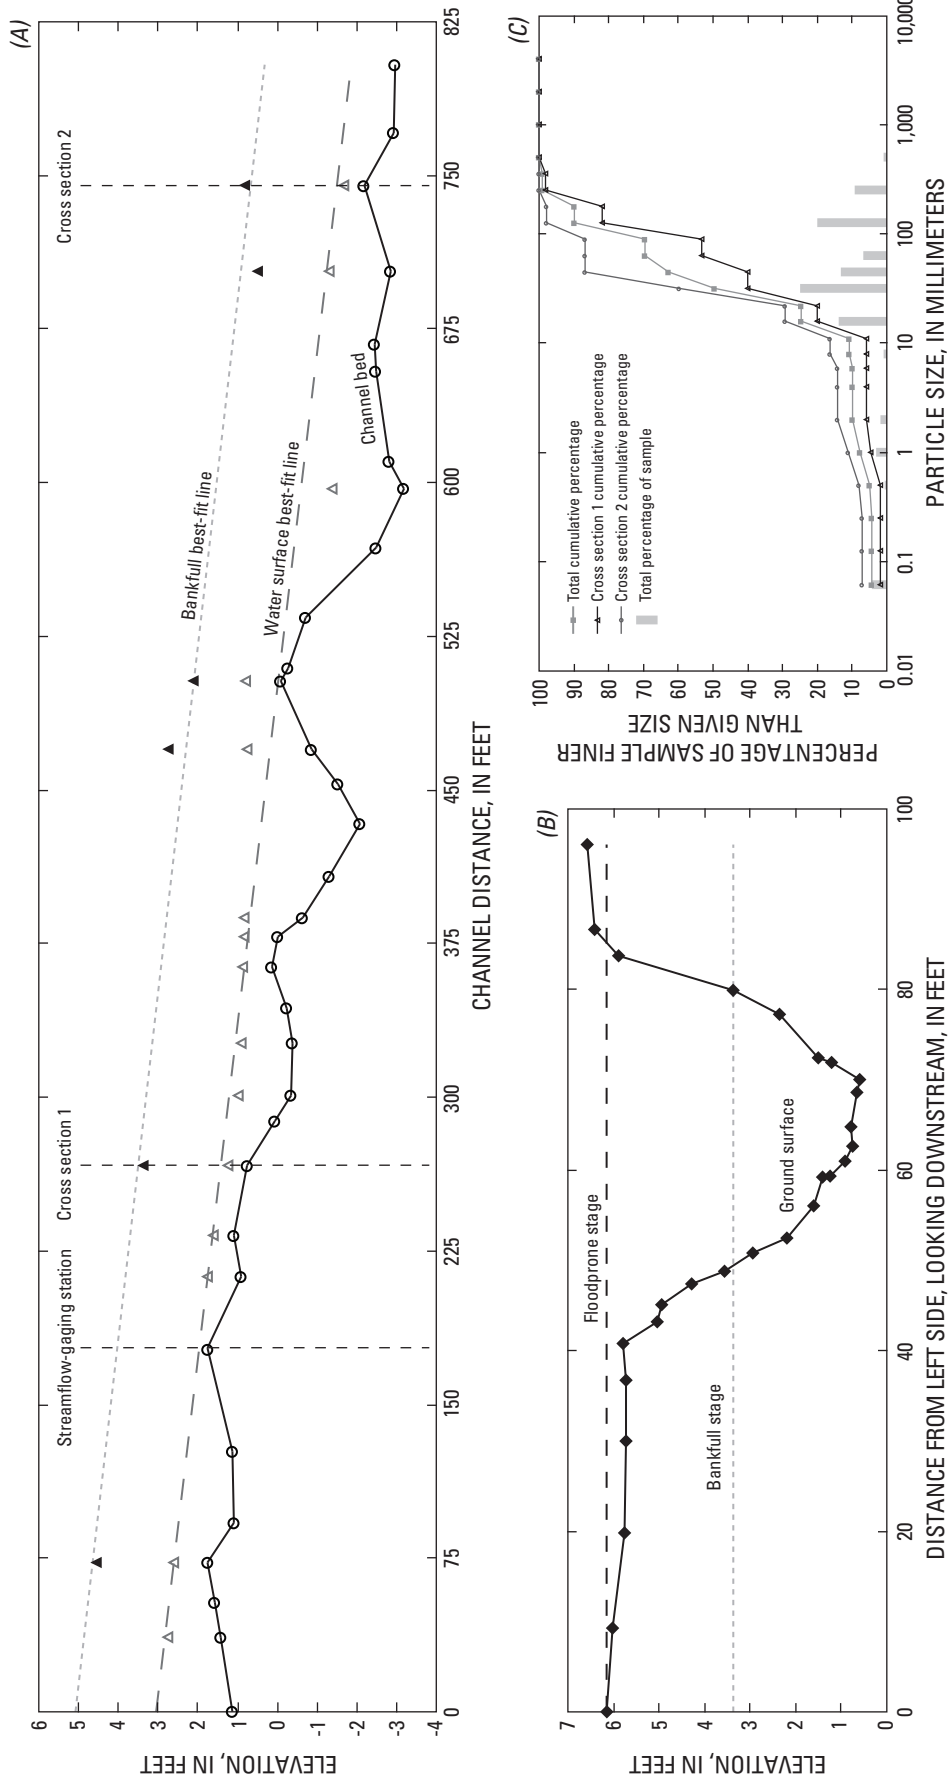
Figure A17. Longitudinal profile (A), riffle cross section 1 (B), and particle-size distribution of bed material (C), in study reach of Crooked Run near Mt. Jackson, Va., June 13, 2003.

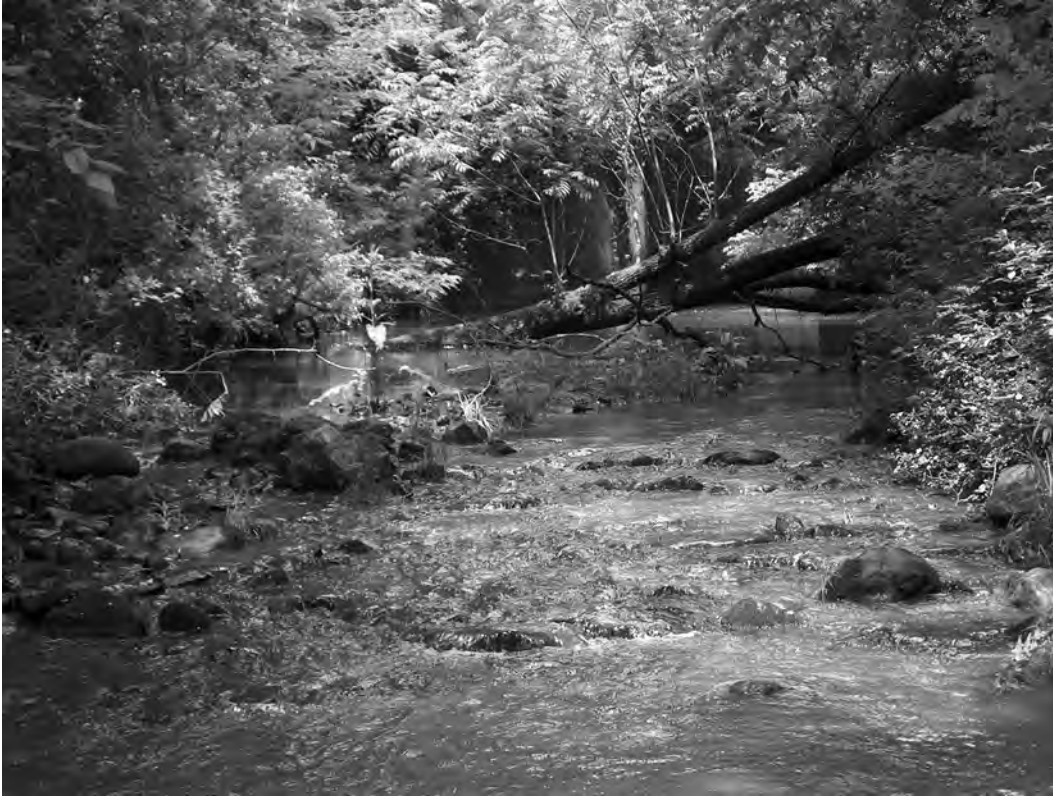
Station 01633650
Pugh's Run near Woodstock, Va.

View looking upstream at reach of Pugh's Run near Woodstock, Va.

This site has a crest-stage streamflow-gaging station installed on both the upstream and downstream side of a box culvert. The rating for this station is theoretical, which results in a greater uncertainty in the relation of stage to discharge.

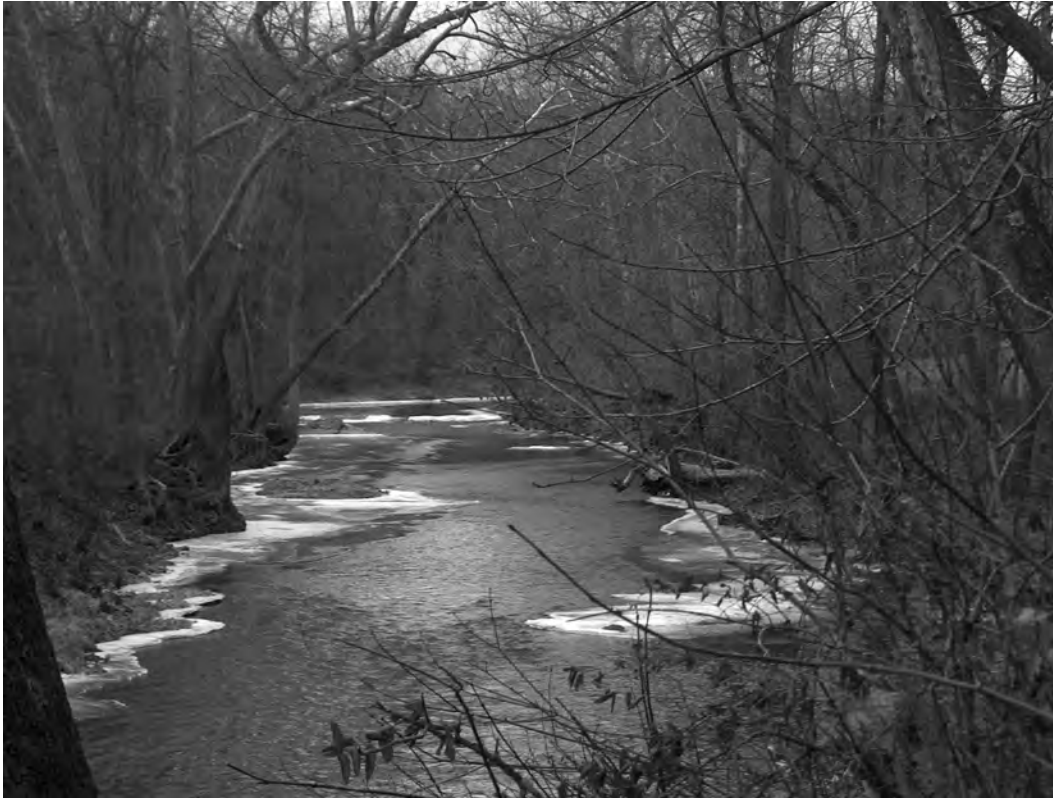
Station 01634500
Cedar Creek near Winchester, Va.

View looking upstream at reach of Cedar Creek near Winchester, Va.

The streamflow-gaging station at this site is located 1600 ft upstream of the bridge. This station is a long running continuous-record station.

Between the bridge and the station there was a section of gorge with large boulders in the channel and deep, slow-moving water. The gorge ended approximately 750 ft downstream of the bridge. The channel upstream of the gorge for several thousand feet was similar to the section near the station. The banks through the study reach were fairly high, indicating that the channel was somewhat incised. There was significant erosion on the banks, making it difficult to find bankfull features. The only bankfull feature found was a break in slope near the top of the bank. The channel had a riparian buffer on either side 5 to 20 ft wide which consisted of woody and herbaceous vegetation. On either side of the channel, pasture lands extended for hundreds of feet beyond the buffers. The bed material in the channel was primarily large gravel and small cobbles. No exposed bedrock was observed. The stream was a riffle/run dominated system with few pools. At the downstream end of the study reach a large steep riffle ended in a long, deep section of pool. The stream was fairly straight through the study section and had a mild gradient.

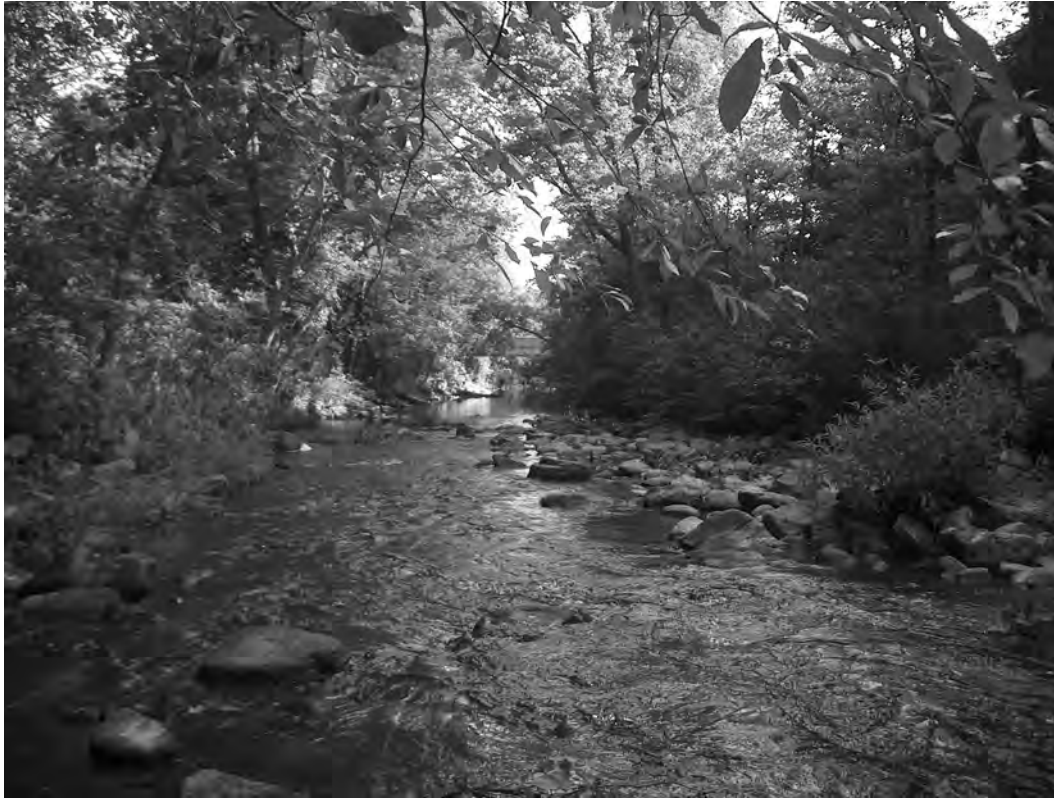
Station 01635500
Passage Creek near Buckton, Va.

View looking downstream at reach of Passage Creek near Buckton, Va.

The continuous-record streamflow-gaging station at this site is approximately 300 ft upstream of a bridge which is not likely to impede flow at bankfull discharge.

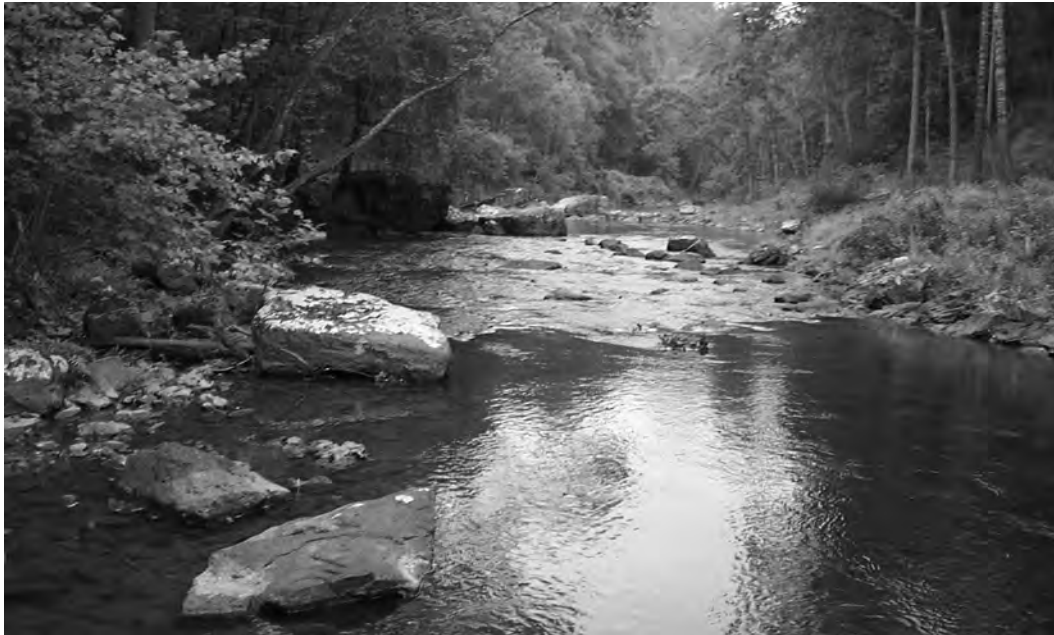
Station 02011400
Jackson River near Bacova, Va.

View looking downstream at reach of Jackson River near Bacova, Va.

The continuous-record streamflow-gaging station at this site is approximately 2,000 ft downstream from a low-water bridge and there are no other structures in the reach.
