Development and Analysis of Regional Curves for Streams in the Non-Urban Valley and Ridge Physiographic Province, Maryland, Virginia, and West Virginia

Scientific Investigations Report 2005-5076

By Jefferson N. Keaton, Terence Messinger, and Edward J. Doheny

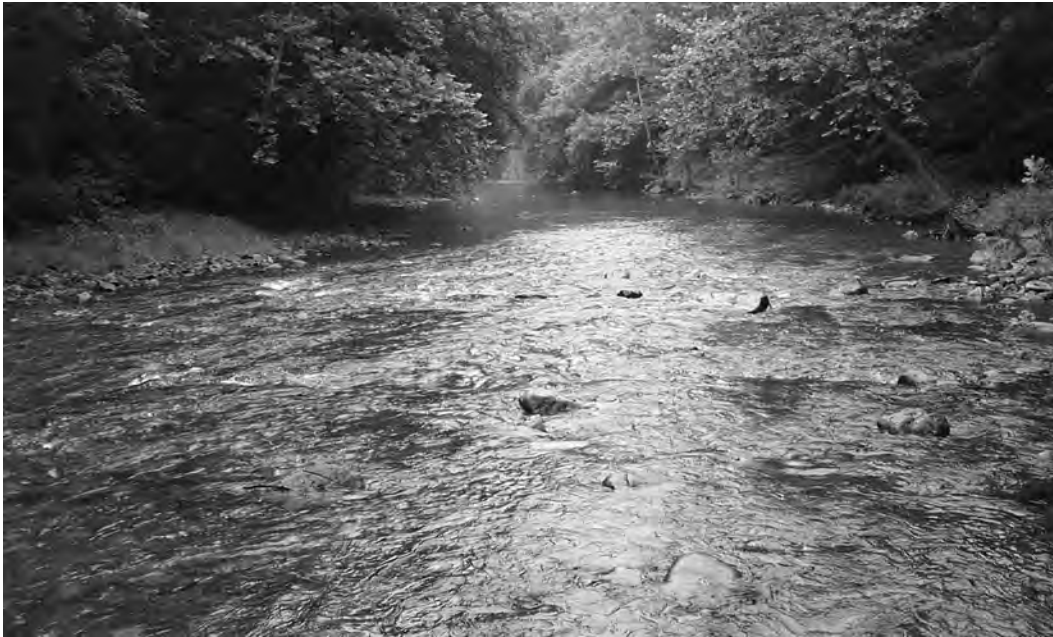
Station 02013000
Dunlap Creek near Covington, Va.

View looking downstream at reach of Dunlap Creek near Covington, Va.

The continuous-record streamflow-gaging station is approximately 50 ft downstream from a bridge that likely has little effect on the bankfull discharge in the survey reach.

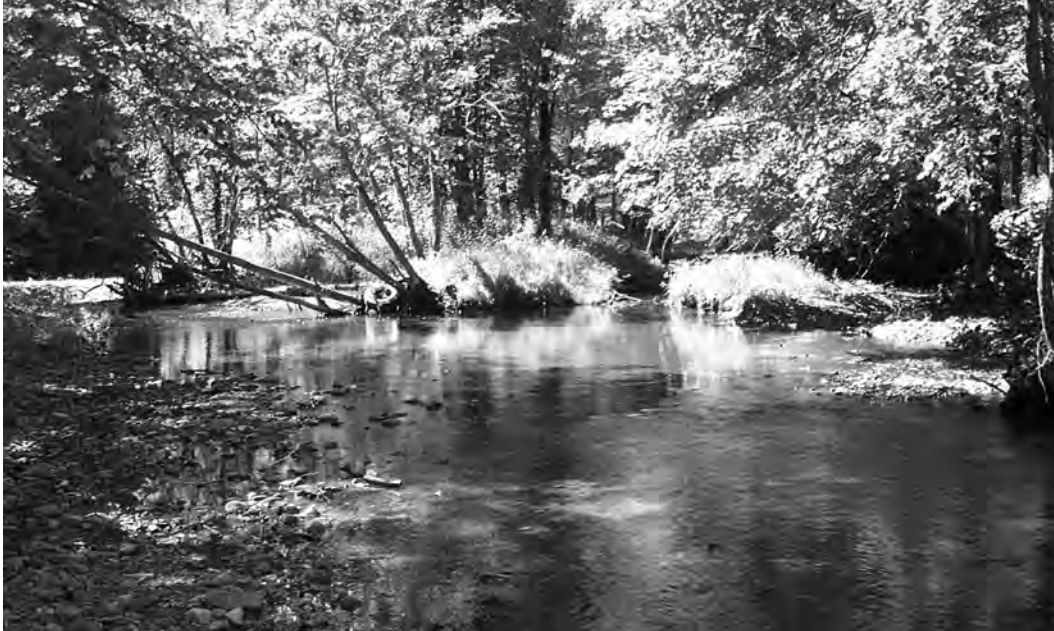
Station 02014000
Potts Creek near Covington, Va.

View looking upstream at reach of Potts Creek near Covington, Va.

The streamflow-gaging station is approximately 50 ft downstream from a bridge that likely has little effect on the stage-discharge relation at bankfull discharge.

The bankfull features were difficult to identify throughout most of the reach. Field indicators used included changes in bank slope and top of the bank. Several breaks in slope of benches were present along the banks through most of the reach. The banks were lightly forested with dense undergrowth. The banks upstream from the bridge showed little erosion, but the banks downstream from the bridge had several slumps and rotational failures. The study reach was moderately sinuous and had a mild slope. The bed material was mostly coarse gravel and cobble. The stream channel upstream from the bridge was bordered on the right side by a narrow flood plain, and on the left side by a hill with a flat shelf about 25 ft above the stream bed. The stream channel downstream from the bridge also had narrow flood plains on both sides.

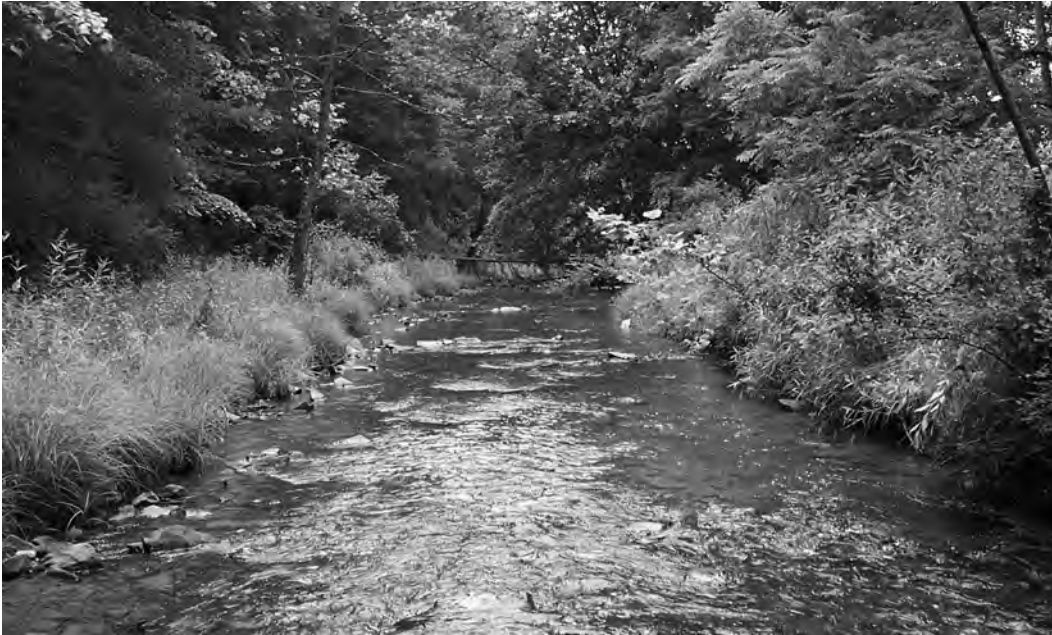
Station 02015600
Cowpasture River near Head Waters, Va.

View looking downstream at reach of Cowpasture River near Head Waters, Va.

The crest-stage streamflow-gaging station was attached to the downstream wing wall of the left-descending abutment of a now removed bridge. The constriction of flow at the old bridge span probably results in backwater at higher flows. The station was in operation as a crest-stage station at the time of the survey.

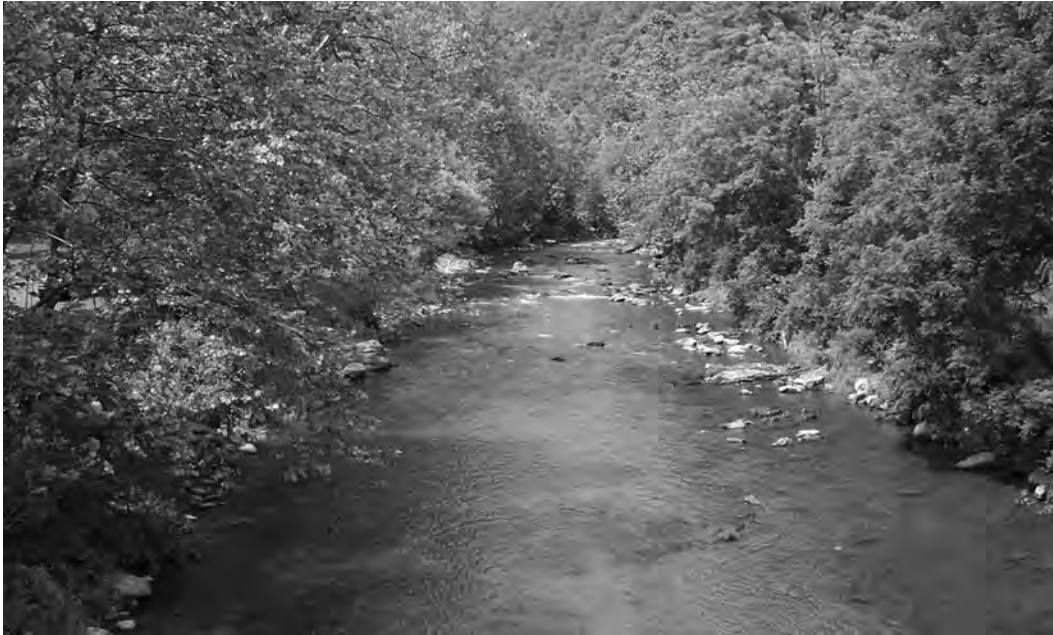
Station 02015700
Bullpasture River at Williamsville, Va.

View looking downstream at reach of Bullpasture River at Williamsville, Va.

The continuous-record streamflow-gaging station at this site is approximately 50 ft downstream from a highway bridge. The bridge likely has little backwater effect on the bankfull discharge at the station, but may create substantial backwater upstream from the bridge. The study reach was discontinued approximately 200 ft upstream of the bridge.

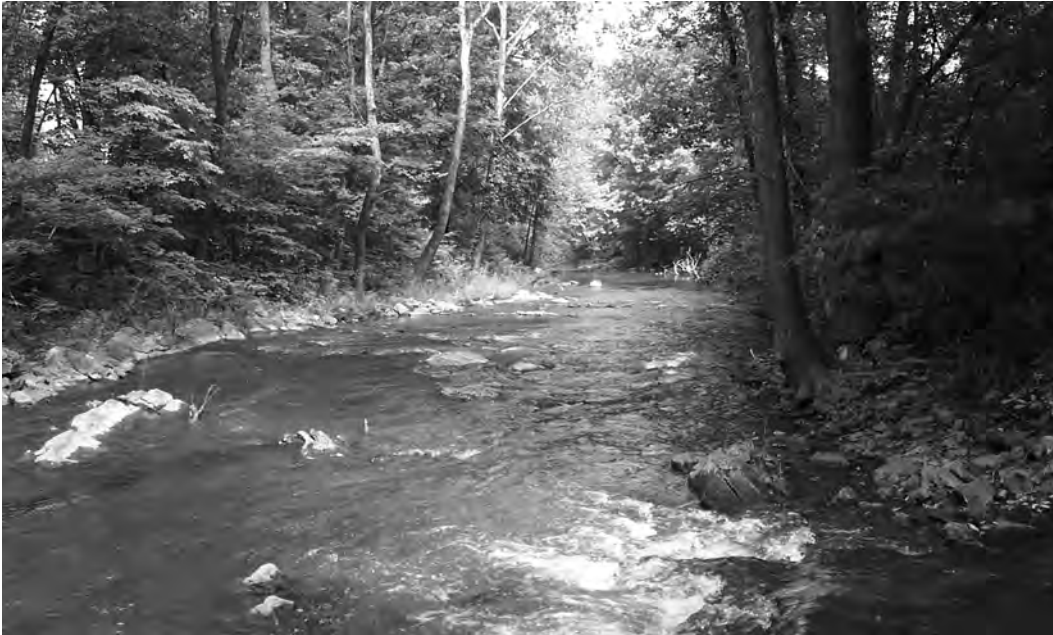
Station 02018500
Catawba Creek near Catawba, Va.

View looking downstream at reach of Catawba Creek near Catawba, Va.

The continuous-record streamflow-gaging station is approximately 150 ft downstream from a bridge that likely has little effect on the stage-discharge relation at bankfull discharge, and about 200 ft upstream from another bridge that may create a substantial backwater at bankfull discharge. The survey reach included the first bridge, but not the second.

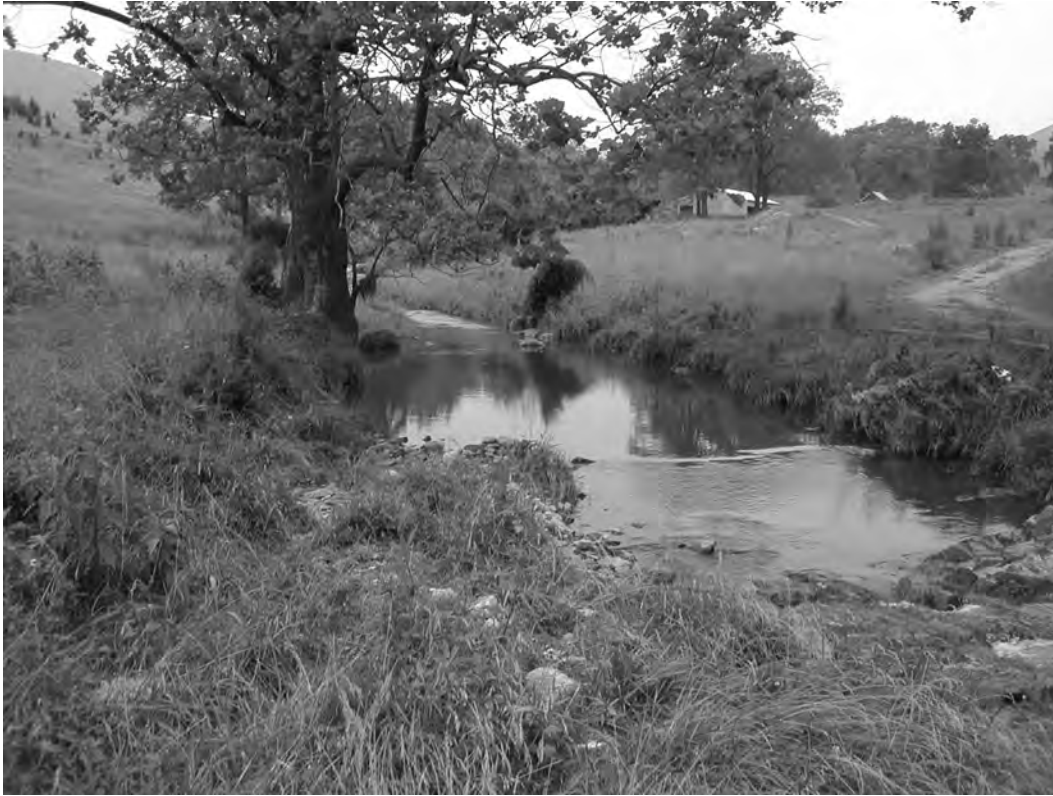
Station 02020100
Renick Run near Buchanan, VA

View looking upstream at reach of Renick Run near Buchanan, Va.

The crest-stage streamflow-gaging station at this site was attached to the upstream wingwall of a box culvert. The culvert likely has a substantial backwater effect on the stage-discharge relation at bankfull discharge. The rating for this station is theoretical. Only eight measurements have been made at the site, and all were made for discharges below the bankfull discharge.

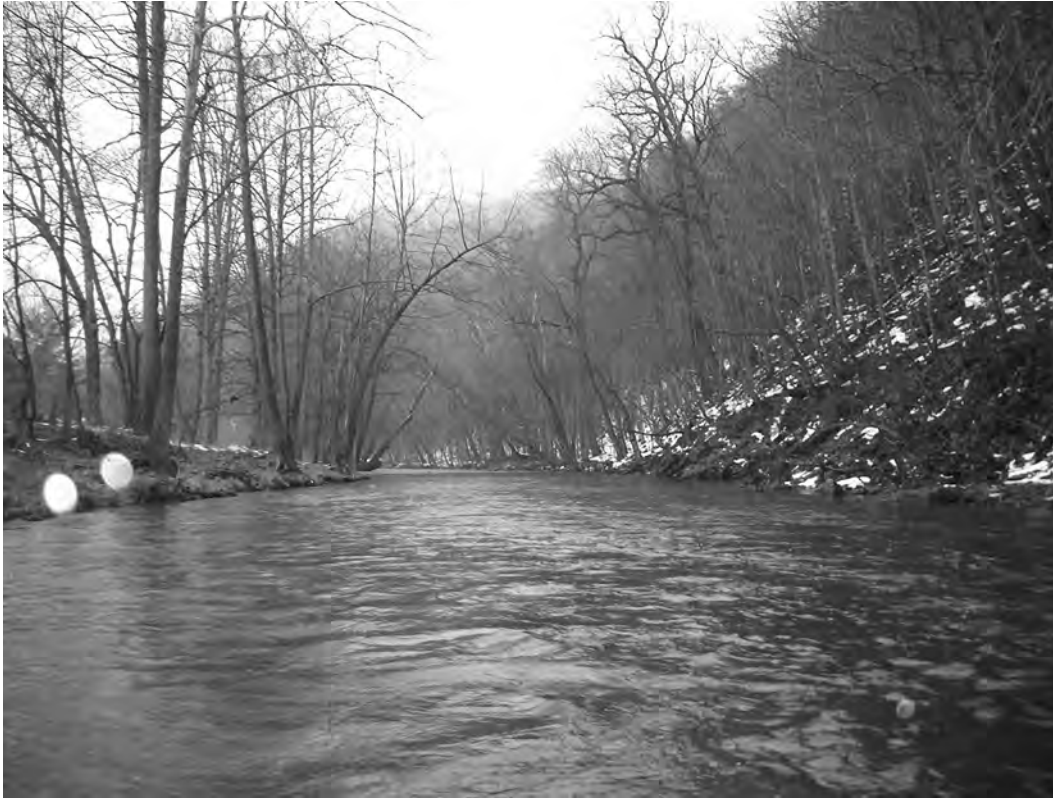
Station 02053800
South Fork Roanoke River near Shawsville, Va.

View looking downstream at reach of South Fork Roanoke River near Shawsville, Va.

The streamflow-gaging station at this site is a continuous record station located at a pool approximately 95 ft downstream of a bridge on the right bank. The bridge deck is approximately 30 ft above the water surface and has two concrete piers in the channel. Minimal backwater effects may occur at bankfull discharge.

The channel was a riffle-run dominated stream with a cobble bed. The cobble seemed to be well cemented with sand and small gravel. Some sections of the bed were predominantly sand, especially in the few small pools present. No exposed bedrock was observed in the study reach. The primary bankfull indicator at this site was the top of the bank or, in the upstream sections, a stable bench feature below the top of the bank. The channel banks were vegetated with trees and grass but little small woody or herbaceous vegetation. Moderate scour was observed at some locations on the banks. The channel had a mild slope and was very straight except for a turn that was made as the stream approached and ran alongside a steep mountainside. Except for this section the flood plains were flat, cleared, and used for home sites and a church.

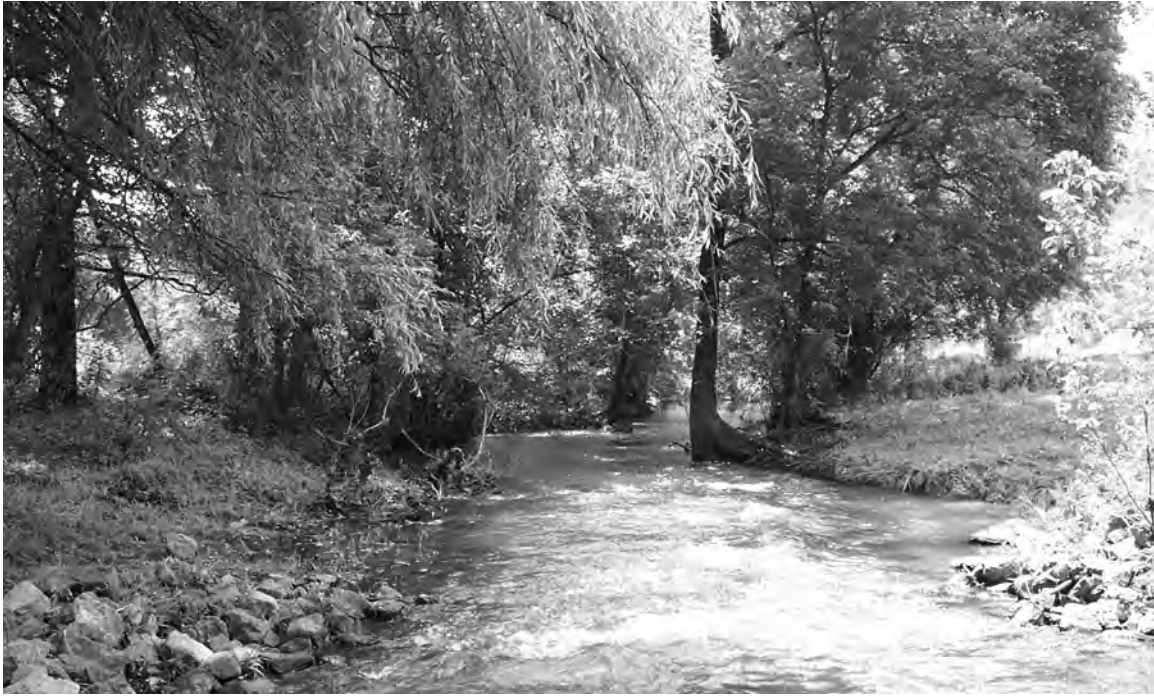
Station 02055100
Tinker Creek near Daleville, Va.

View looking downstream at reach of Tinker Creek near Daleville, Va.

This continuous-record streamflow-gaging station is about 1,000 ft downstream from a large pipe culvert that likely had no effect on bankfull discharge in the survey reach.

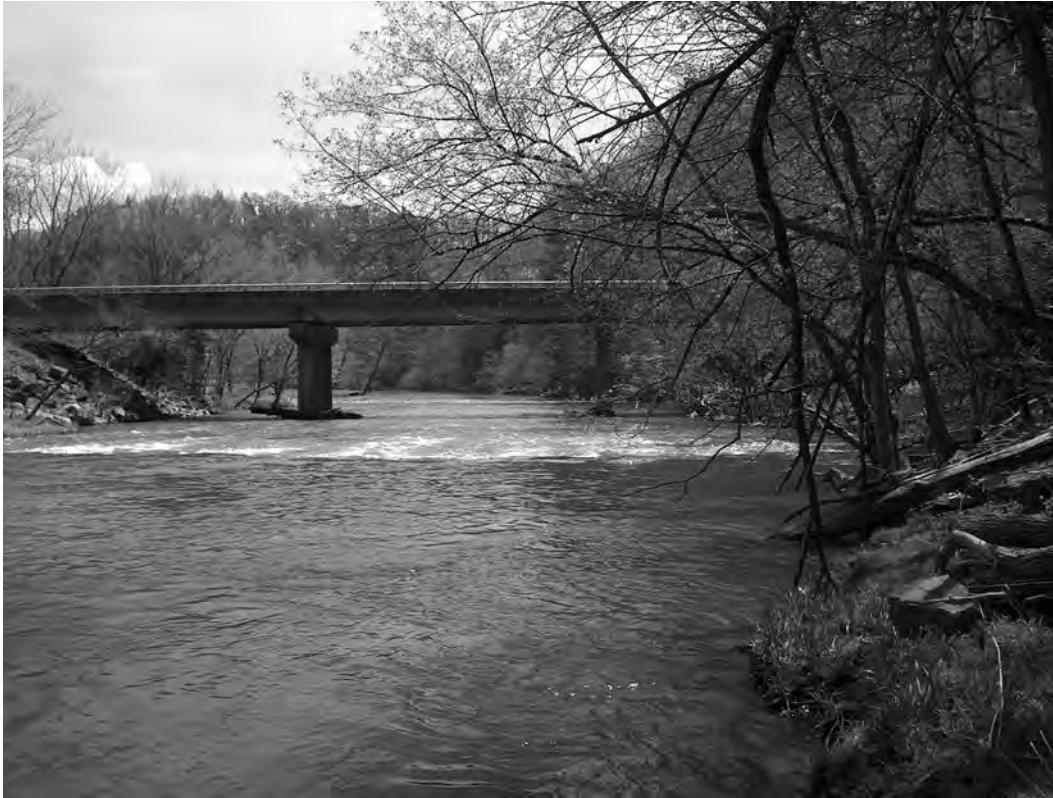
Station 03167000
Reed Creek at Grahams Forge, Va.

View looking downstream at reach of Reed Creek at Grahams Forge, Va.

This continuous-record streamflow-gaging station is located 20 ft downstream of a highway bridge. The bridge has two piers in the channel, which may cause some backwater effect at high flows though it is likely minimal.

The channel was relatively wide and shallow with many bedrock outcroppings and large boulders. There was also a lot of cobble bed material throughout the reach. The study reach was very straight and ran along a high, densely vegetated bluff on the right side. The left bank was vegetated with only grass and a few scattered trees. Very little bank erosion was observed. The gently sloping flood plain on the left side was farmland, private yards, and the site of an old, abandoned store and mill. The study reach was a riffle-run system except for a large, 200-ft-long pool that dominated the middle of the reach. The primary bankfull features identified at the site were the top of the bank or a bench below the top of the bank. The slope of the study reach was mild.

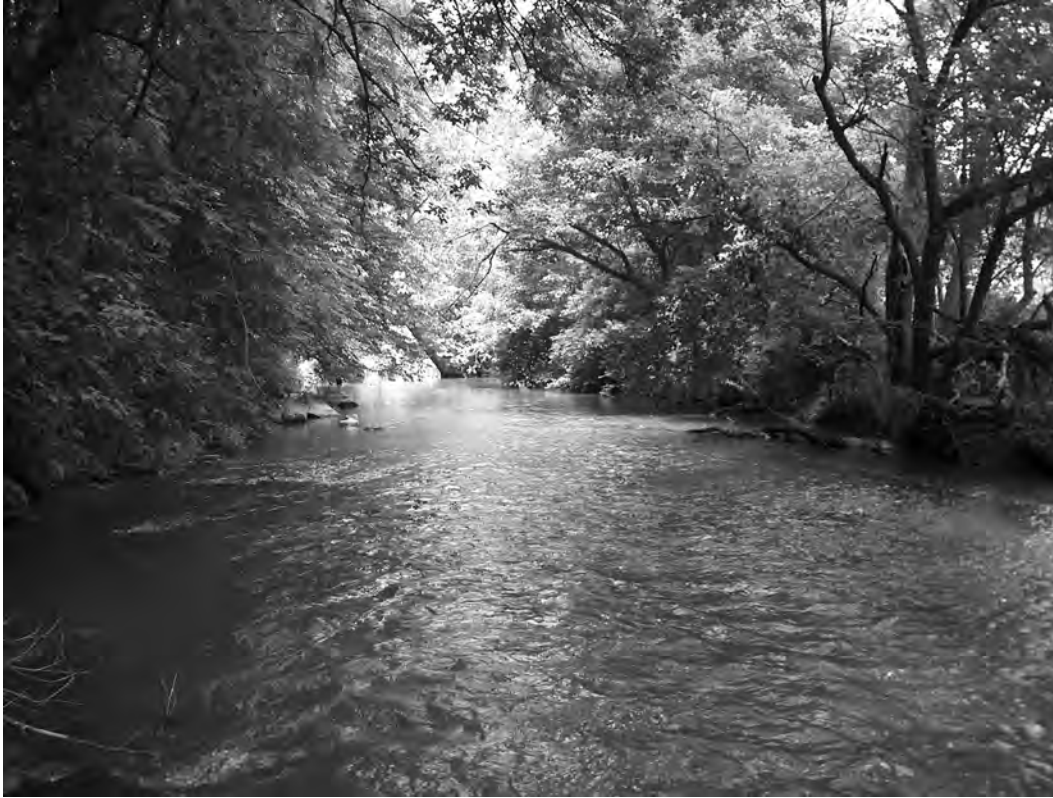
Station 03177710
Bluestone River at Falls Mills, Va.

View looking upstream at reach of Bluestone River at Falls Mills, Va.

The streamflow-gaging station is a continuous record station just upstream from a small bridge that likely has little backwater effect at bankfull discharge. The station at this site has been discontinued since 1997.

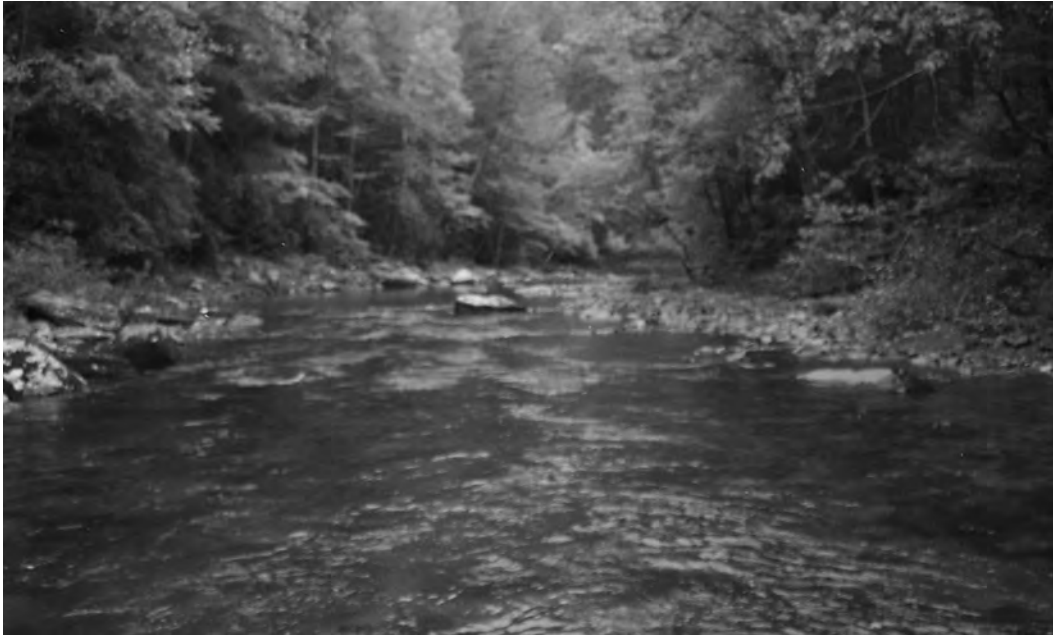
Anthony Creek near Anthony, W. Va.

View looking downstream at reach of Anthony Creek at Anthony, W. Va.

This continuous-record streamflow-gaging station was about 1 mile downstream from the nearest bridge. The station has been discontinued since 1982, and the structure is no longer present. The period when the continuous streamflow-measurement station was active, 1971-1982, was an exceptionally wet period, and Log-Pearson peakflow frequency statistics calculated for this station were exceptionally high for the region (Wiley and others, 2000). Regional frequency statistics were judged to be more representative for this station than station frequency analysis. The bankfull discharge was determined from the rating, but the frequency was from the regional regression equation.

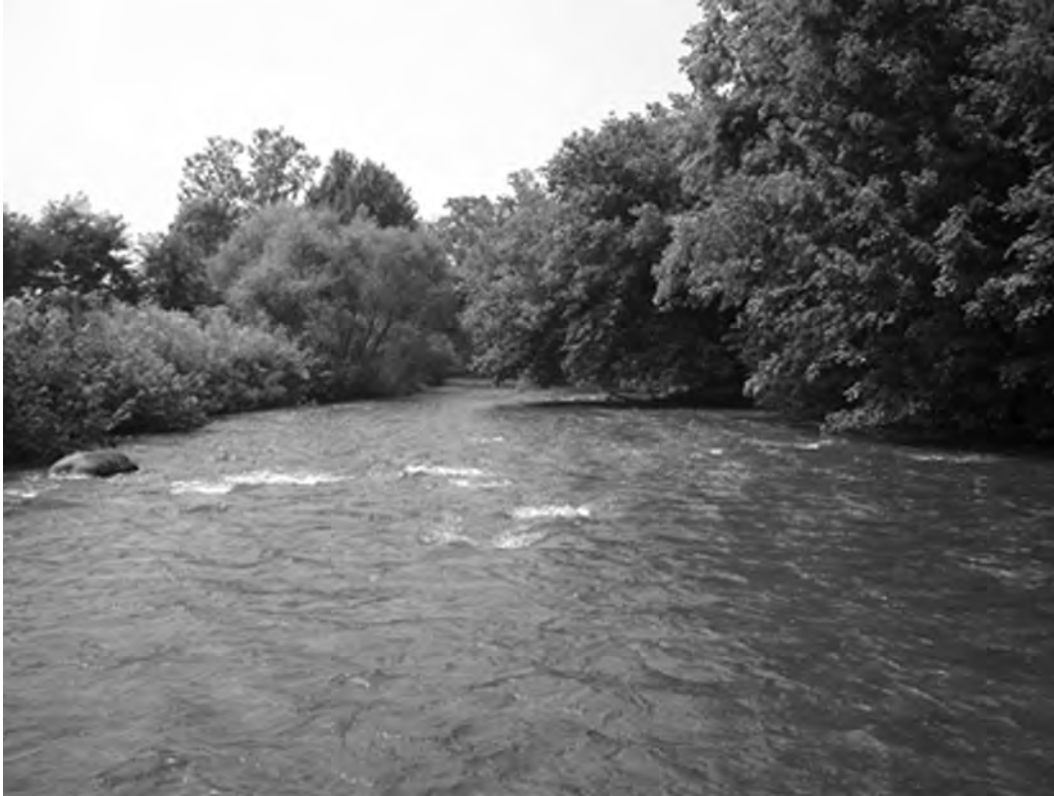
Station 03471500
South Fork Holston River at Riverside near Chilhowie, Va.

View looking upstream at reach of South Fork Holston River at Riverside near Chilhowie, Va.

The continuous-record streamflow-gaging station at this site is located approximately 400 ft upstream from a highway bridge. The bridge has two piers in the channel, which may cause a slight backwater effect at high flows.

The bed material in the study reach was mostly gravel and cobble over bedrock, which was exposed in many places. The bankfull channel was well defined by the top of banks. In some sections of the channel, there was a stable bench feature below the bankfull feature. The right bank of the study reach was well vegetated with trees and small woody vegetation. Very little bank erosion was observed. The flood plains on both sides were generally flat. The left flood plain was cleared for private yards and the grounds of a church. In the upstream section, the left bank was vegetated only with grass. In the downstream section the left bank was covered with small woody vegetation. The reach was very straight and had a mild slope. The reach had riffles, runs, glides, and several deep pools.

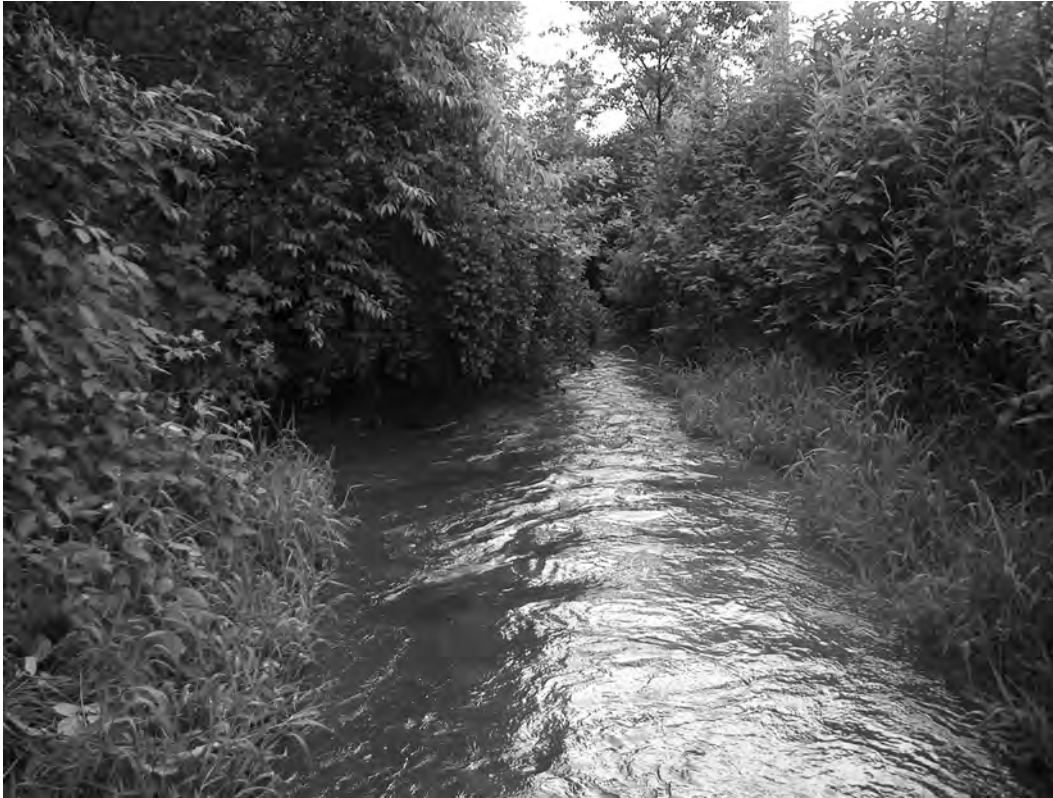
Station 03473500
Middle Fork Holston River at Groseclose, Va.

View looking downstream at reach of Middle Fork Holston River at Groseclose, Va.

The original streamflow-gaging station at this site has been discontinued and it is now operated as a crest-stage station. The station is on the left bank immediately downstream of a large box culvert, which will cause a backwater effect at bankfull discharge. The study reach was downstream of the culvert.

The local slope at the outlet of the culvert was fairly steep but the remainder of the study reach had a much flatter gradient. The reach had long sections of pool and shorter riffles and runs. The reach was dominated by gravel bed material and there were no bedrock outcroppings observed. The channel is fairly narrow with dense woody and herbaceous vegetation on both banks. The right side of the stream runs along the bottom of a steep railroad grade for the entire length of the study reach, which is very straight. The stream was likely channelized when the railroad was constructed. The left bank appeared to be natural with a stable bankfull bench. There was also a low bench feature below bankfull throughout the reach. In the upstream section the left flood plain was quite steep; in the downstream portion the slope was more gentle but still rising high above the stream bed. Because of this and the railroad grade on the right, the stream is entrenched.

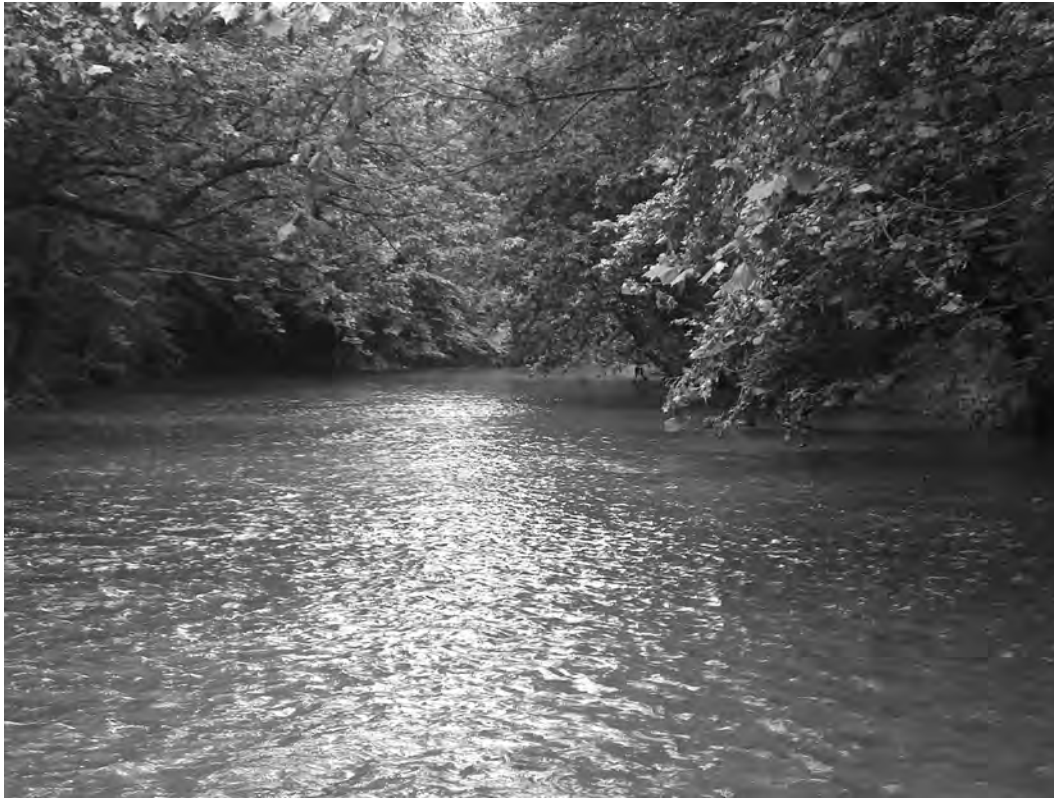
Station 03474000
Middle Fork Holston River at Seven Mile Ford, Va.

View looking downstream at reach of Middle Fork Holston River at Seven Mile Ford, Va.

The streamflow-gaging station at this site is a continuous record station that is on the right bank downstream of a bridge at the end of a long pool. The bridge has two piers in the channel and the deck is approximately 20 ft above the water surface. There may be some slight backwater effect at the bankfull discharge.

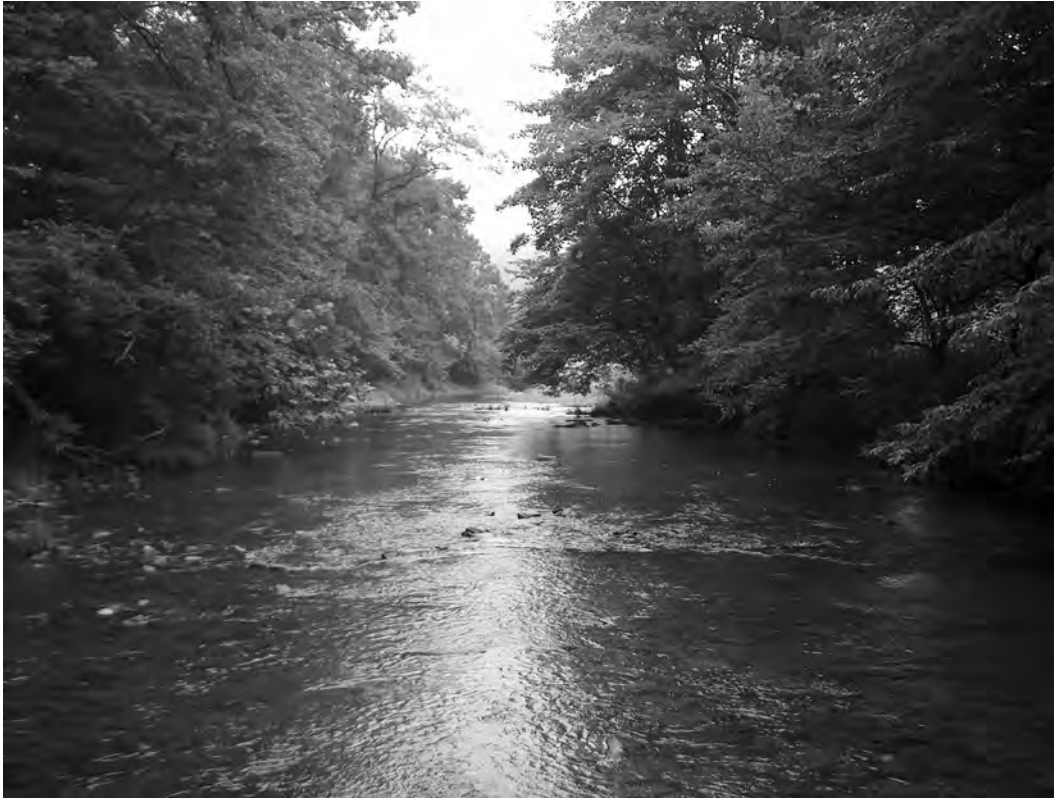
Station 03487800
Lick Creek near Chatham Hill, Va.

View looking downstream at reach of Lick Creek near Chatham Hill, Va.

The streamflow-gaging station at this site was once a continuous-record station but has been a crest-stage station only since 1968. It is located on a farm 270 ft upstream of a highway bridge. It is not likely that the bridge causes backwater during high flows.

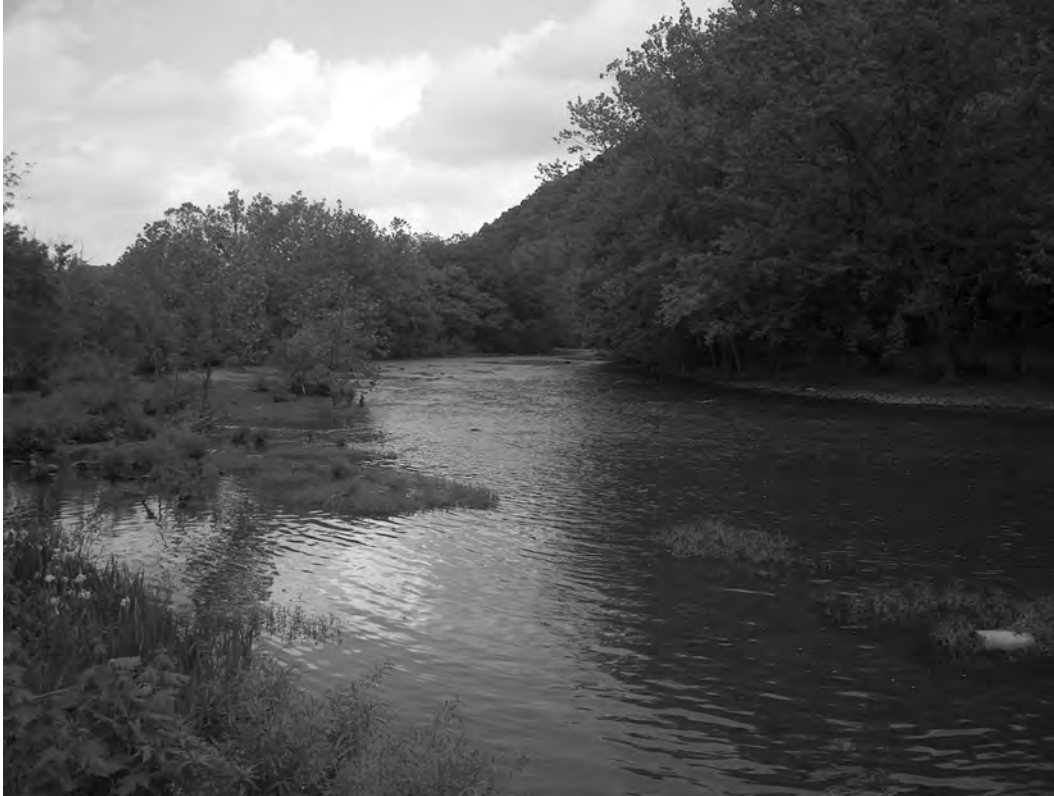
Station 03488000
North Fork Holston River near Saltville, Va.

View looking upstream at reach of North Fork Holston River near Saltville, Va.

The continuous-record streamflow-gaging station at this site is not in the vicinity of a bridge. There are no structures present to impede flow.

The channel was very wide and shallow and there is vegetation growing in the bed in many locations. The study reach had one of the most gentle gradients of any in the study and it was one of the most sinuous. The bed material was composed of gravel and small cobble. No exposed bedrock was observed in the study reach. The banks were vegetated sporadically with trees, small woody vegetation, and herbaceous vegetation. In many areas the flat flood plain was used for private yards and farm fields. In these locations, the banks were only grass covered. Little evidence of bank erosion was observed throughout the study reach. The primary bankfull indicator at this site was the top of the bank or a stable bench feature.

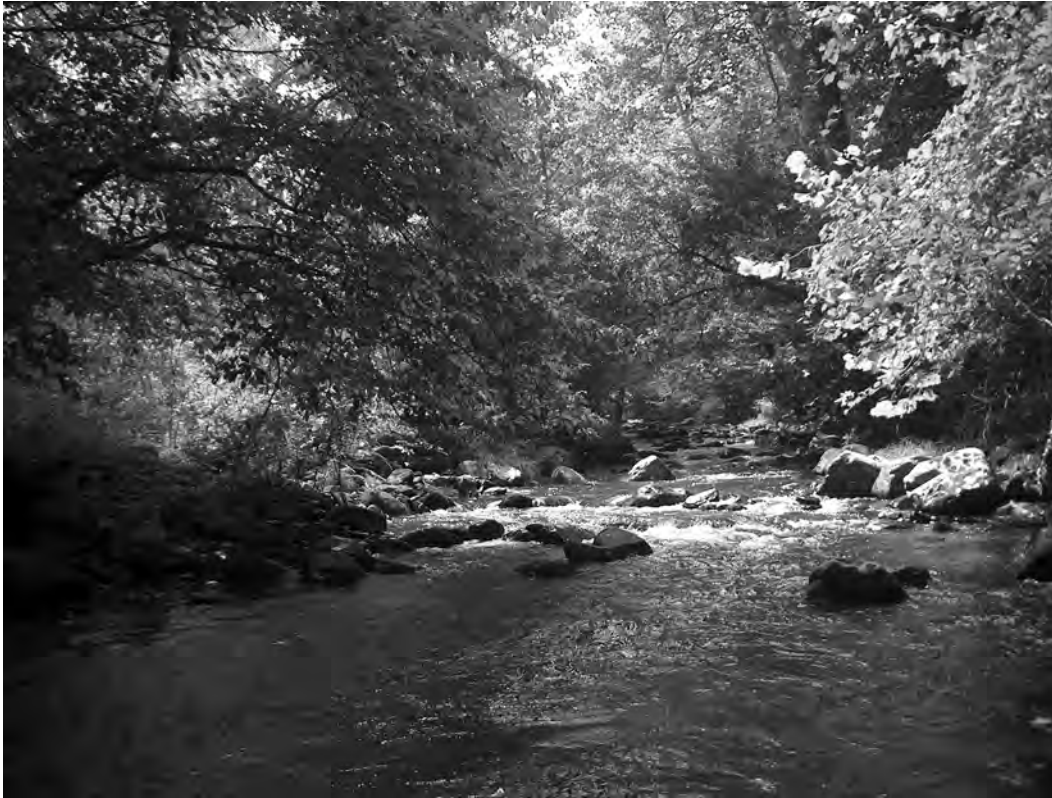
Station 03488450
Brumley Creek at Brumley Gap, Va.

View looking upstream at reach of Brumley Creek at Brumley Gap, Va.

This site has a crest stage streamflow-gaging station on the downstream abutment of the bridge on the right side. Few measurements have been made at the site, all for discharges well below bankfull, and the rating is theoretical. The bridge has one pier in the center of the stream which does not likely cause backwater at bankfull flows.

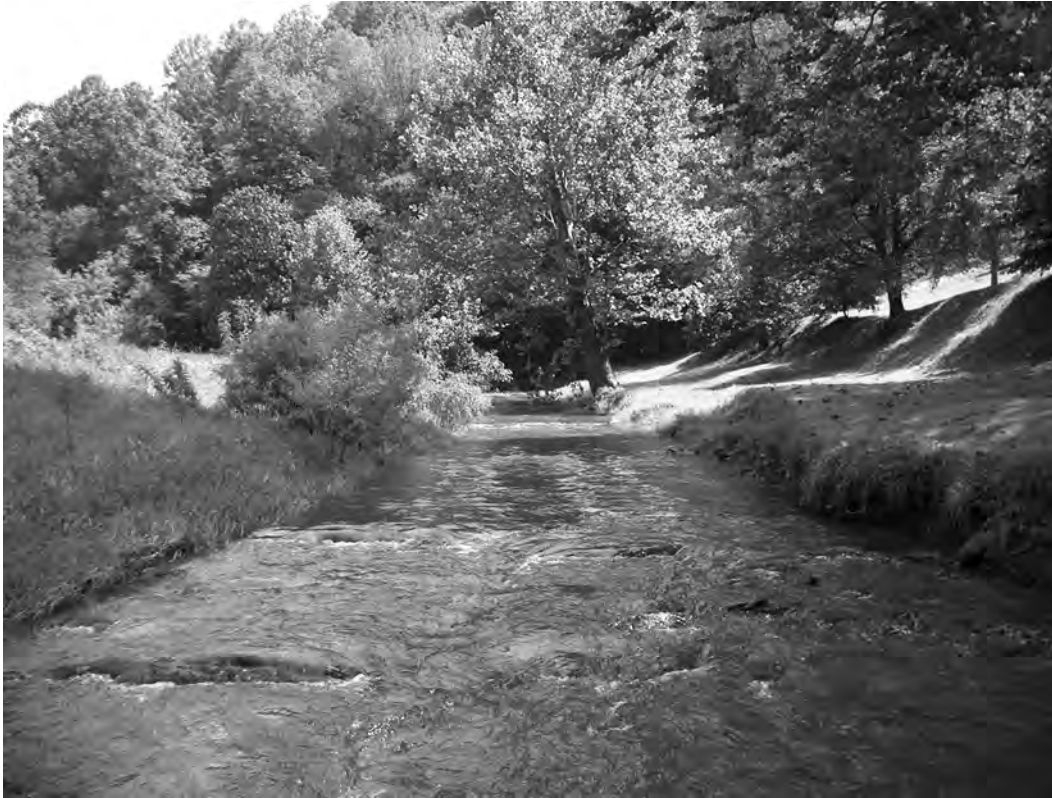
Station 03489800
Cove Creek near Shelleys, Va.

View looking upstream at reach of Cove Creek near Shelleys, Va.

This site is a crest stage streamflow-gaging station attached to an upstream wingwall of a bridge. The only point on the stage discharge rating above the bankfull discharge was estimated with the contracted opening method indirect measurement. The bridge opening is narrow and the structure likely causes a backwater effect at high flows including bankfull. Although there are no piers in the channel, the bridge cuts off access to the flood plain completely.

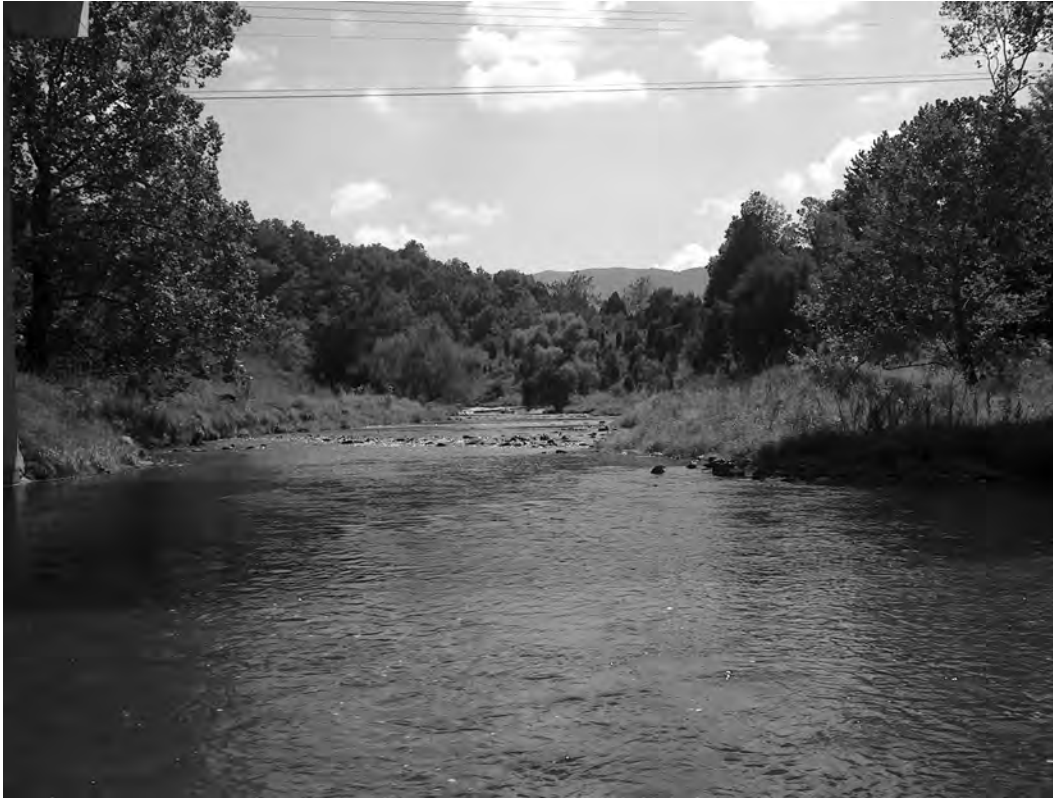
Station 03523000
Big Cedar Creek near Lebanon, Va.

View looking upstream at reach of Big Cedar Creek near Lebanon, Va.

This site has a crest-stage streamflow-gaging station and the measurement record is limited. Most measurements were made during the 1950's and early 1980's. The station is located on a pier of an old bridge. The bridge deck is gone, but two abutments remain. A new highway bridge spans the channel. Neither structure seems likely to impede flow.

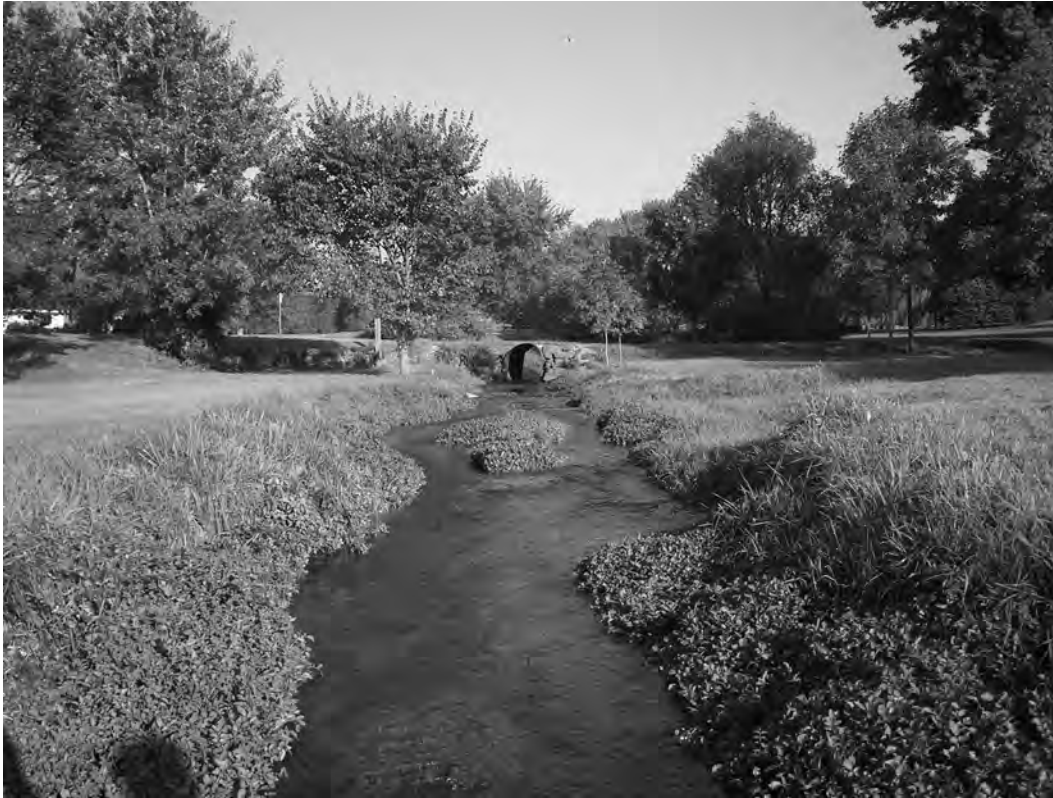
Station 3475600
Cedar Creek near Meadowview, Va.

View looking upstream at reach of Cedar Creek near Meadowview, Va.

This site has a crest-stage streamflow-gaging station only. Very few measurements have been made at the site, all of which were far less than the bankfull discharge. The rating is theoretical and several measurements do not fit the rating curve well. The upstream end of the study reach is crossed by a one lane bridge over a 48-inch culvert. The culvert may restrict the high flows to some degree. There is also a culvert near the downstream end of the study reach where the crest-stage station is located, which may also restrict bankfull flows.
