COMPLETE MOSAIC, MORNING SCENE, CAMERA 2

THE VIKING MISSION Two Viking spacecraft, each consisting of an orbiter and lander, were launched from Kennedy Space Center on August 20 and September 9, 1975. The Viking 1 spacecraft arrived at Mars on June 19, 1976, and was placed in a highly elliptic orbit around the planet at a periapsis altitude of nearly 1500 km. The orbiter cameras were used in conjunction with other instrumental methods to find a suitable landing site for the lander. After about 30 days in orbit, the lander was separated from the orbiter, and on July 20, 1976, Viking Lander 1 touched down on the surface of Mars at lat 22.483° N.\* and long 47.968° W. (Morris and Jones, 1980) on the west edge of a large basin called Chryse Planitia. It landed in a stable position at a 3° tilt downward in the direction 284.9° clockwise from north. The side of the lander on which the two cameras are mounted faces southeast. When the cameras are pointed in a direction normal to the front of the lander, the viewing direction is 141.6° clockwise from north along the horizon. The first picture from the surface of Mars, of an area near the lander's footpad 3, was taken immediately after lan

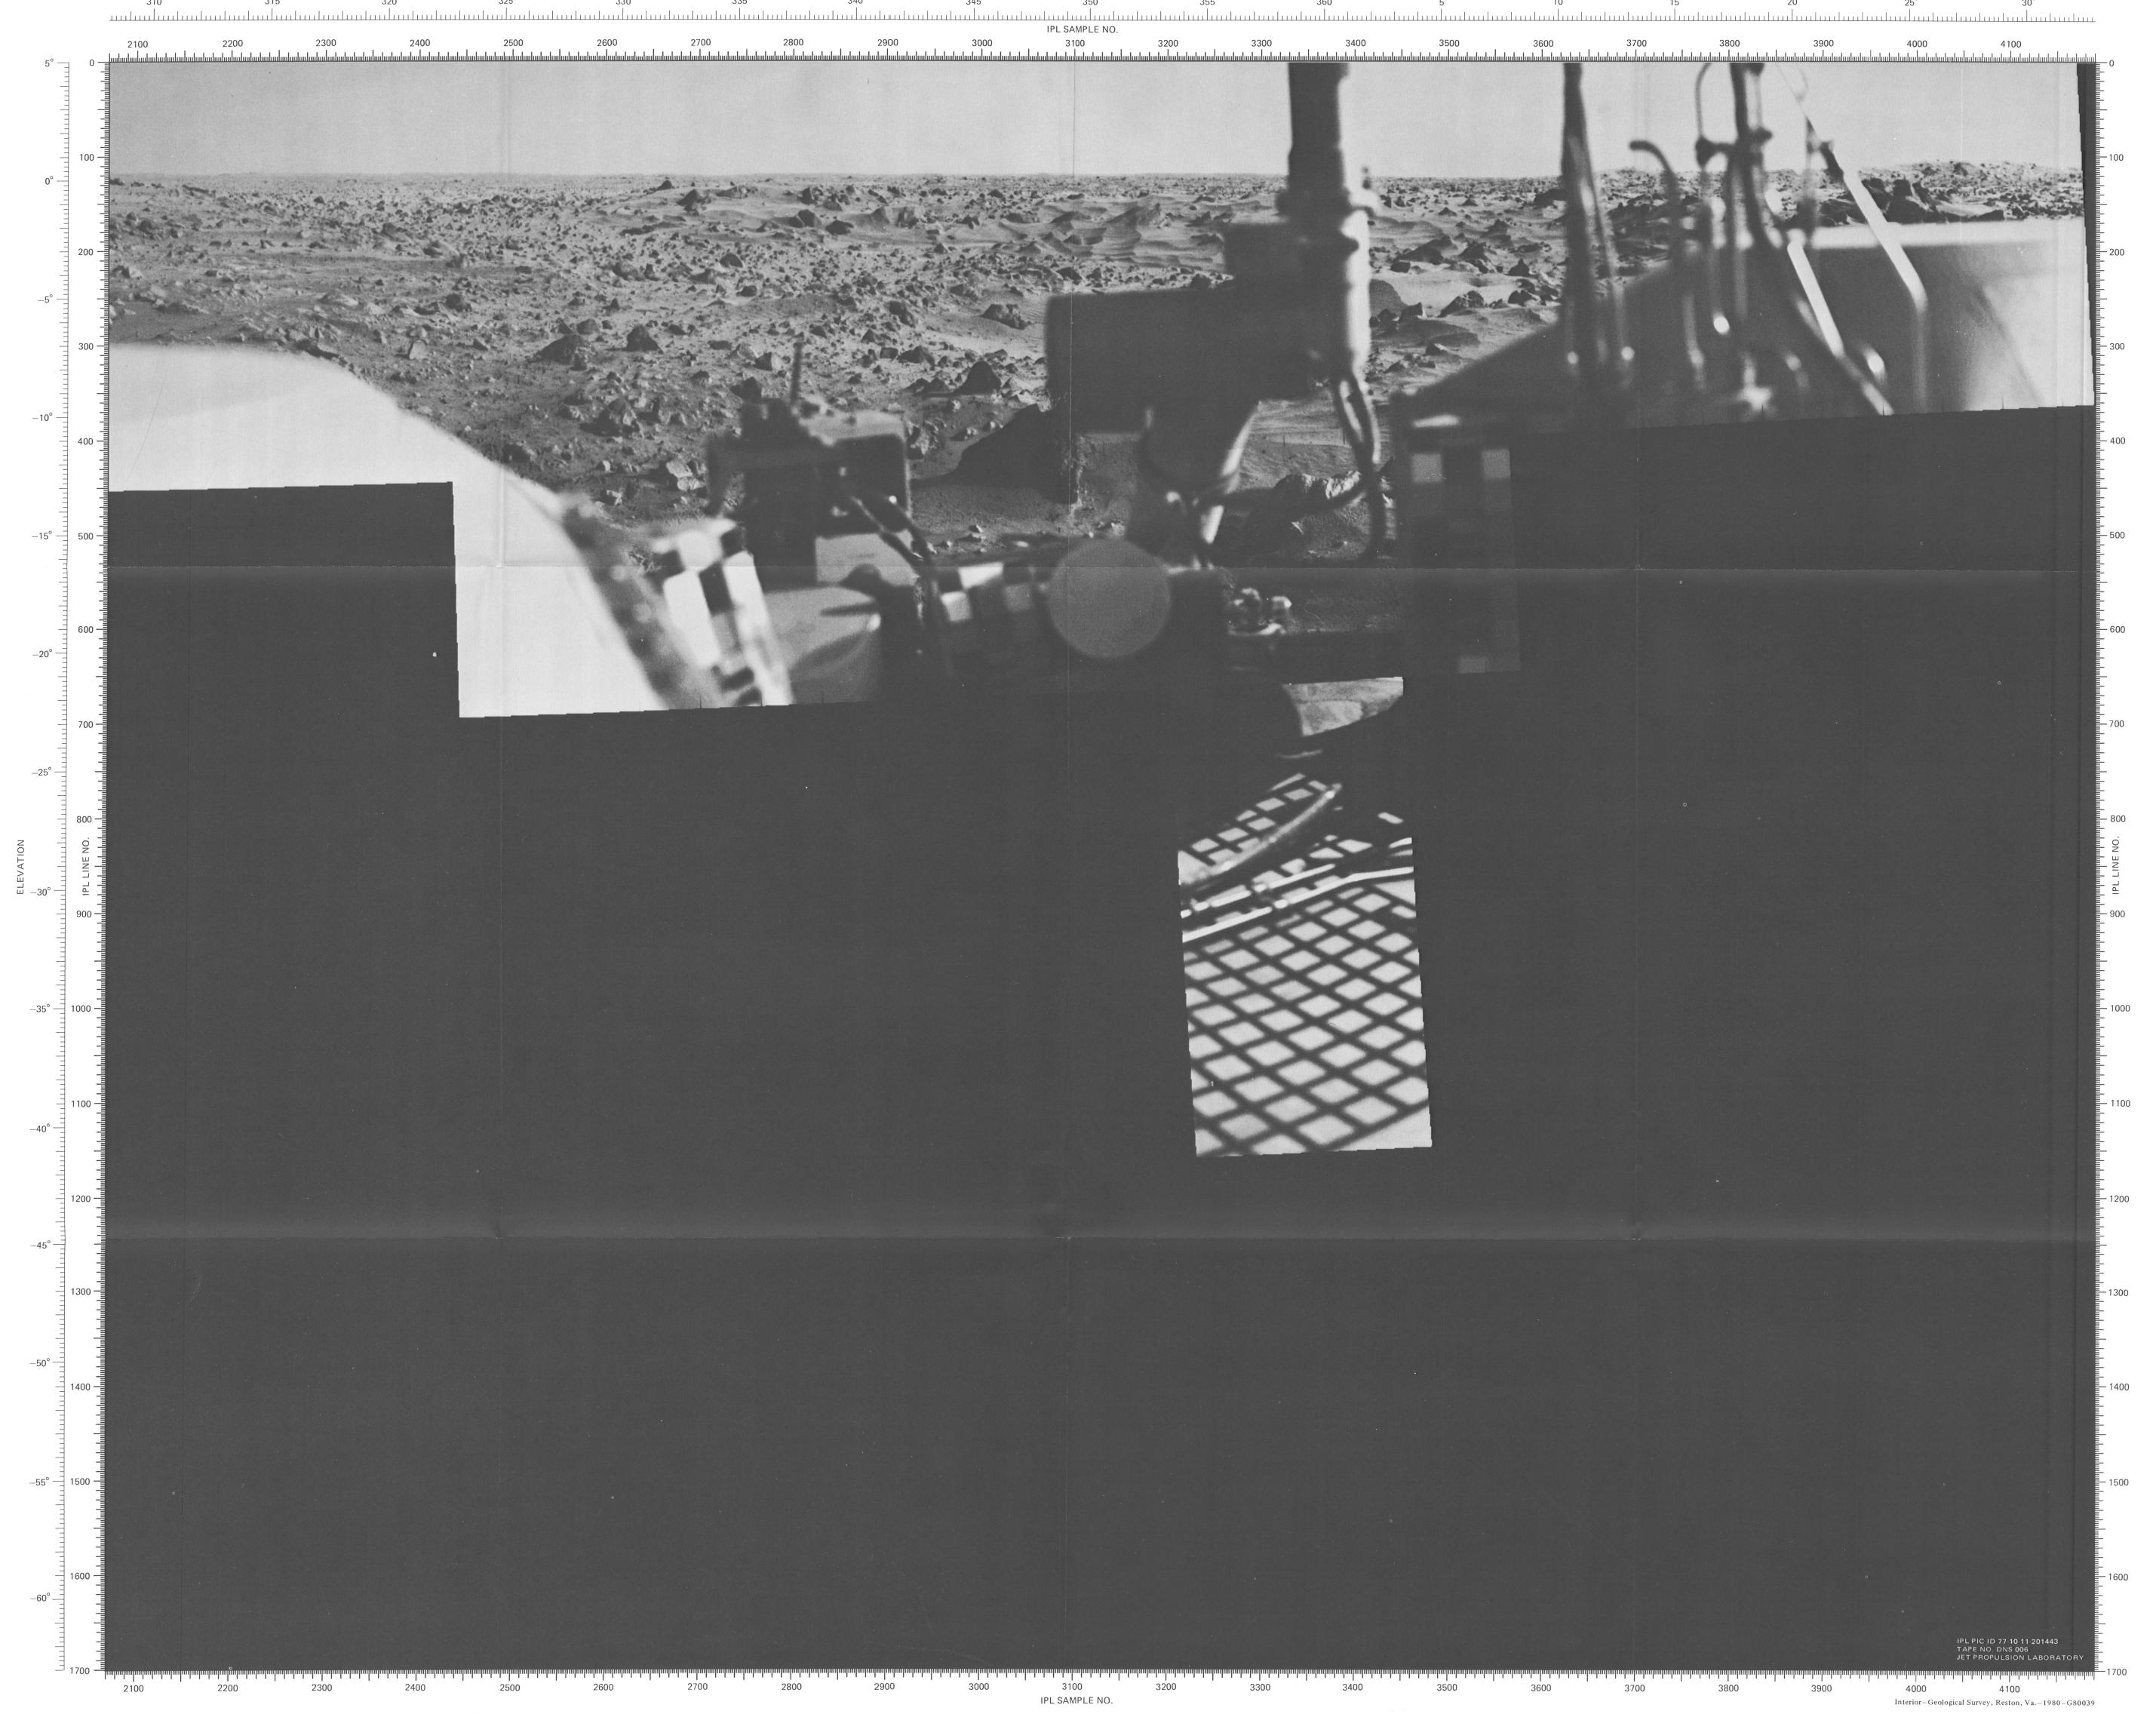
CAMERA CONTROL AZIMUTH AZIMUTH ANGLES FROM MARS NORTH

DESCRIPTION OF SCENE The view is north, directly over the top of the lander. The terrain behind the lander is a flat, level plain littered with angular blocks centimeters to meters in size, which are buried in places by drifts of very fine grained material. The surface has less relief than the terrain in front of the lander. Parts of the lander block the view of the foreground. The mast of the high-gain antenna dominates the center of the scene (line 200, sample 3350). The two large bright objects on each side are covers of the Radioisotope Thermoelectric Generators (RTG's) that power the lander. Three photometric calibration charts for the cameras are seen mounted on top of the lander (line 650, sample 2750; line 600, sample 3000; line 450, sample 3500). A circular magnifying mirror used to view particles on magnets mounted on the collector head of the surface sampler is at the right center of the lander (line 575, sample 3150). A grid painted on top of the lander to aid in determining sizes of particles dumped onto it by the surface sampler is seen in the bottom center of the

GEOMETRY OF THE MOSAICS The cameras on the Viking Lander acquire data by sampling in equal increments of elevation and azimuth angle. In the accompanying mosaic, 8 mm subtends a 1° horizontal or vertical angle, regardless of the place of measurement within the panorama. If the martian surface were flat, one pixel (0.04°) on the surface would be 1 mm wide at -60° camera elevation and 2 m wide at the horizon 3 km away. Characteristically for this type of imaging system, most straight lines in the scene appear curved in the reconstruction. This representation of the picture data differs from that of a con-

ventional camera having "point perspective" picture geometry, in which rays are projected from object space, through the perspective point in the camera lens, to an image The geometry of the lander pictures is complicated by additional factors. Because both landers are tilted with respect to the horizon, on the uncorrected pictures the horizon resembles a sine curve. Computer rectification of the pictures results in a straight horizon along which vertical angles can be measured with respect to the local gravity vector, and horizontal angles can be measured from martian north. These angles are not related in any simple way to the azimuth and elevation angles given in "camera coordinates" for the un-

There are other geometric distortions due to the camera: optic path distortion that affects a light ray after it passes the camera windows; and camera-system distortions, or "bolt-down" errors, that are caused by the way the cameras are mounted on the lander. The geometric transformation used in creating the mosaics took into account the optic path distortion but not the "bolt-down" errors. However, along the horizon, the error in azimuth angle is equal to the rotational "bolt-down" error for each camera to an accuracy of less than 1 pixel. The scale "azimuth angles from Mars north" has been adjusted to take into account this correc-The residual azimuth angle errors are less than 1 pixel along the horizon and become larger with steeper elevation angles and large lander tilts. For the worst case, Lander 2, camera 1, this error is a maximum of  $5.7 \pm 1$  pixels at  $-60^{\circ}$  elevation. The somewhat sinusoidal azimuth-dependent residual elevation error is a maximum of 3 ± 1 pixels for Lander 2, camera
