Shifting Shoals and Shattered Rocks— How Man Has Transformed the Floor of West-Central San Francisco Bay

Circular 1259

By John L. Chin, Florence L. Wong, and Paul R. Carlson

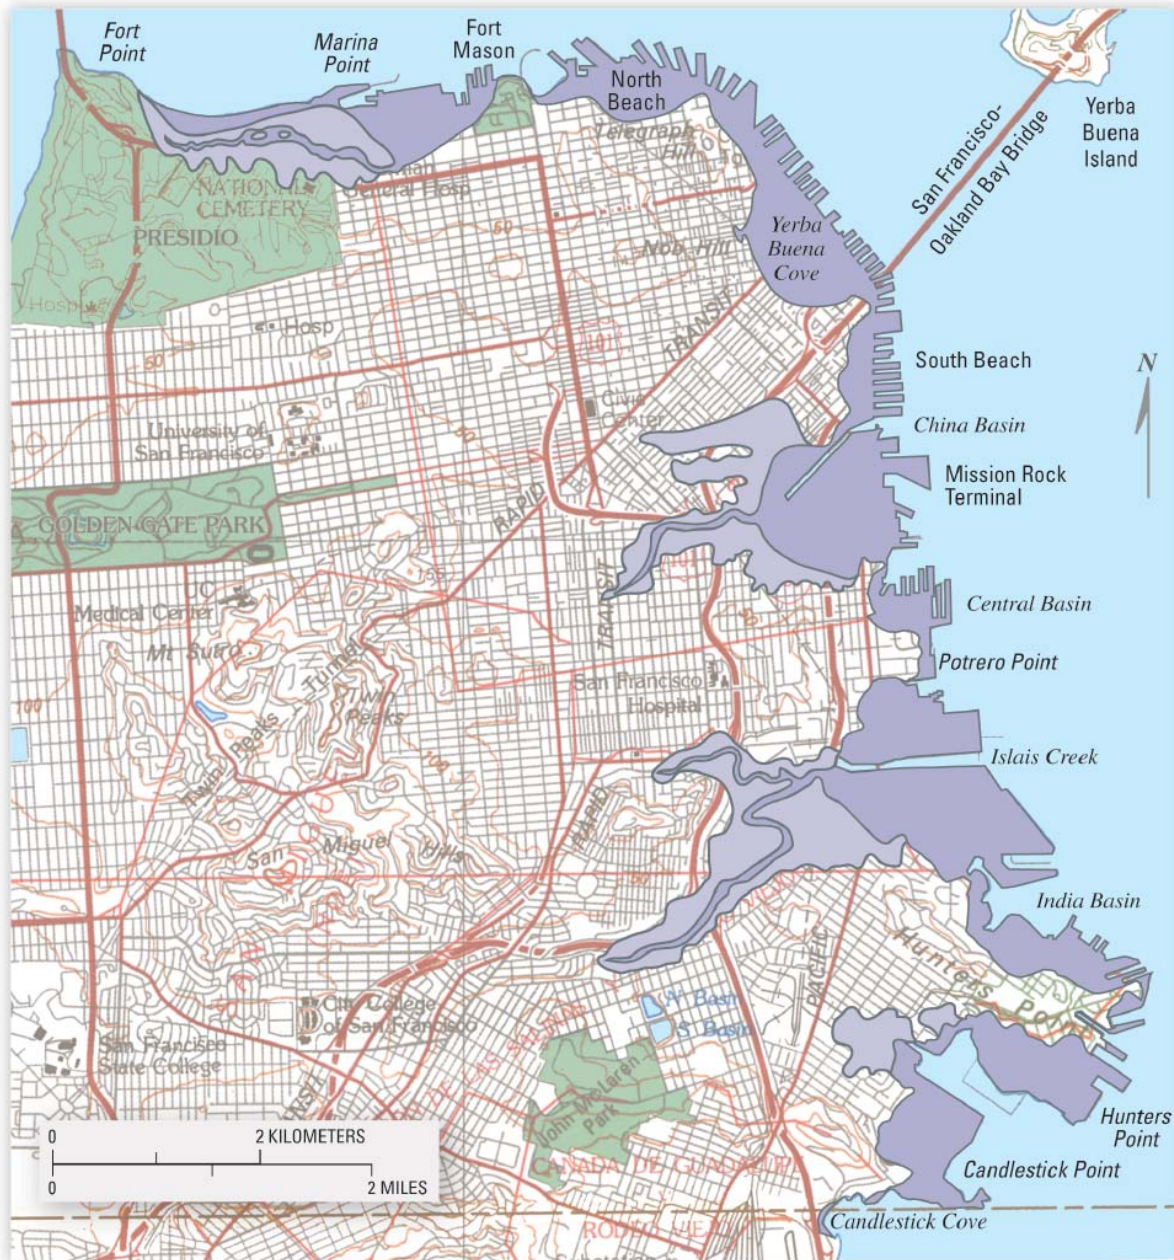
Figure 3. Historical changes to the bay margins in the City of San Francisco. Light purple, tidal marshlands that have been filled since 1847. Dark purple, open water areas filled since 1847. (Modified from Dow, 1973; base map is USGS San Francisco Quadrangle 1:100,000-scale topographic map, 1978 edition.)

The Marina District of San Francisco, adjacent to the southern margin of Presidio Shoal (fig. 3), has undergone significant modifications since about the mid-1800's. Dow (1973) and Bonilla (1991) documented extensive filling and alteration

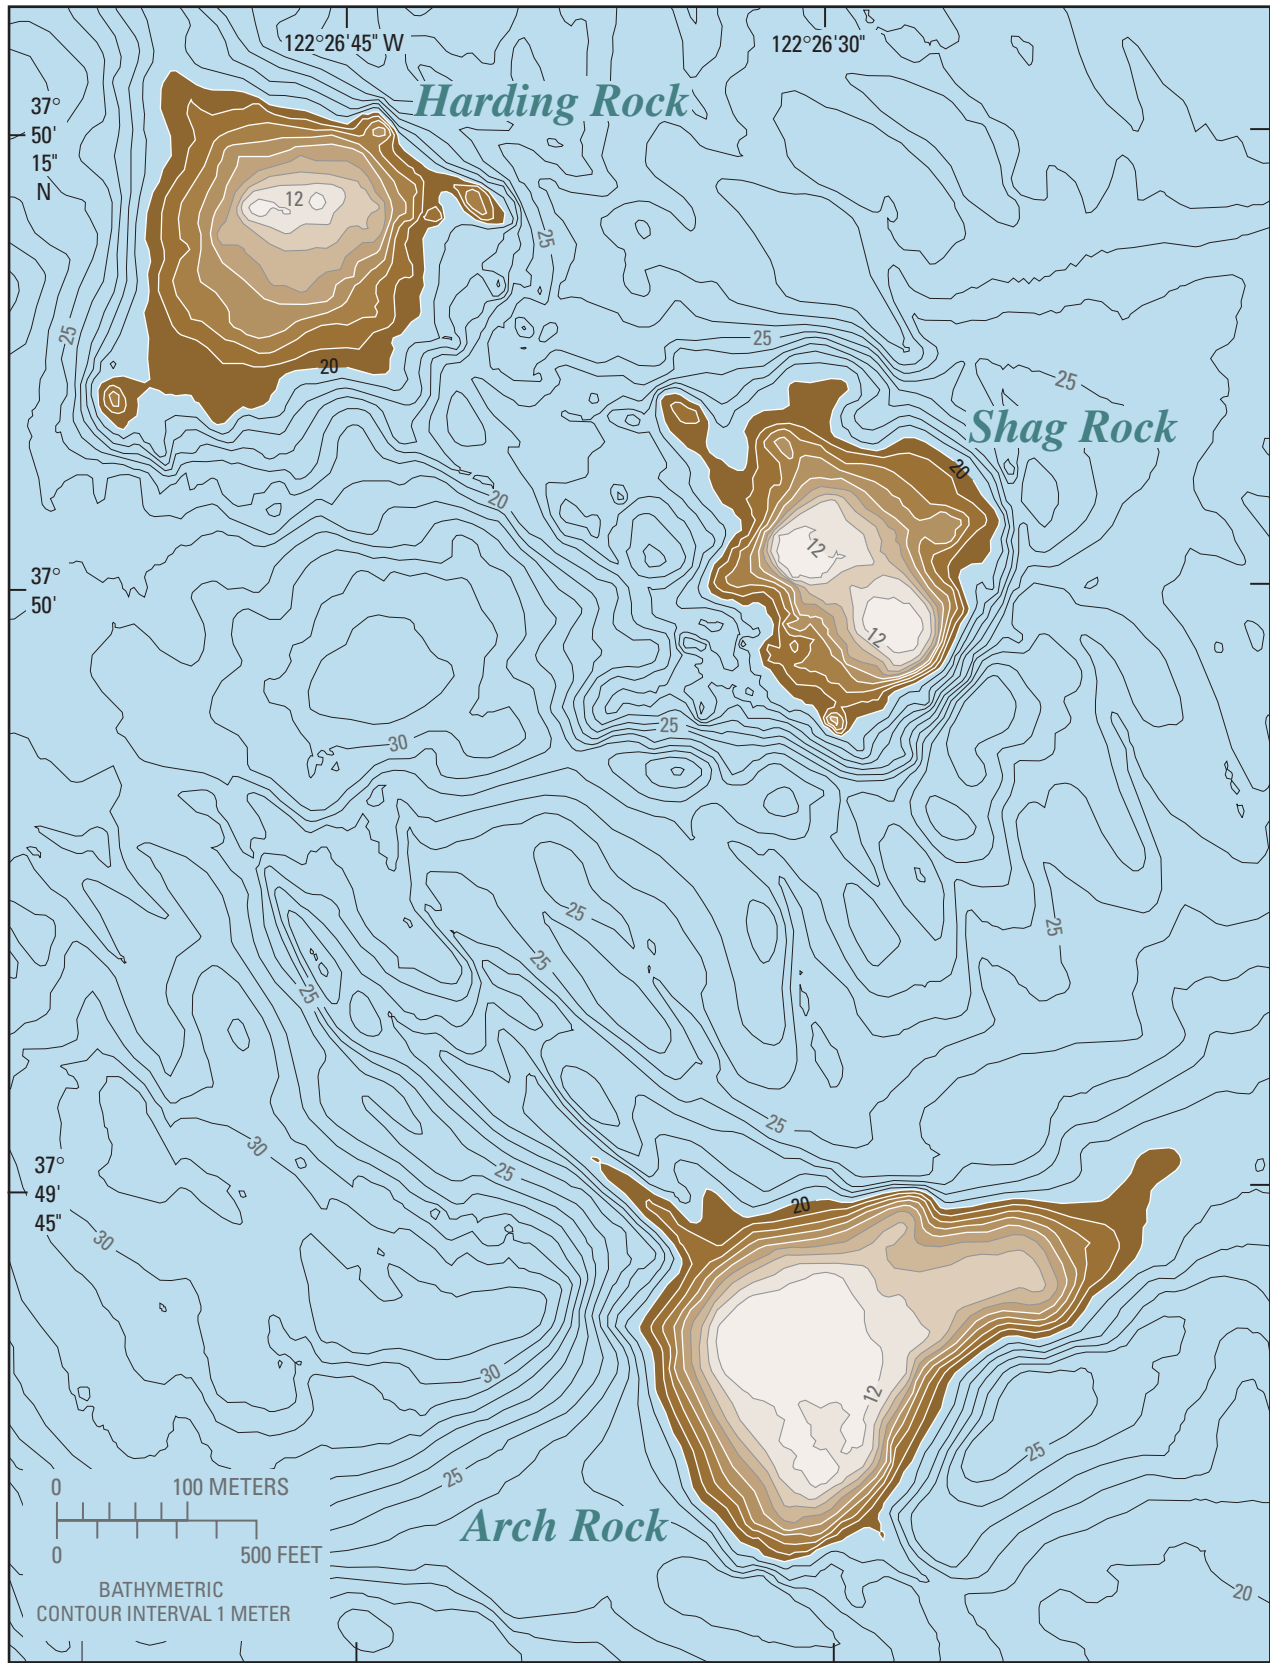
Figure 5. Bathymetry (water depths) over Harding, Shag, and Arch Rocks. Depths in meters corrected to MLLW (mean lower low water; the average height of the lower of the two daily low tides); contour interval is 1 m (1 meter=3.281 feet). Areas shallower than 20 m (66 feet) shown in brown shades. Data from 1997 U.S. Geological Survey multibeam (95 kHz) survey.

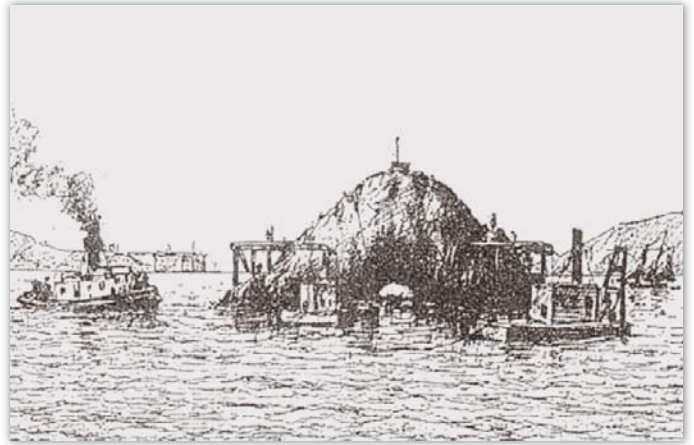
Figure 6. Sketch of Arch Rock (with the Golden Gate in the background) around 1900, before it was blasted away as a hazard to navigation. The opening through the rock was visible only at low tide, and navigating small boats through it provided a challenge to daring souls. The death of one such adventurer helped seal the rock’s fate. (Image courtesy of U.S. Army Corps of Engineers.)

The likely “natural” condition of these bedrock knobs, as evidenced by Angel and Yerba Buena Islands and by unmodified rock knobs, such as Red Rock, is a pointed or rounded peak. Before it was lowered by blasting, Arch Rock projected above water as a sharp cone, with a large opening through it (hence the name) visible at low tide (fig. 6). The relatively flat top of Alcatraz Island is known to be a result of man’s modifications since the 1800’s. All the flat tops of the submerged rock knobs in west-central San Francisco Bay probably have a similar origin.

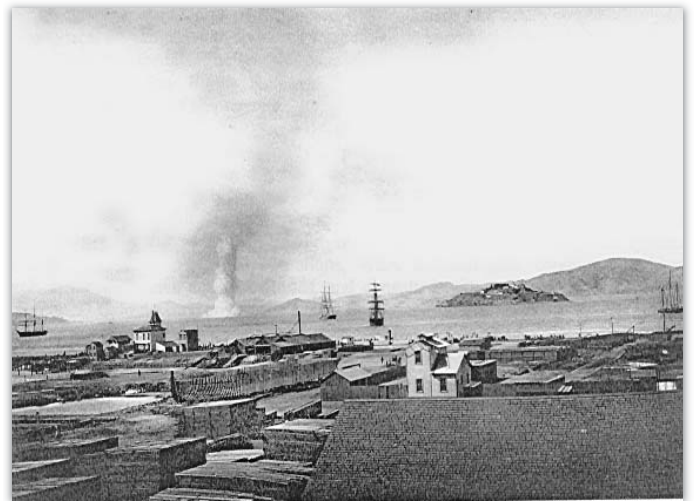
Figure 7. Blasting of Arch Rock in 1901 is seen in this photograph taken from San Francisco. Alcatraz Island is in the right middle ground. (Photograph courtesy of U.S. Army Corps of Engineers.)

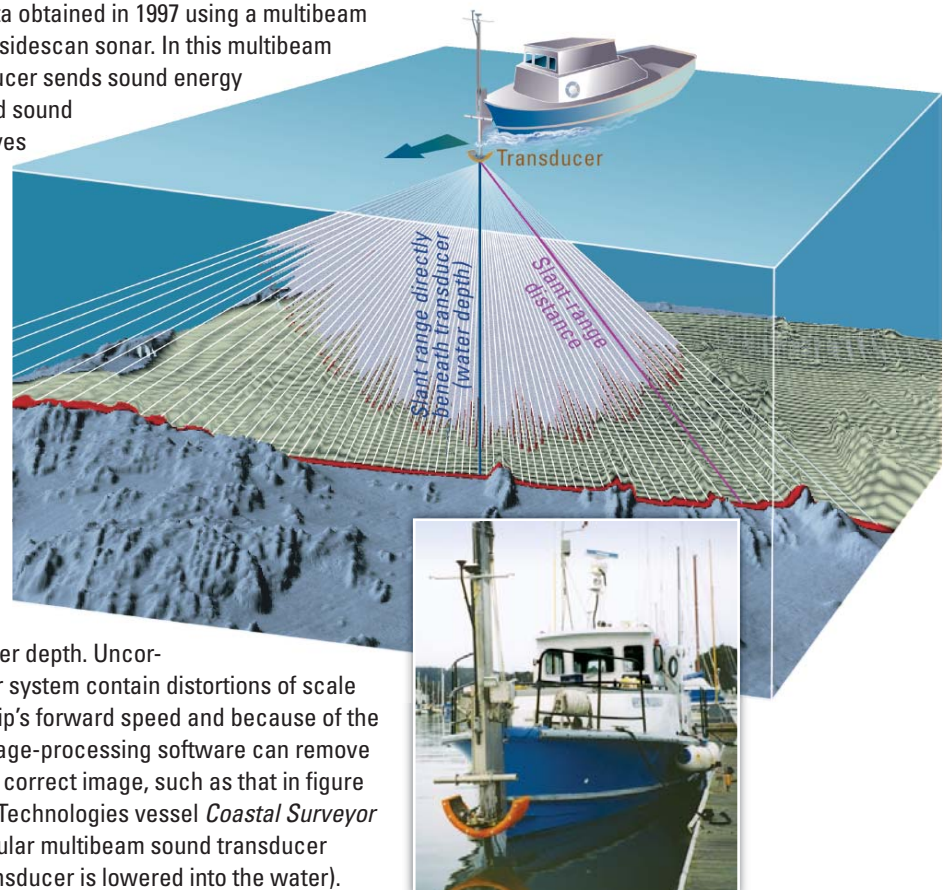
Figure 8. The U.S. Geological Survey shaded-relief image of the floor of west-central San Francisco Bay (fig. 2) was created from data obtained in 1997 using a multibeam swath bathymetry system, which is a variety of sidescan sonar. In this multibeam system, diagramed here, a hull-mounted transducer sends sound energy toward the sea floor and receives back reflected sound through multiple narrow beams. As the ship moves forward (toward the lower left in the diagram), it maps a swath of sea floor. The record or image created on the shipboard recorder has the ship's direction as one axis and the distance between the transducer and the bottom ("slant range") as the other axis. Strong returned signals ("high backscatter") form dark areas on the image; weak signals ("low backscatter") form light areas. The first signal returned is from directly below the ship, and its slant range is equal to the water depth below the transducer. Traditional sidescan-sonar systems produce similar images (see figs. 13 and 15-18), but because the transducer is towed behind the ship, data are not precisely referenced as to location and water depth. Uncorrected images produced by any sidescan-sonar system contain distortions of scale and shape, both because of variations in the ship's forward speed and because of the varying angles of the slant-range distances. Image-processing software can remove these distortions and produce a geographically correct image, such as that in figure 2. The 1997 survey was operated from the C&C Technologies vessel *Coastal Surveyor* (seen in the inset photograph with the semicircular multibeam sound transducer raised above water—during operations the transducer is lowered into the water).

Acoustic data were obtained with two different instrument systems. On the 1997 surveys, a Simrad EM-1000 multibeam swath bathymetry system was used to image the bay floor (fig. 8). Approximately 17.5 square miles (45 km²) of the bay floor was imaged using the multibeam system. This system simultaneously acquired spatially coregistered bathymetric and backscatter data at a frequency of 95 kHz. Tracklines were run with 100 percent overlap so as to produce a continuous mosaic of the area (fig. 2).

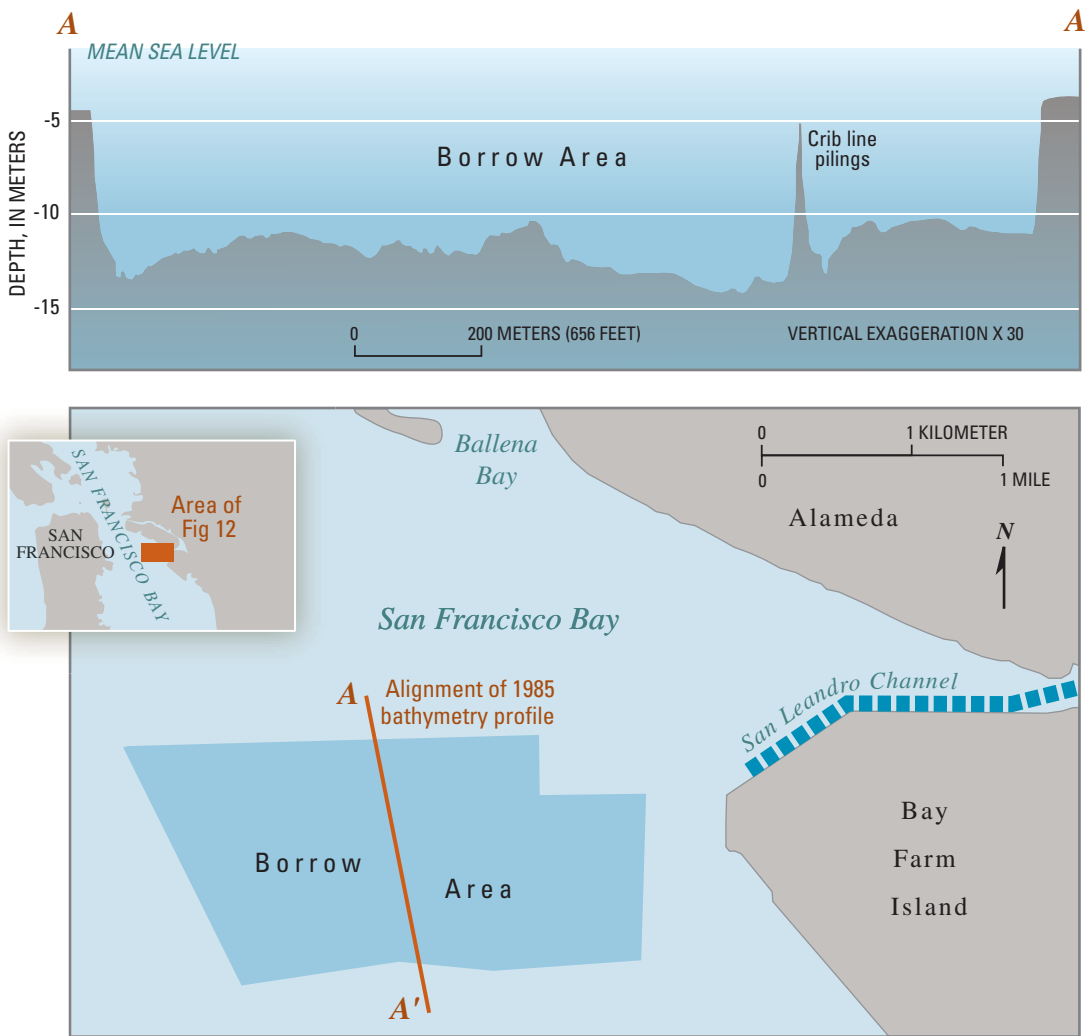
Figure 12. Bathymetric profile and map of borrow area set aside for dredging of fill material in San Francisco Bay adjacent to Bay Farm and Alameda Islands. This borrow area encompassed roughly 5.6 million square yards (4.7 million m²) and served as a source of sediment for construction fill on Bay Farm Island. It likely was excavated by a stationary dredge and in places was 26 to 33 feet (8-10 m) deeper than the surrounding area. (U.S. Geological Survey data collected in 1985 using 200-kHz sonar.)

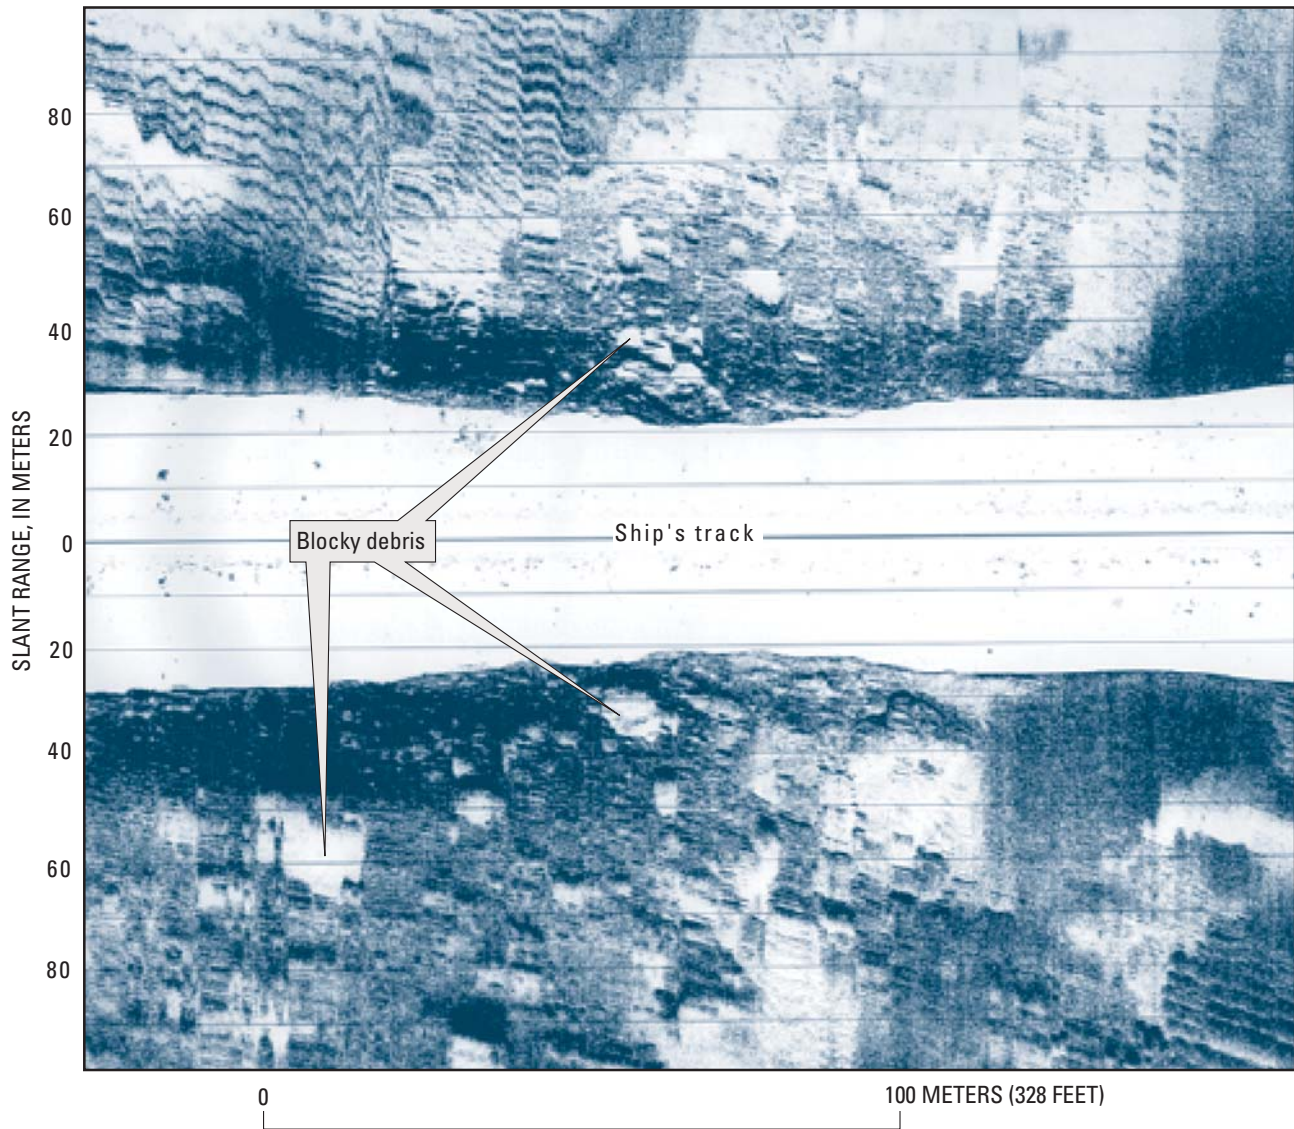
Figure 18. U.S. Geological Survey sidescan-sonar image (100 kHz; uncorrected) over Shag Rock collected in January 1999, showing the rocky debris that covers its surface. The debris includes boulders and blocky rubble of various sizes and shapes. On upper left side of figure are sand waves that terminate against the flank of Shag Rock. (For explanations of slant-range scale and light and dark areas in image, see figure 8.)

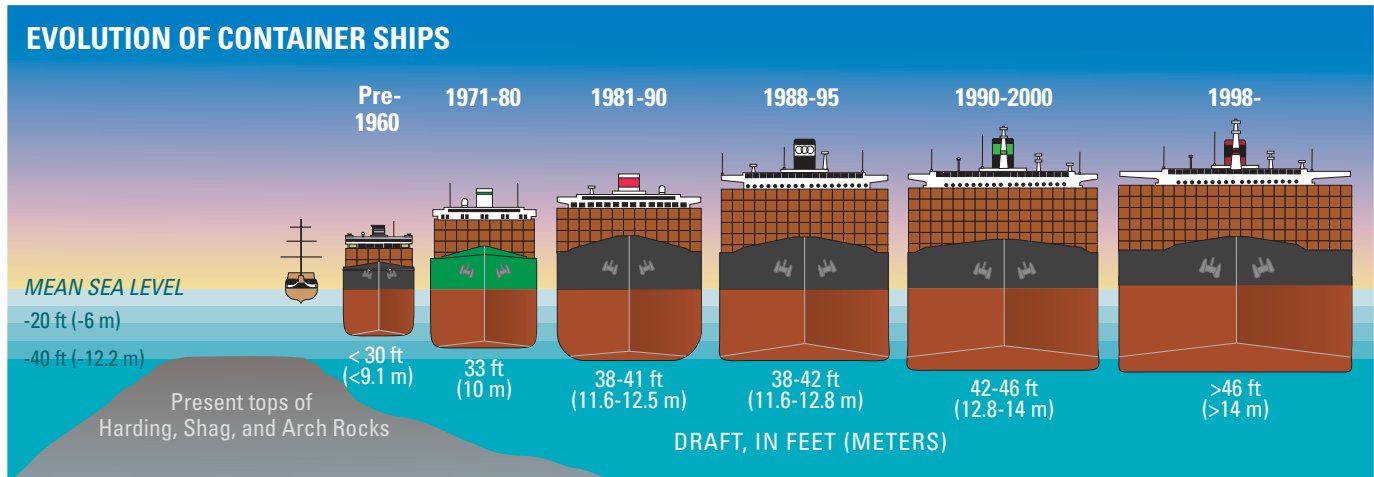
Figure 19. The evolution of vessel draft through time. Image at far left represents a sailing ship from the Gold Rush era; the other images show successive generations of ever-larger container ships. The evolution of oil tankers has paralleled that of container vessels, with increasing vessel size and draft over time. The bedrock knobs in San Francisco Bay that were artificially lowered to about 40 feet below mean sea level in the first half of the 20th century are clearly once again a potential hazard to the largest vessel (see fig. 20). Diagram modified from Pisani (1989); original schematic copyright by Port of Oakland, September 1989.

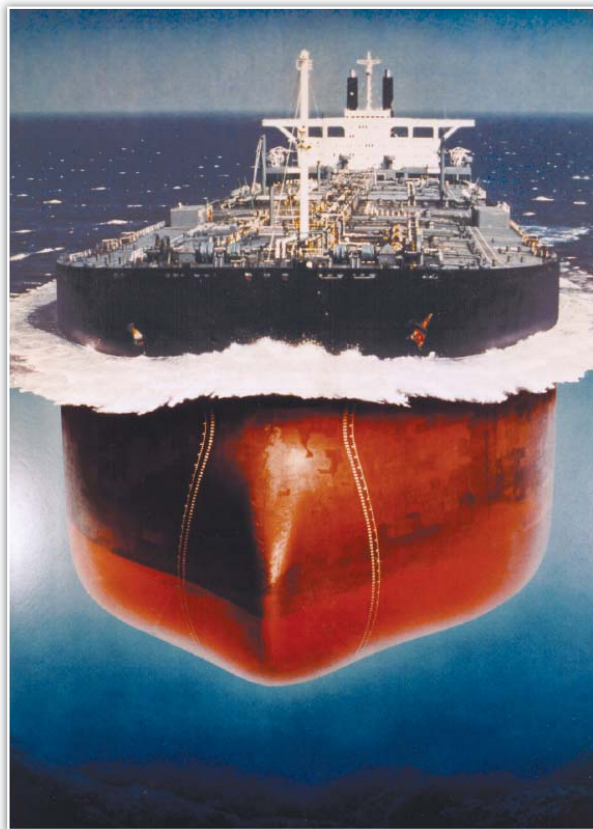
Figure 22. Large, modern oil tankers, when fully loaded, ride low in the water. However, as this combination photograph/diagram shows, the hull of the ship extends several tens of feet below the surface. (Image courtesy of Petroleum Association of Japan.)
